*Professional
Environmental
Services, LLC*

**200 Essex Street, Lynnfield, MA
Municipal Street Tree
Condition Report**

01/05/2024

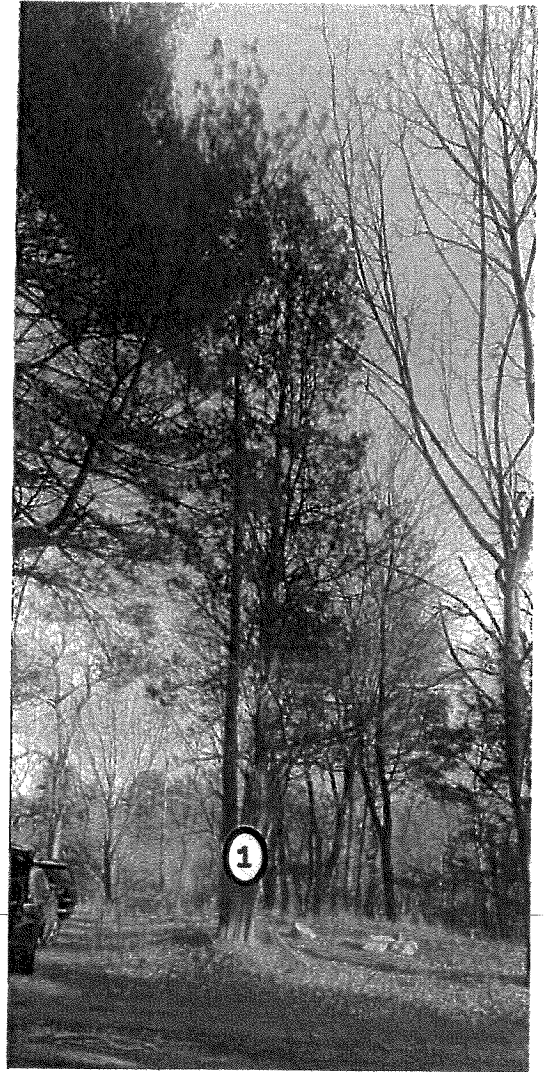
TREE # 1

CONDITION: There are numerous dead limbs in the crown of the tree with the majority in the lower crown. The main trunk has sawdust at the base, indicating heart rot decay, there are many broken branches and a few cavities in the main trunk. It appears that the main trunk is made up of several leaders that grew together creating an opportunity for decay to develop where the leaders compete for growth space internally. Looking at the thinness of vegetated crown cover, the tree appears to be in decline. When sounding the tree with a sounding hammer there is indications of internal cavities. The candy cane probe showed the depth of cavities and the sounding hammer indicated internal decay.

RECOMMENDATION: Removal

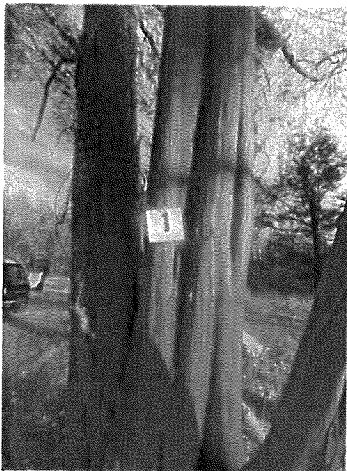
This photo shows the multiple competing leaders of Tree 1.

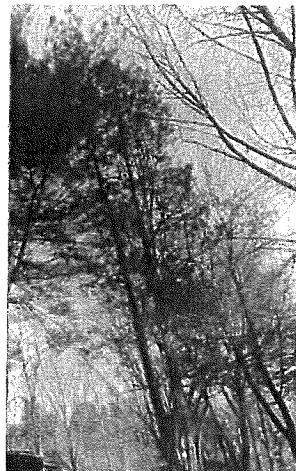
This photo shows the thinning canopy of Tree 1.

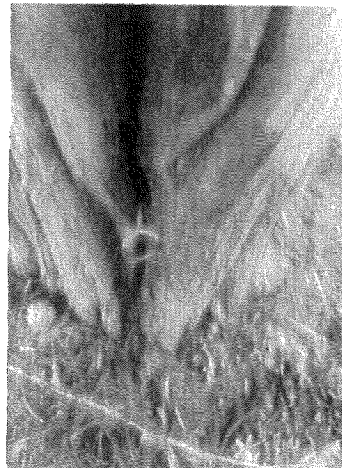
This photo shows the candy cane probe sunken most of the way into the trunk gap of Tree 1.

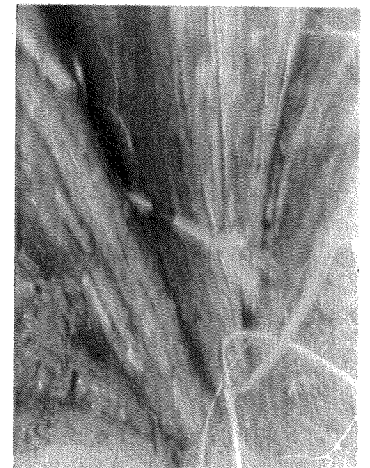
This photo shows the candy cane probe sunken over halfway into the trunk gap of Tree 1.

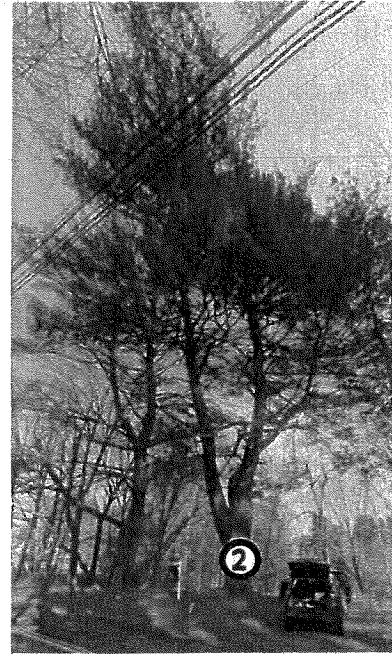
TREE # 2

CONDITION: A major leader was removed at one point in time at about 4 feet up the trunk, leaving a large seam beneath it with internal heart rot. Just above the removed leader are two other large leaders that are overhanging the roadway with weak branch unions and applying weight over the area where the bark is split and there is heart rot present. At the base of the tree there are numerous insect holes, numerous dead branches throughout the crown which overhang the roadway. The majority of the tree and the tree's leaders are all putting weight towards the roadway, creating a major liability for pedestrian and vehicular traffic. There had been some branch removals with cavities now present. The candy cane probe showed the depth of cavities and the sounding hammer indicated internal decay.

RECOMMENDATION: Removal

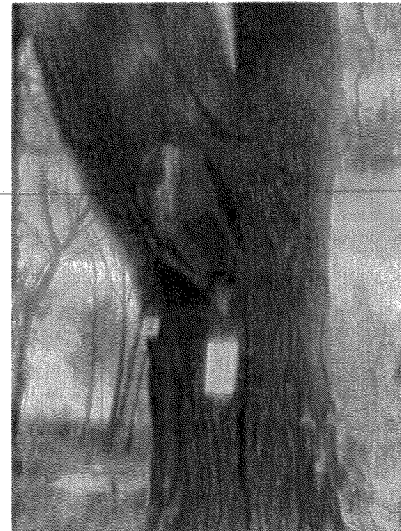
This photo shows the removed leader stub with seams above, beside and below the stub of Tree 2.

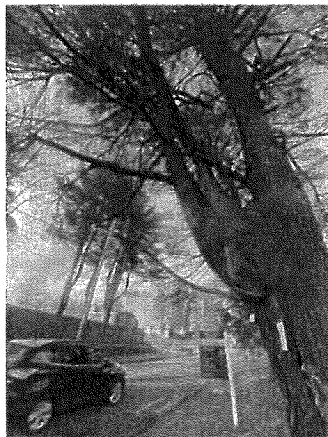
This photo of Tree 2 shows the damaged area of the tree, dead limbs and the tree leaning over vehicular traffic.

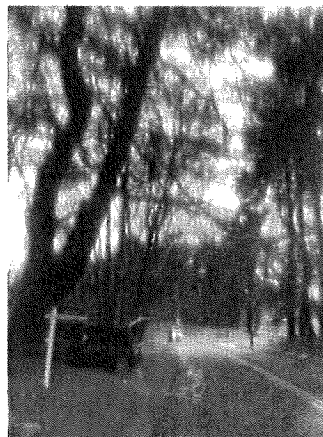
This photo of Tree 2 shows the tree and its two major leaders leaning over the roadway with the high school entrance in the background

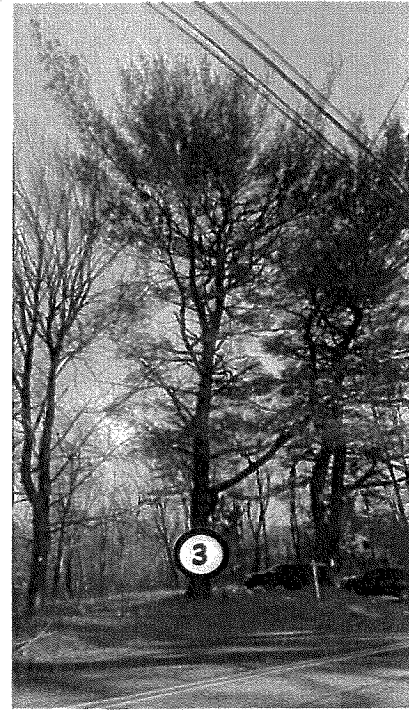
TREE # 3

CONDITION: Just above the root flare facing the street side of the tree is a large sunken area, indicating there may be an internal cavity. There are numerous dead limbs in the crown overhanging the roadway at the top of the tree about 30 feet up is a large branch union that is a weak union. A very thin crown indicates that the tree is in decline. The sounding hammer indicated internal decay. The tree is weighted toward the roadway.

RECOMMENDATION: Removal

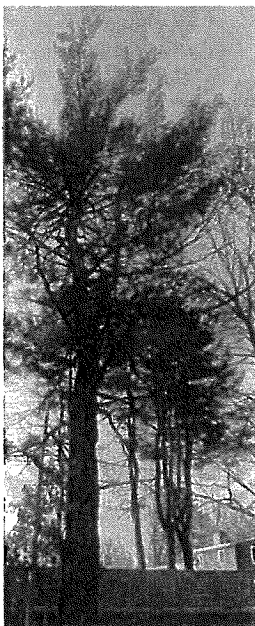
This photo shows the main trunk of Tree 3 leaning toward the road.

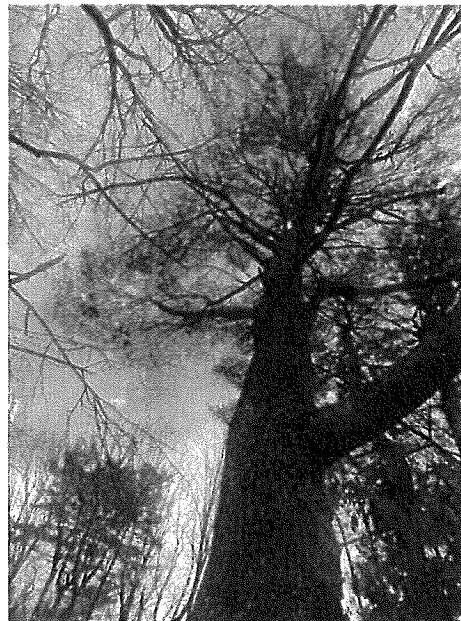
This photo shows the declining crown of Tree 3.

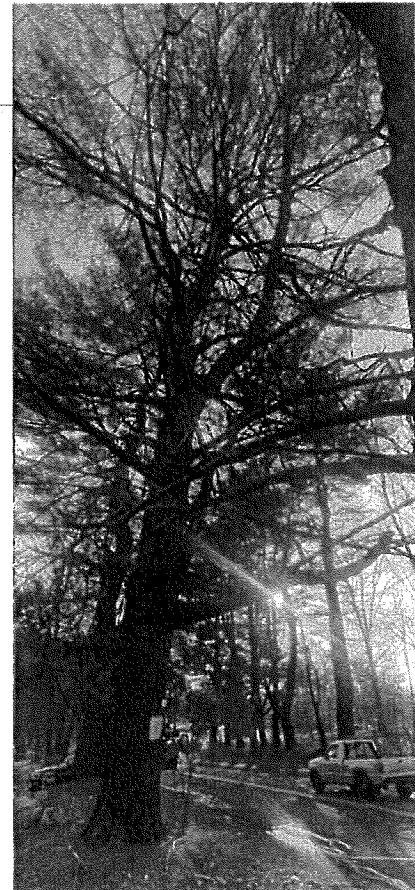
This photo shows the large dead and dying leaders of Tree 3 overhanging the roadway.

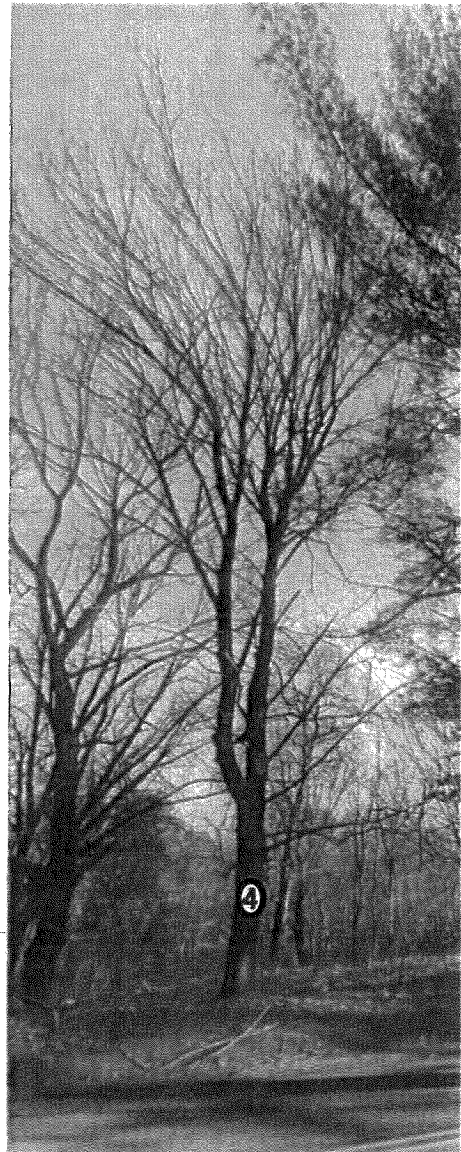
TREE # 4 Invasive Tree species

CONDITION: Tree has numerous dead branches in the lower part of the crown and throughout the crowns three main leaders. The tree has a weak branch union and many dead branches overhanging the roadway. The tree leans towards the roadway. Several branches had broken off, leaving cavities at the point of breakage. The tree is in decline.

RECOMMENDATION: Removal

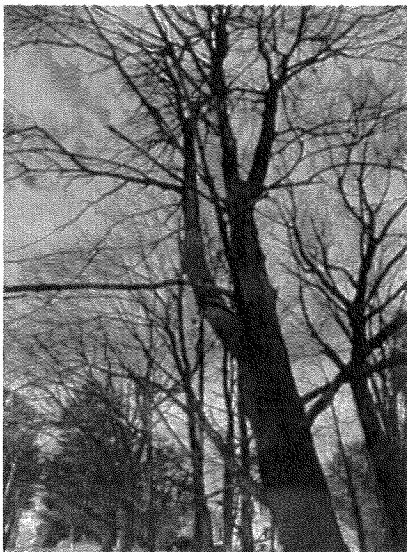
This photo shows a sunken area on the trunk of the tree the three main leaders in Tree 4.

Tree # 4 is a Norway Maple tree is in decline, has numerous dead branches, a girdling root, and signs of branch decay at the branch collars where branches had broken off and heart rot decay indicated by sounding with a sounding hammer. This tree is an invasive species and should be removed before there is further failure of crown branches and leaders.

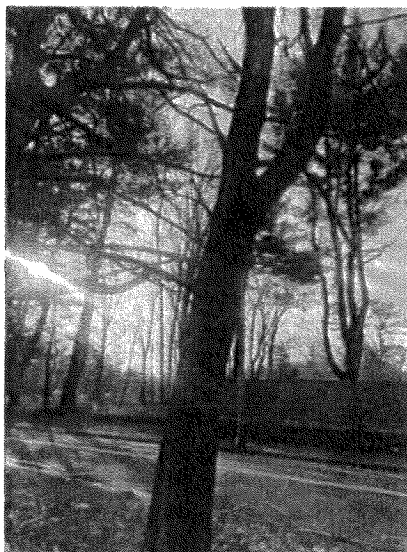
This photo shows Tree 4 leaning toward Essex Street.

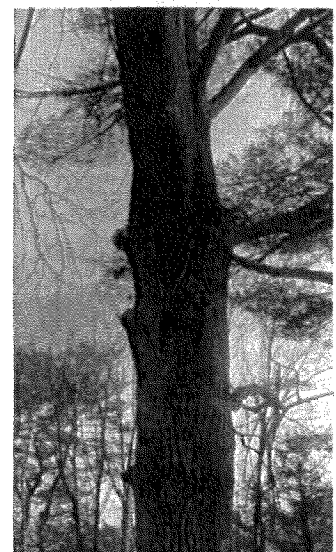
This photo shows the broken branch stubs of Tree 4 with cavities.
