# **922 Lynnfield Street, Lynnfield, MA Tree Protection Zone Assessment Report**

**For  
Richard A. Salvo, P.E.  
Engineering Alliance, Inc.**

**Prepared By:  
James M. MacArthur  
Owner and Business Manager**

**12/21/2022**

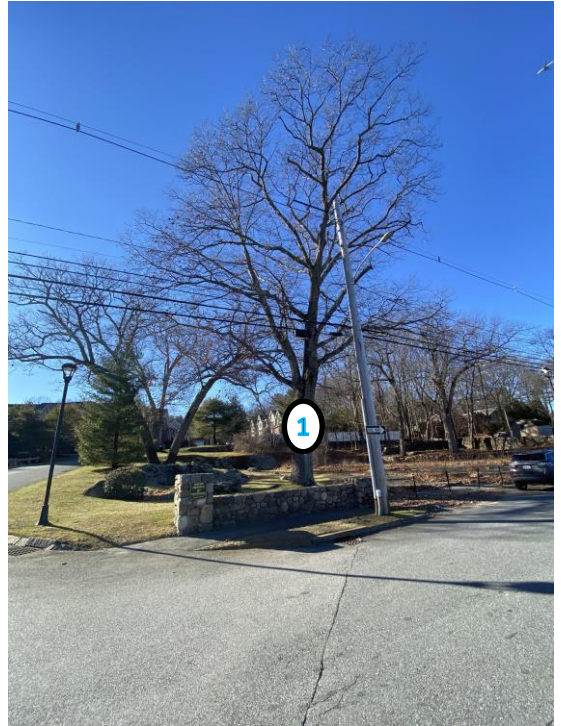
**TREE # 1**

**CONDITION:** There are several dead branches in the crown. The tree is crown overhangs the utility lines, sidewalk area and Lynnfield Street. There is staining on the bark at a major crown branch union which is an indication of a cavity at this point. The root flare has a girdling root and a conk is present on the root flare indicating internal degradation due to root rot.

**TARGET:** Lynnfield Street 922 Lynnfield Street property and the Lynnfield Street Sidewalk.

**RECOMMENDATION:** Removal

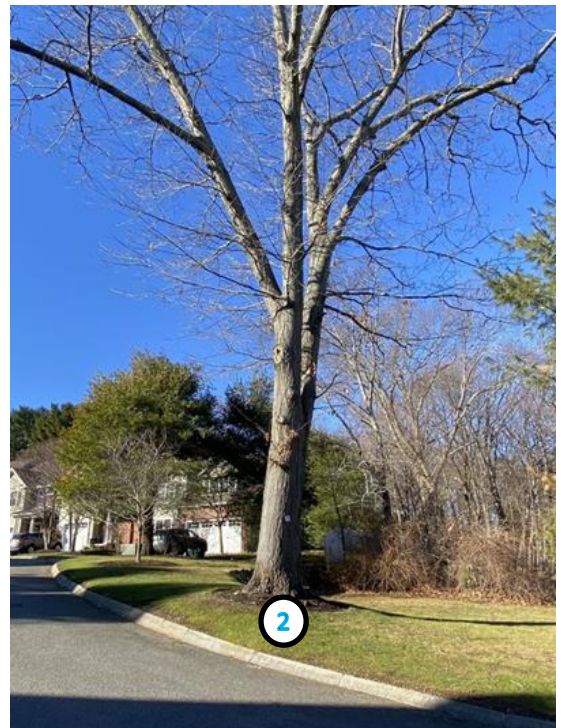
**TREE # 2**

**CONDITION:** There are several dead branches in the crown. There is staining on the bark at a major crown branch union which is an indication of a cavity at this point. The root flare has a girdling root.

**TARGET:** 900 Lynnfield Street Entrance way, 900 Lynnfield Street Condominium structure, and 922 Lynnfield street lot.

**RECOMMENDATION:** Retain

Tree number 2, Red Oak, is 35.5 inches DBH and is recommended to be retained due to its proximity to construction. See Exhibit D for the recommended tree protection measures.

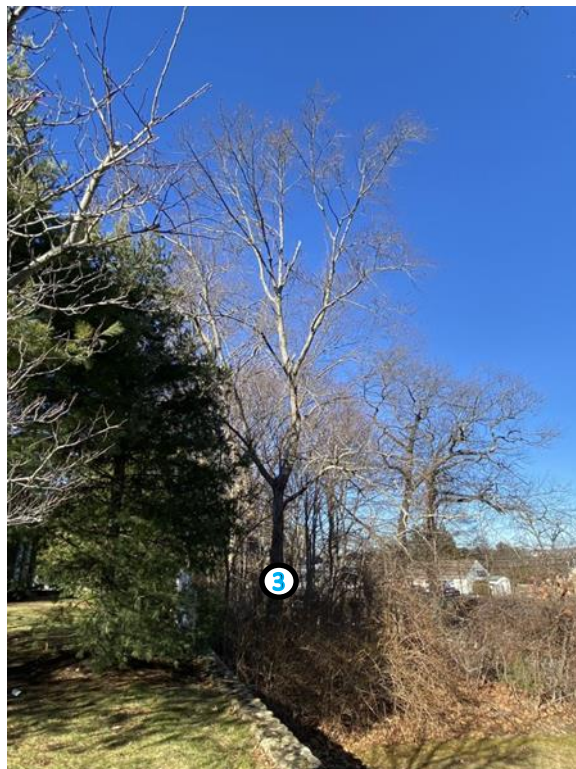
**TREE # 3** Invasive Tree species

**CONDITION:** Several dead and broken branches, decaying bark, sounding indicates internal decay and heart rot. The tree is in serious decline.

**TARGET:** High risk potential. 900 Lynnfield Street property fence and condominium structure.

**RECOMMENDATION:** Removal

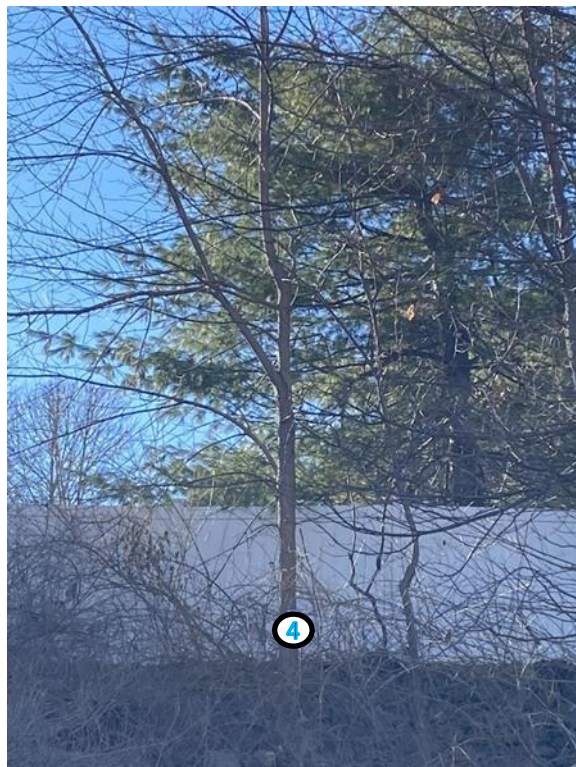
**TREE # 4**

**CONDITION:** Several dead and broken branches. The tree is in decline.

**TARGET:** High risk potential. 900 Lynnfield Street property fence and condominium structure.

**RECOMMENDATION:** Removal

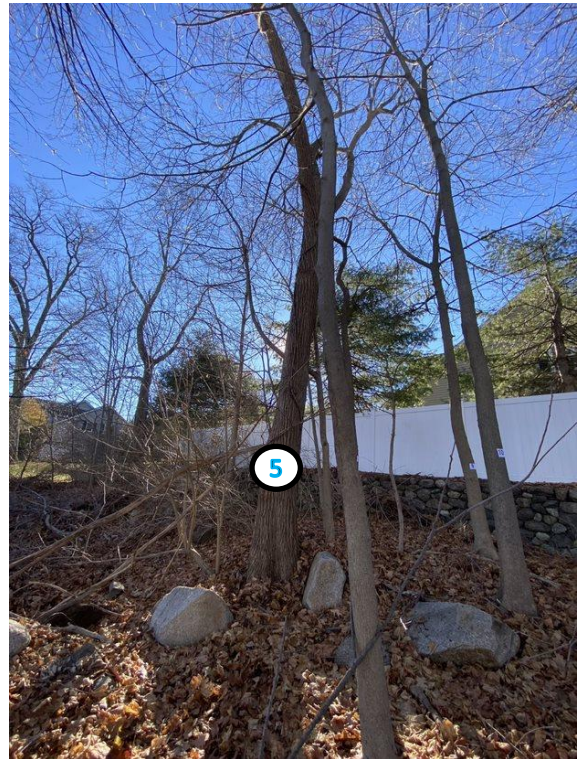
**TREE # 5** Invasive Tree species

**CONDITION:** Several dead and sounding indicates that the tree has internal decay and rot. The tree is in serious decline.

**TARGET:** High risk potential. 900 Lynnfield Street property fence and condominium structure.

**RECOMMENDATION:** Removal

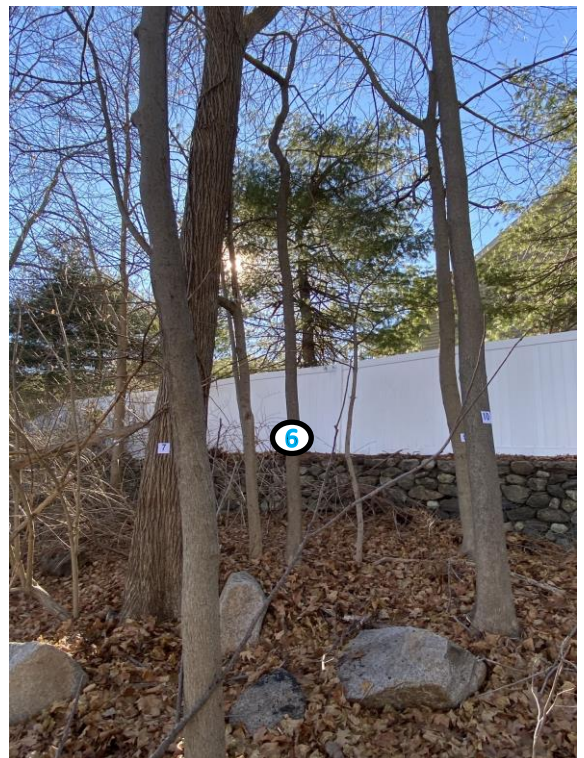
**TREE # 6** Invasive Tree species

**CONDITION:** Several dead branches.

**TARGET:** Medium risk potential. 900 Lynnfield Street property fence and condominium structure.

**RECOMMENDATION:** Removal

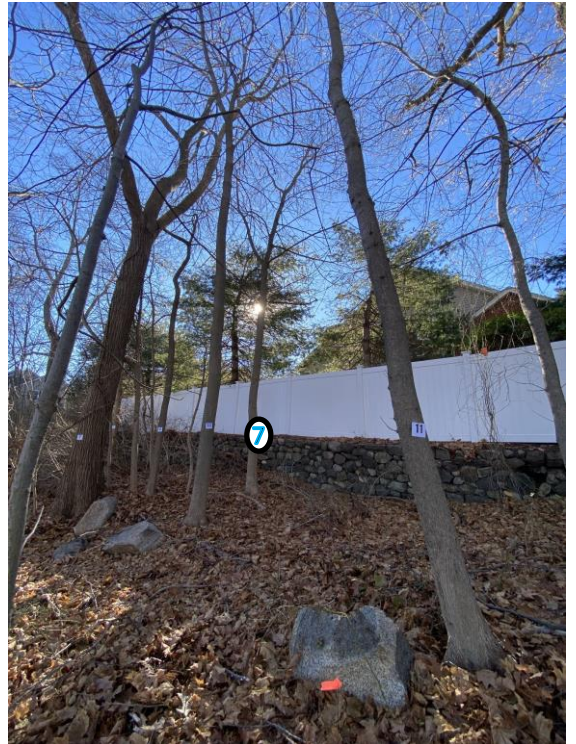
**TREE # 7 Invasive Tree species**

**CONDITION:** Several dead branches. Root flare swelling indicates root decay. The tree is in decline.

**TARGET:** Medium risk potential. 900 Lynnfield Street property fence and condominium structure.

**RECOMMENDATION:** Removal

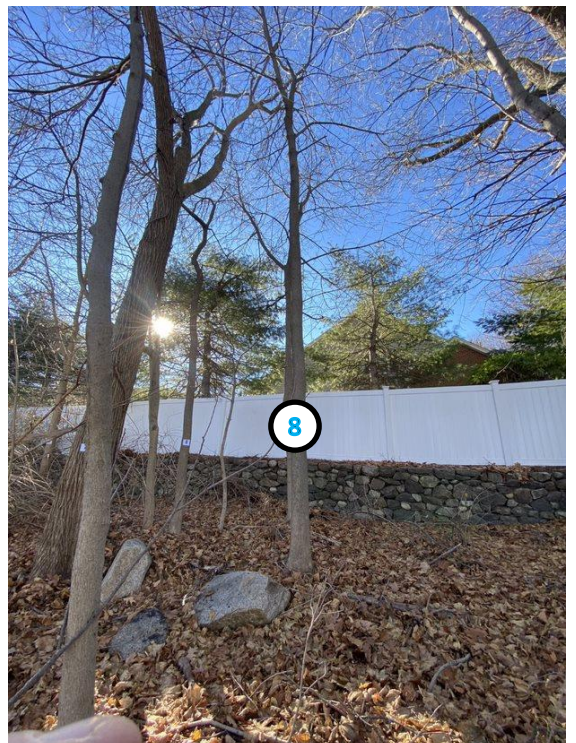
**TREE # 8 Invasive Tree species**

**CONDITION:** Several dead branches. The tree is in decline.

**TARGET:** Medium risk potential. 900 Lynnfield Street property fence and condominium structure.

**RECOMMENDATION:** Removal

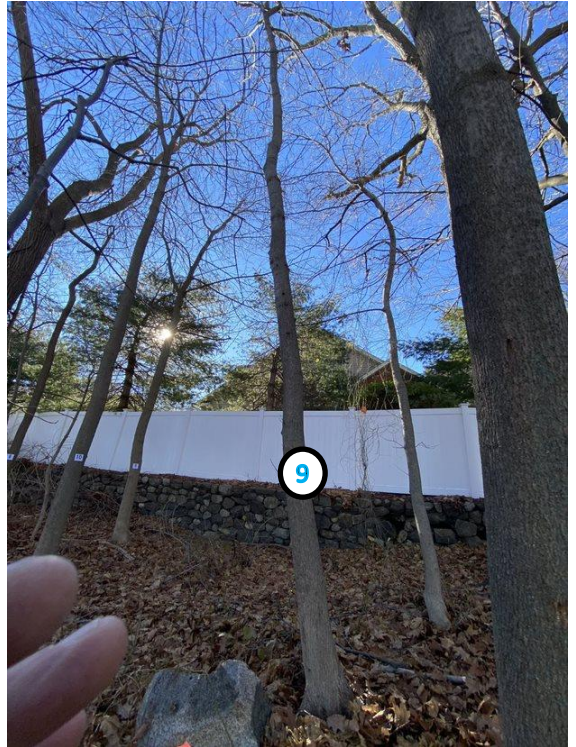
TREE # 9 **Invasive Tree species**

CONDITION: Several dead branches. Root flare indicates root rot. The tree is in decline.

TARGET: Medium risk potential. 900 Lynnfield Street property fence and condominium structure.

RECOMMENDATION: Removal

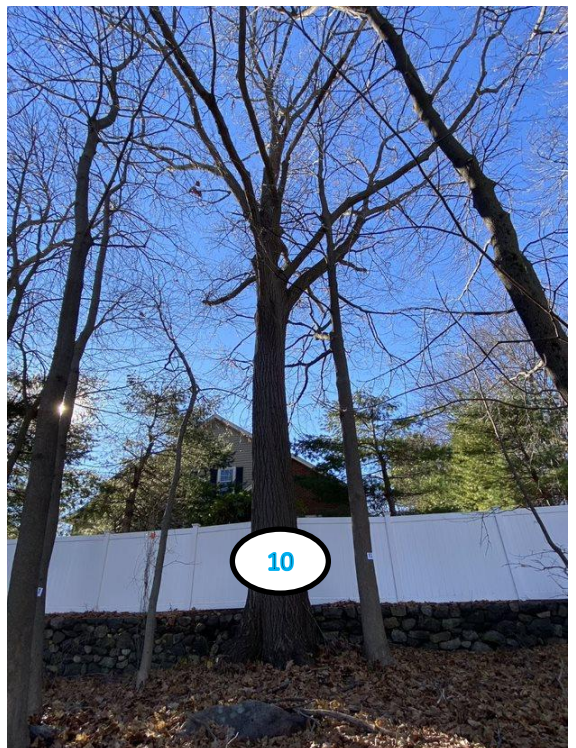
TREE # 10

CONDITION: Several dead branches. Sounding indicates internal decay and rot. Root flare indicates root rot. The tree is in serious decline.

TARGET: High risk potential. 900 Lynnfield Street property fence and condominium structure.

RECOMMENDATION: Removal

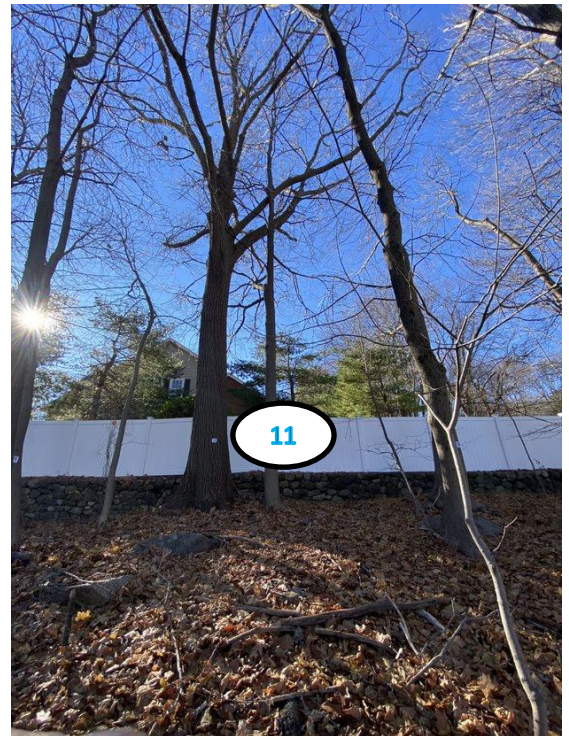
**TREE # 11 Invasive Tree species**

**CONDITION:** Several dead branches. Root flare indicates root rot. The tree is in decline.

**TARGET:** High risk potential. 900 Lynnfield Street property fence structure.

**RECOMMENDATION:** Removal

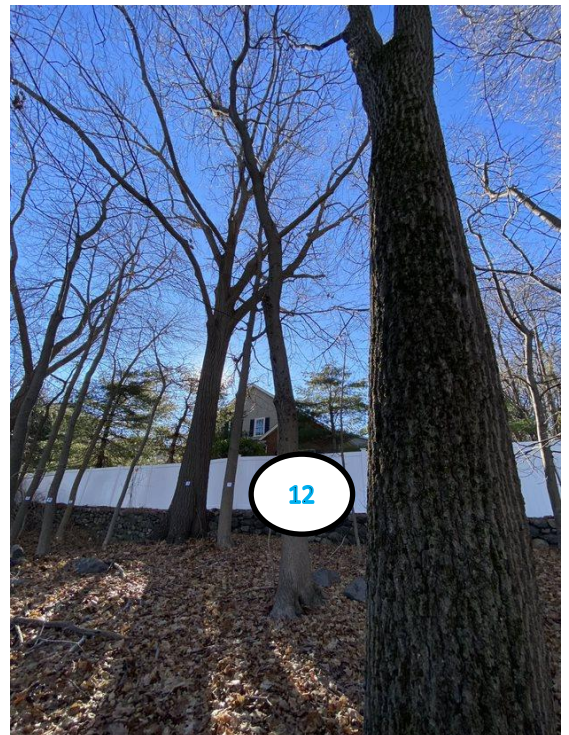
**TREE # 12 Invasive Tree species**

**CONDITION:** Several dead branches. Root flare indicates root rot and sounding indicates internal decay and heart rot. The tree is in decline.

**TARGET:** High risk potential. 900 Lynnfield Street property fence structure.

**RECOMMENDATION:** Removal

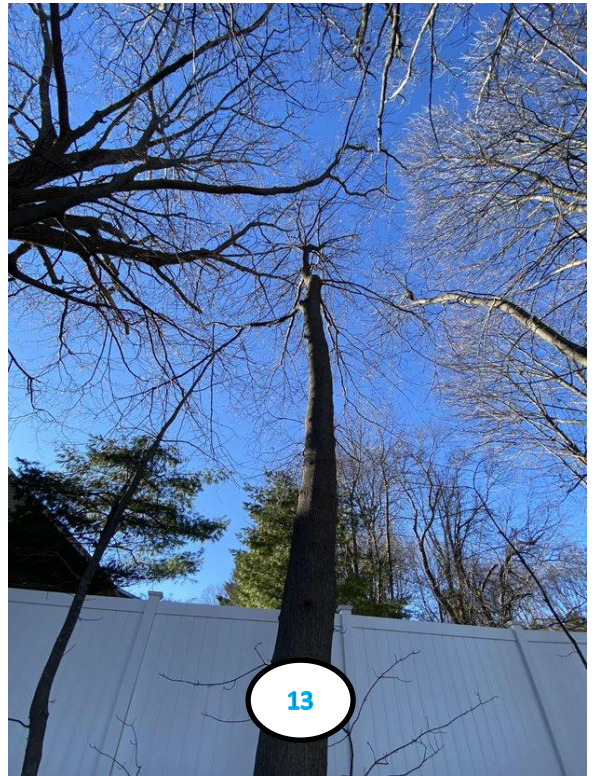
TREE # 13 **Invasive Tree species**

CONDITION: Several dead branches. Root flare indicates root rot and sounding indicates extensive internal decay and heart rot. The tree is in decline.

TARGET: High risk potential. 900 Lynnfield Street property fence structure.

RECOMMENDATION: Removal

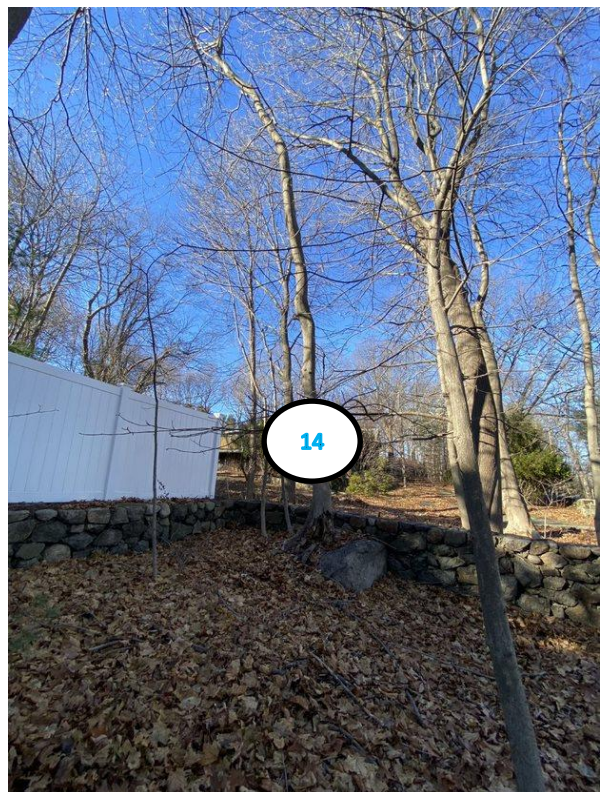
TREE # 14 **Invasive Tree species**

CONDITION: Several dead branches. Root flare shows a cavity and root rot Sounding indicates extensive internal decay and heart rot. The tree is in serious decline.

TARGET: High risk potential. 900 Lynnfield Street property fence structure.

RECOMMENDATION: Removal

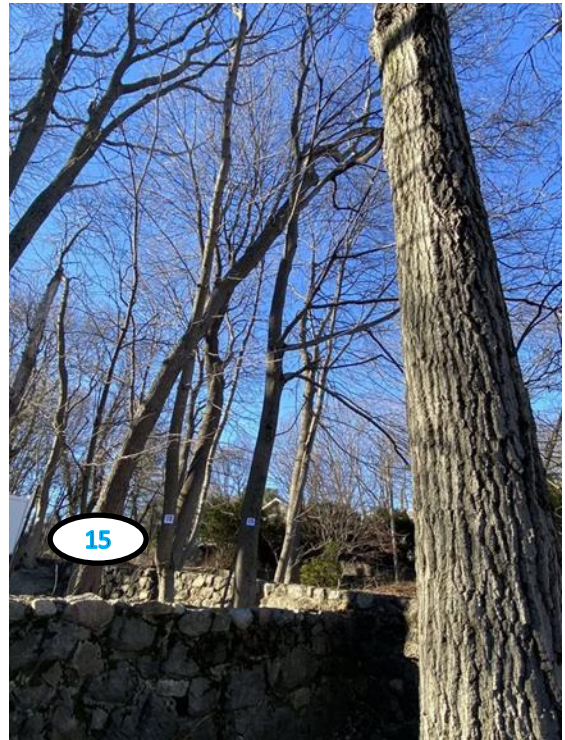
**TREE # 15 Invasive Tree species**

**CONDITION:** Several dead branches. Root flare indicates root rot and sounding indicates extensive internal decay and heart rot. Trunk at about 3 feet has a sunken area that is from internal degradation. The tree is in serious decline.

**TARGET:** High risk potential. 930 Lynnfield Street property fence structure.

**RECOMMENDATION:** Removal

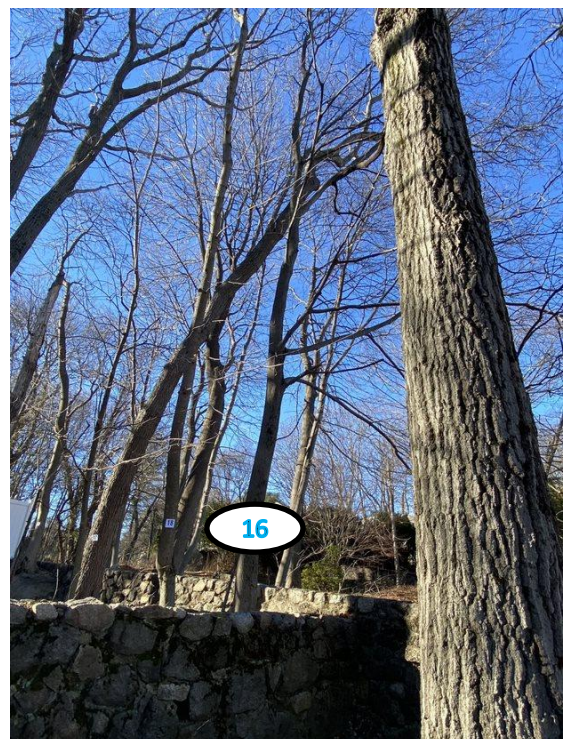
**TREE # 16 Invasive Tree species**

**CONDITION:** Several dead branches. Root flare indicates root rot and sounding indicates extensive internal decay and heart rot. Trunk at about 3 feet has a sunken area that is from internal degradation. The tree is in serious decline.

**TARGET:** High risk potential. 932 Lynnfield Street property fence structure.

**RECOMMENDATION:** Removal

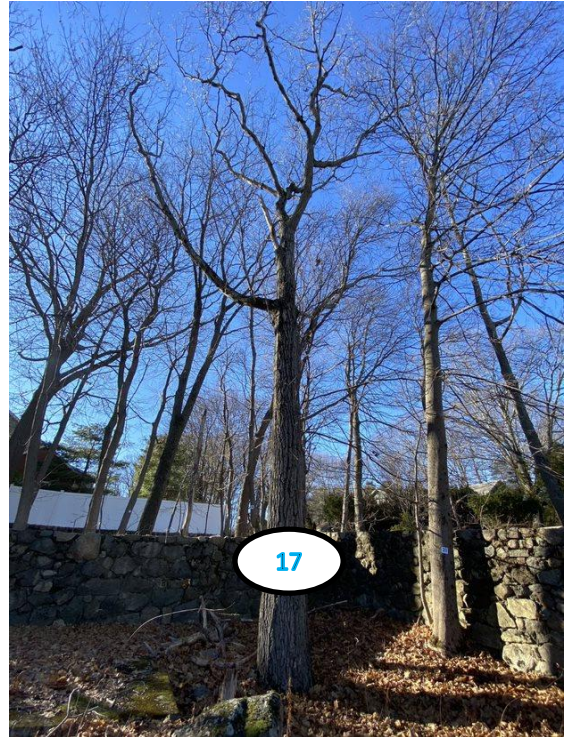
TREE # 17

CONDITION: Numerous dead branches. Sounding indicates internal decay and rot. The tree is in decline.

TARGET: High risk potential. 932 Lynnfield Street property fence and condominium structure.

RECOMMENDATION: Removal

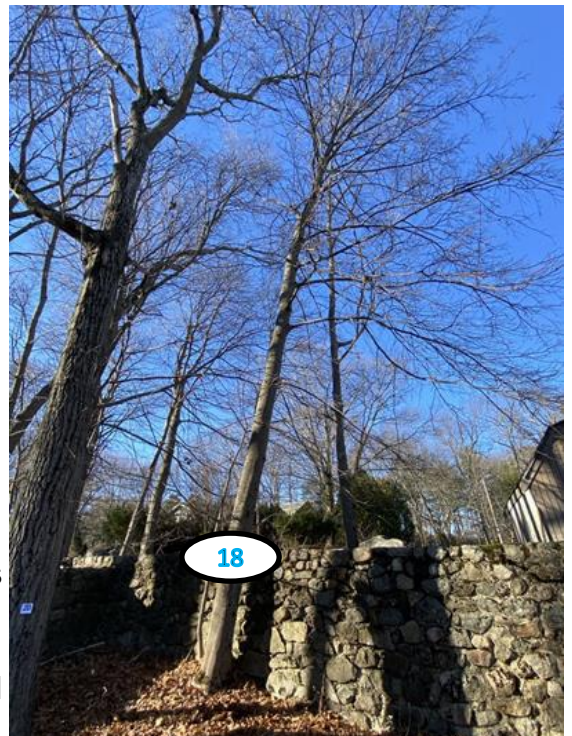
TREE # 18 **Invasive Tree species**

CONDITION: Some dead branches. Root flare indicates root rot and sounding indicates internal decay and heart rot. There are girdling roots at the root flare. The tree is in serious decline.

TARGET: High risk potential to 932 Lynnfield Street property fence structure.

RECOMMENDATION: Removal
