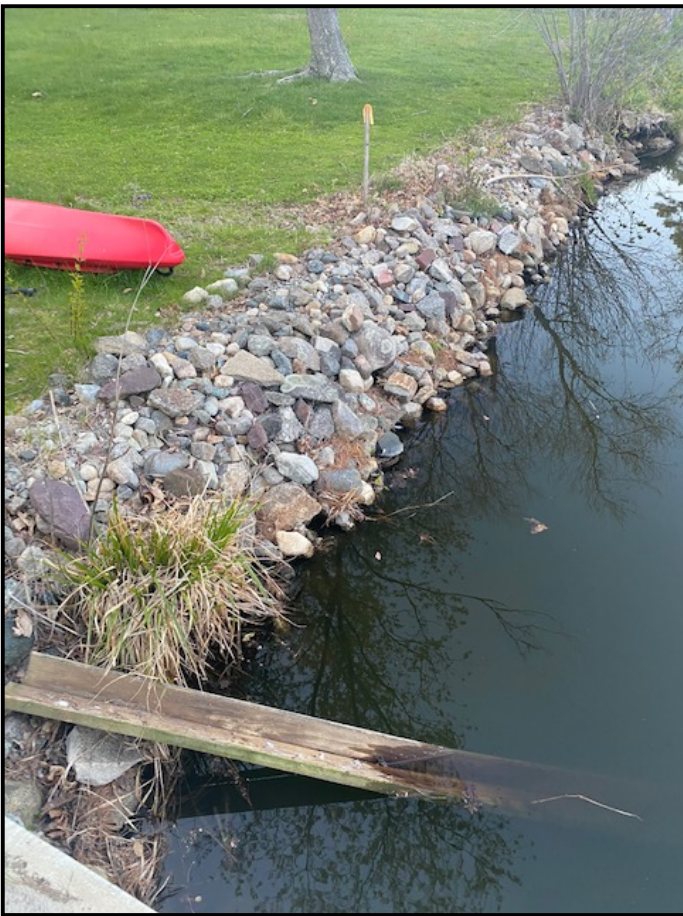
**Photos 1 : Original bank condition prior to wall construction.**

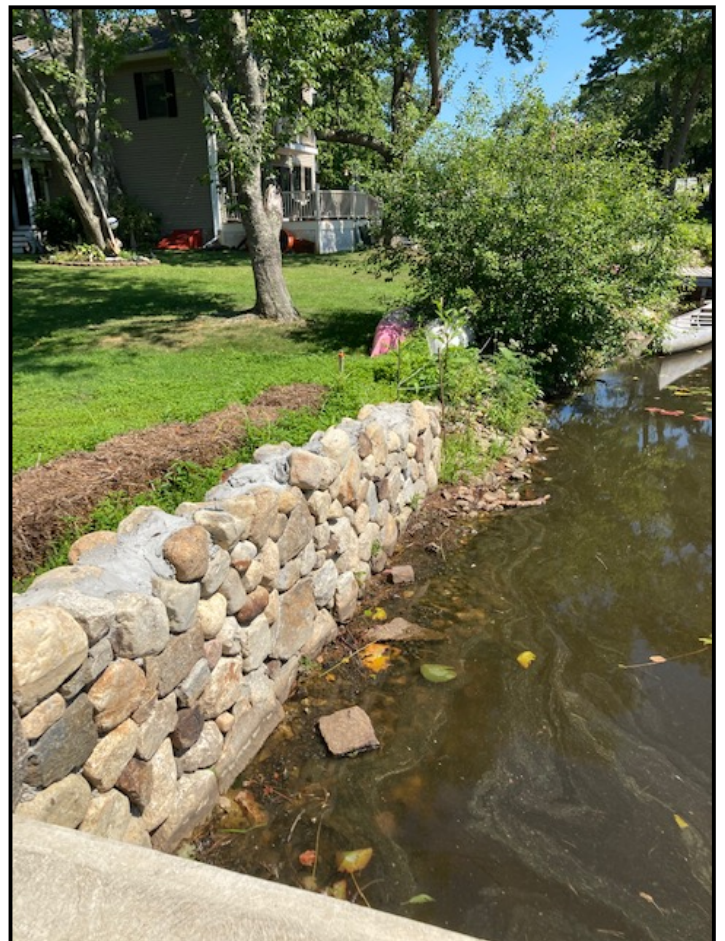
**Photos 2 : Unpermitted stone wall constructed along bank (8.10.20).**

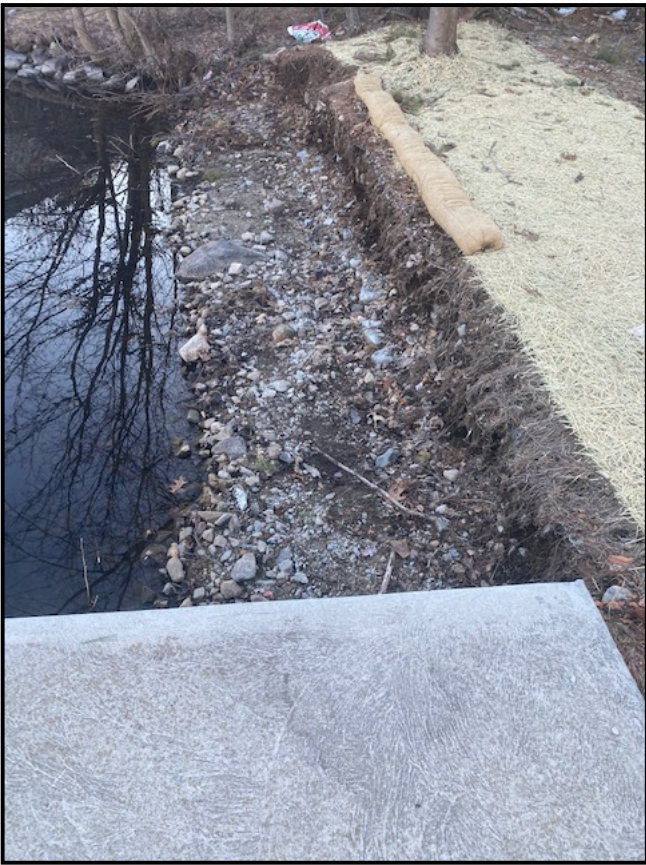
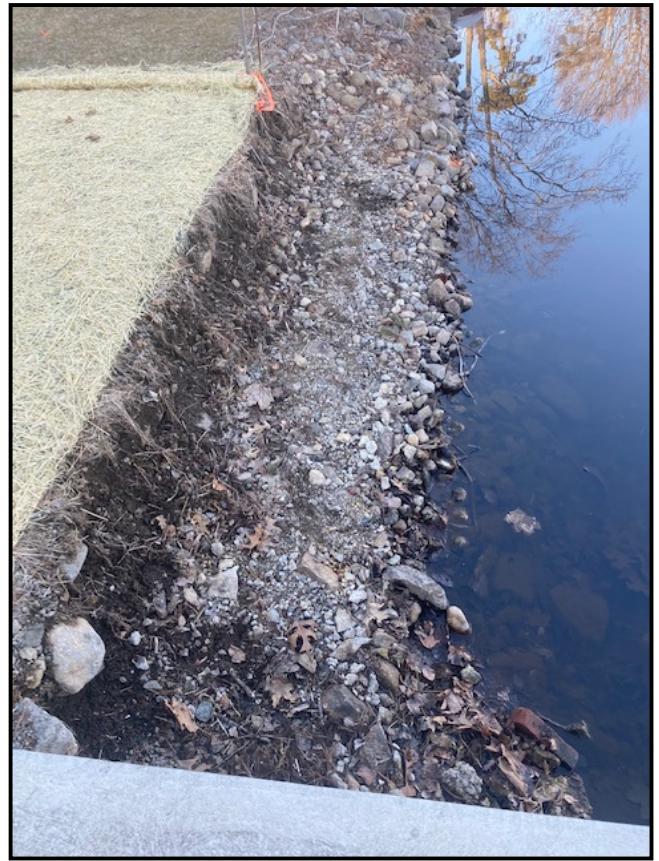
Photos 3 & 4 : Current bank condition after snowmelt (3.21).

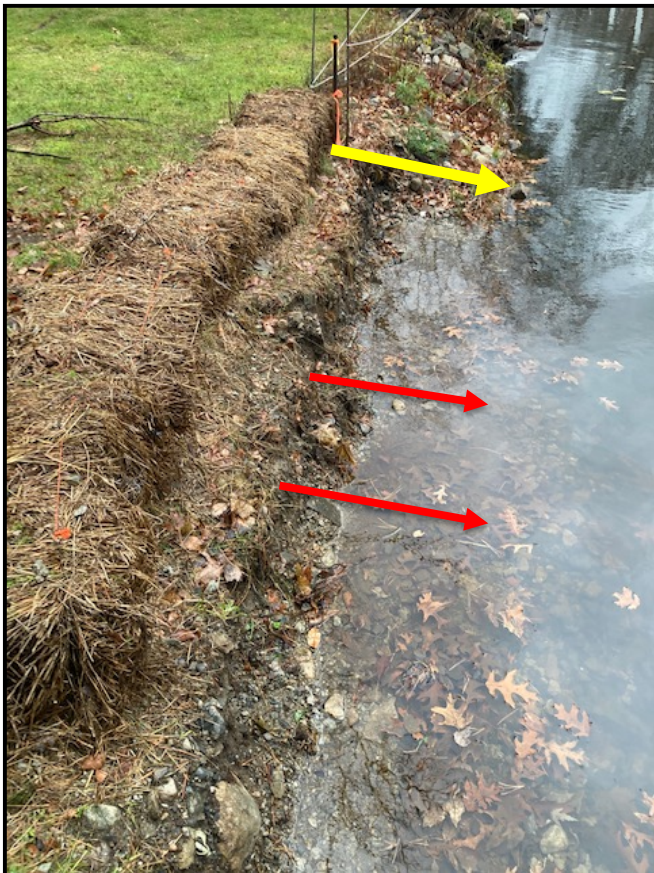
Photo 5 : Yellow arrow indicates original Bank toe of slope. Red lines indicate approximate newly proposed toe of slope of restored bank .
