## Technical Memorandum

**Date:** November 14, 2023

**From:** Renee L. Bourdeau, P.E. (NH), Geosyntec Consultants, Inc.

**Subject:** Road Acceptance Review for Sagamore Place, Lynnfield, MA

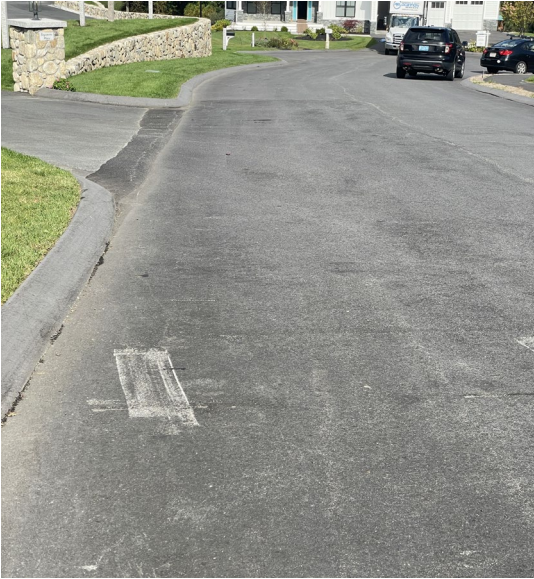
**Photo 1. Minor scuffing along roadway**

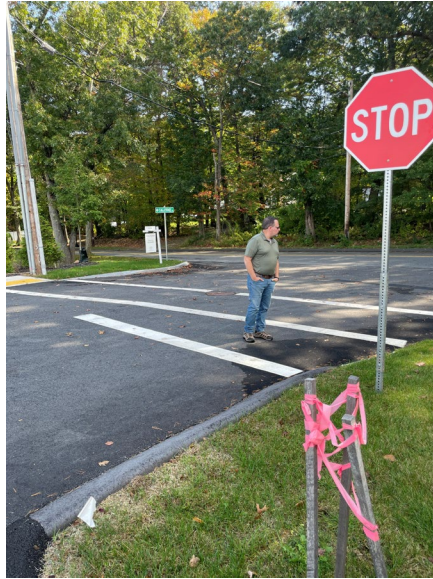
**Photo 2. Stop line and cross walk**

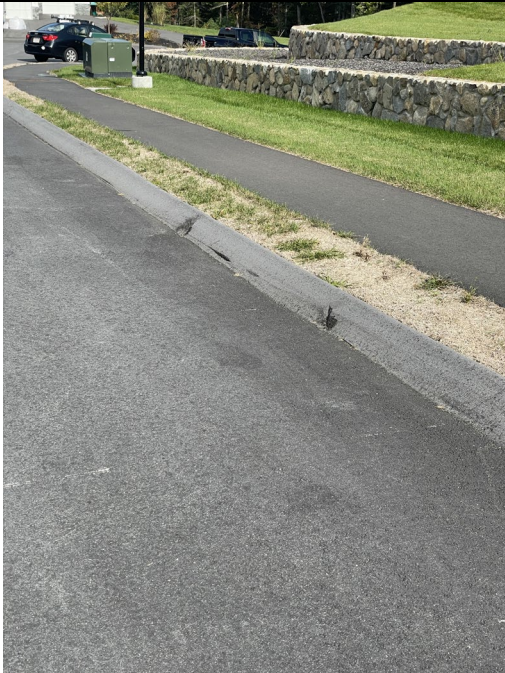
**Photo 3. Wear and tear along curb**

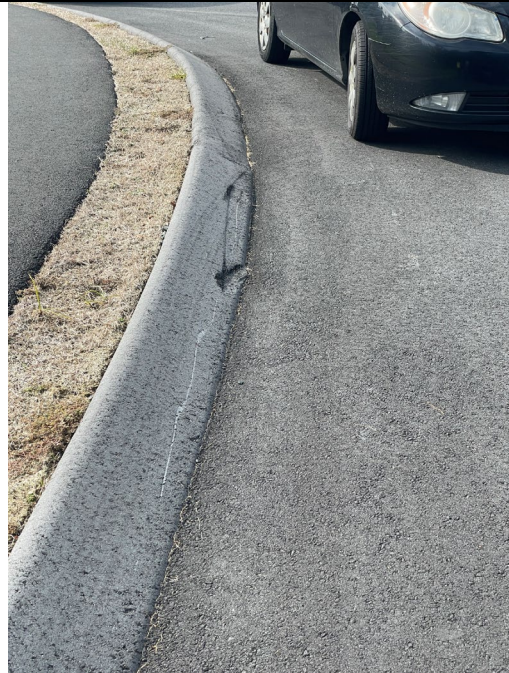
**Photo 4. Wear and tear along curb**

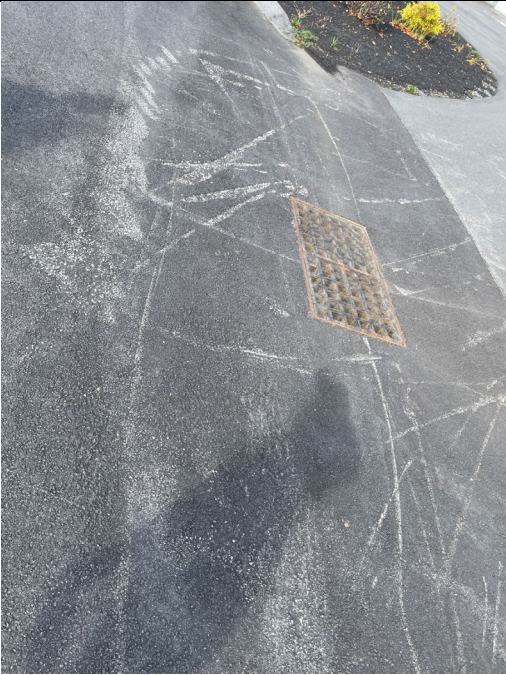
**Photo 5. Scuffing along roadway near double catch basin**
