45 Lakeview Avenue, Lynnfield, MA Amendment/Bank and Buffer Zone Restoration Plan

Site Photographs

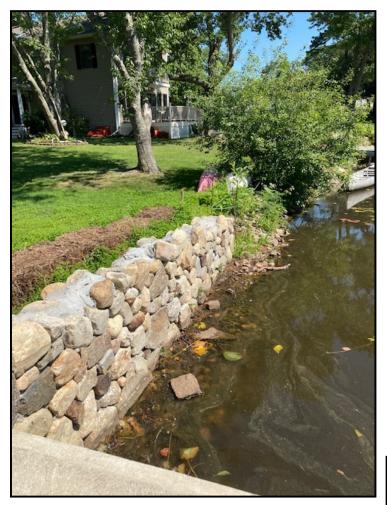
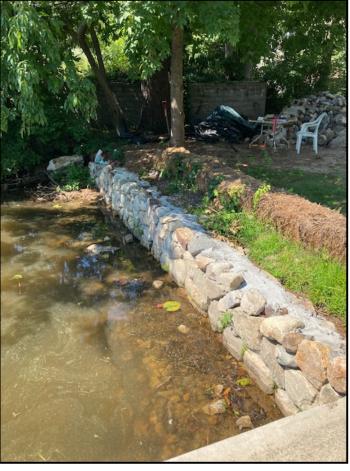
Photos 1 & 2: Unpermitted stone wall constructed along bank (8.10.20).

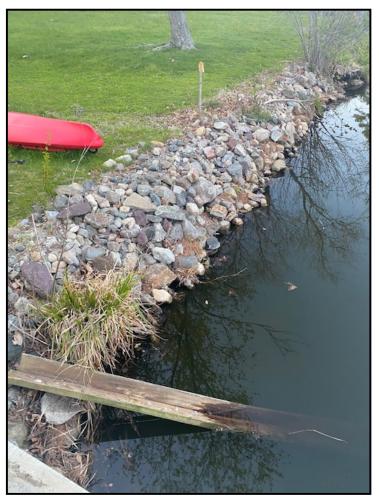
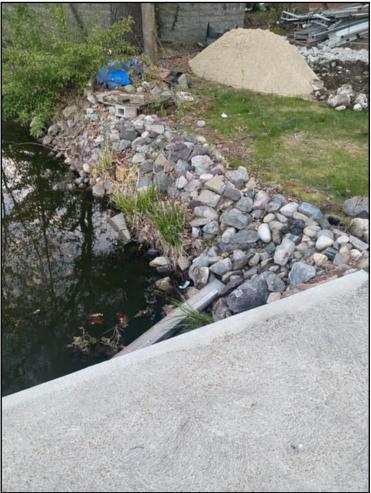
Photos 3 & 4 : Previous bank condition prior to wall construction(2019).

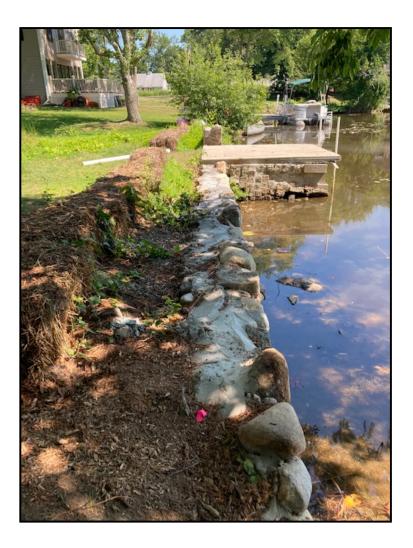
Photos 5: Area 8-feet upgradient Bank to be restored with natural vegetation (8.10.20).

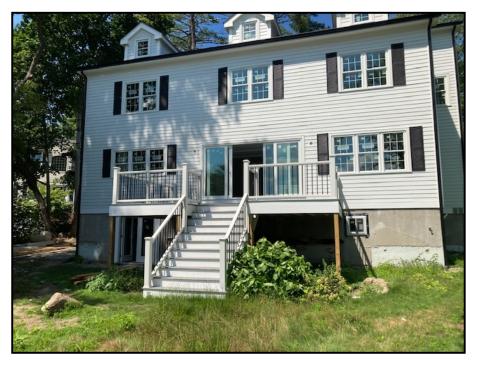
Photos 6: Newly reconstructed house and deck from the rear of the house facing pond side (8.10.20).

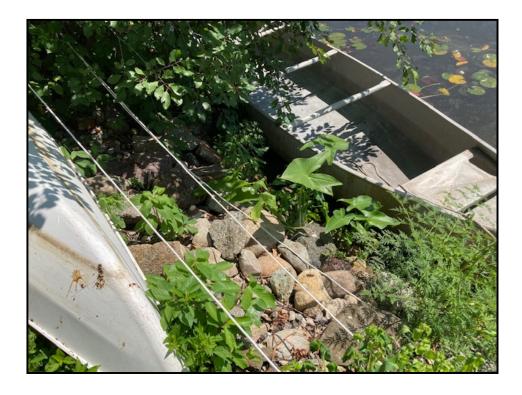
Photos 7: Original bank condition with large stones (8.10.20).

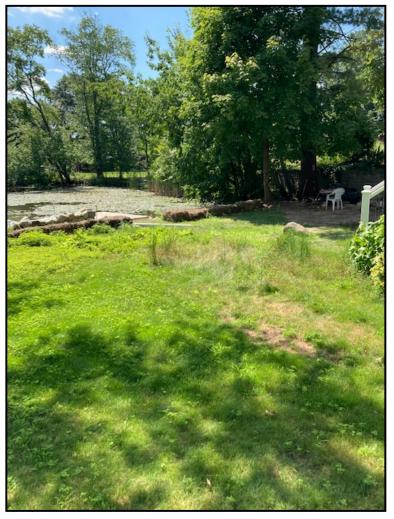
Photos 8: Rear of house facing pond. 8-foot Buffer Zone to be planed off pond banks (8.10.20).

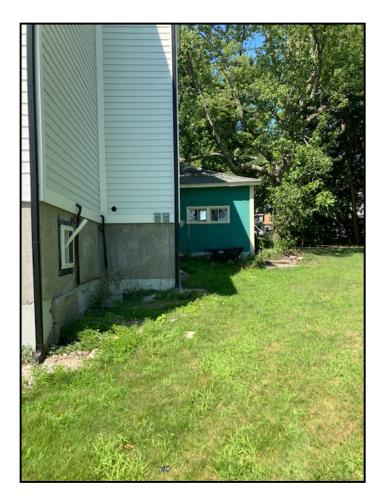
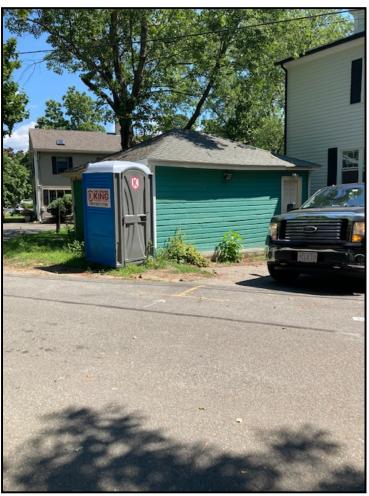
Photos 9 & 10: New subsurface sewage disposal system to be located in front of the house. Garage to be removed (8.10.20).
