Athletic and Recreation Facilities Condition Assessment and Usage Report Town of Lynnfield, MA Volume I

F e b r u a r y 1 4 , 2 0 1 3
R e v i s e d : M a r c h 1 4 , 2 0 1 3

ATHLETIC AND RECREATION FACILITIES CONDITION ASSESSMENT AND USAGE REPORT

TOWN OF LYNNFIELD, MASSACHUSETTS

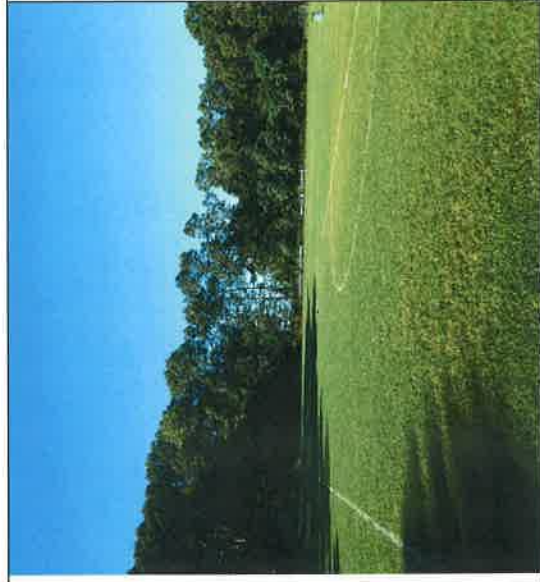
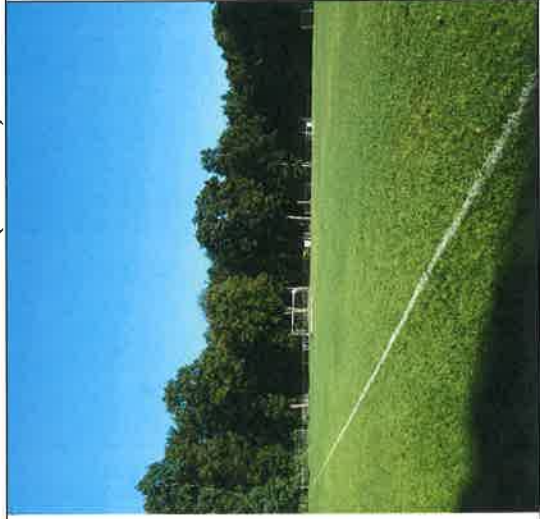
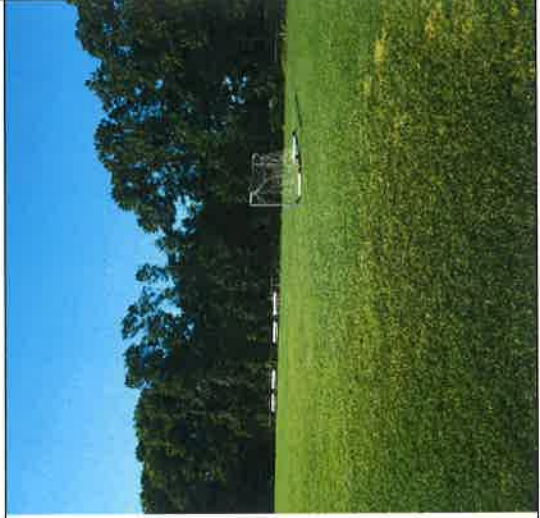
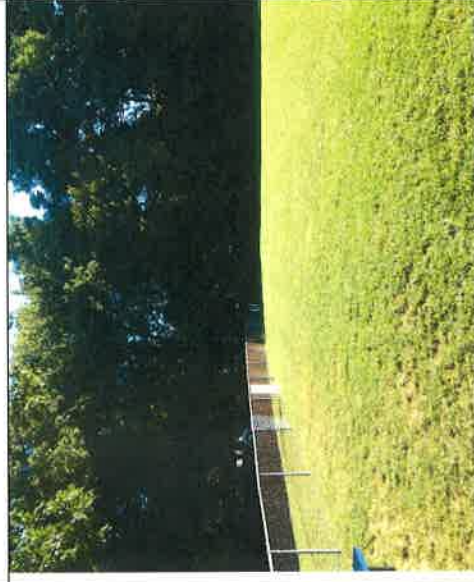
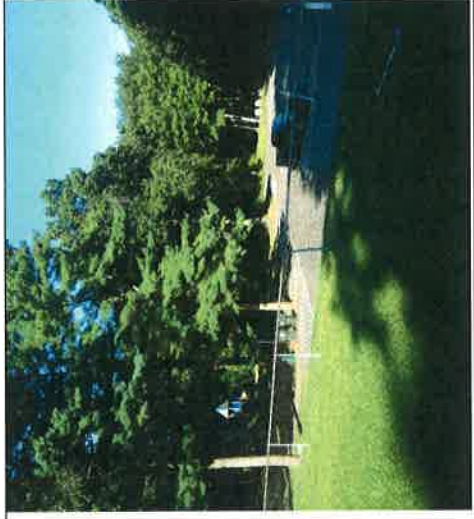
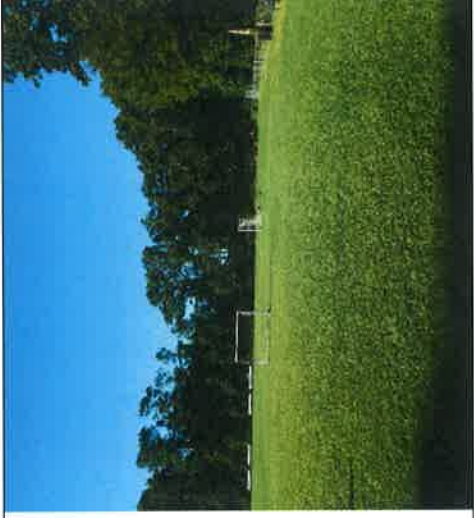
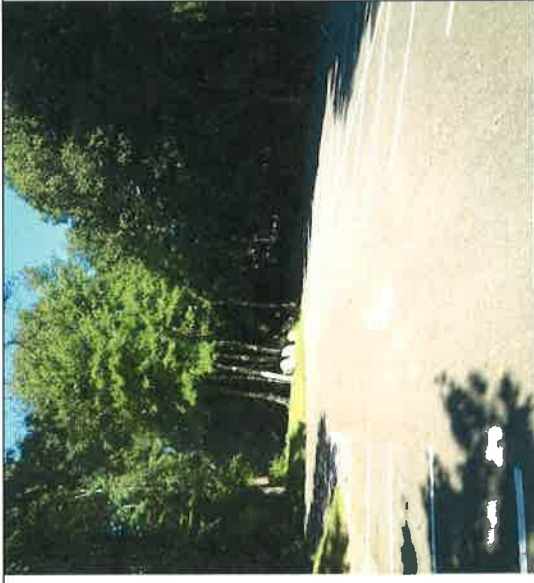
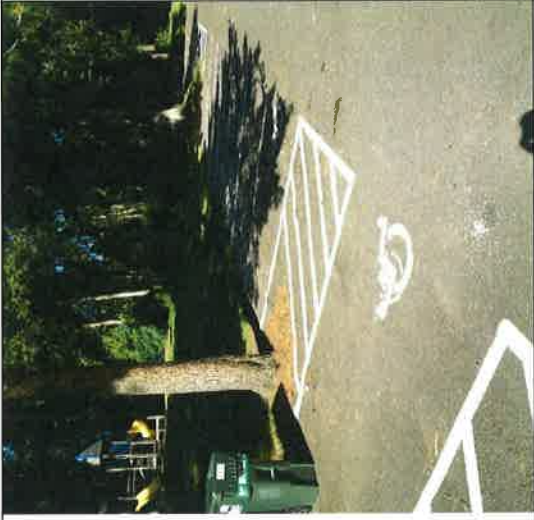
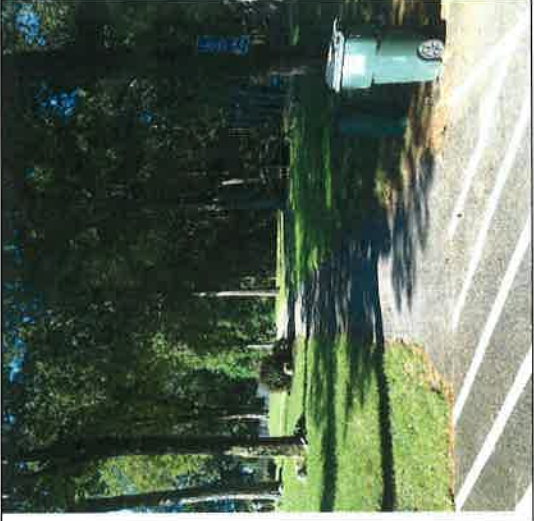
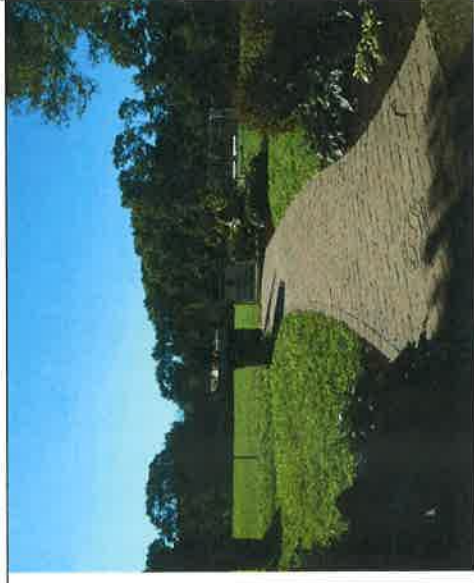
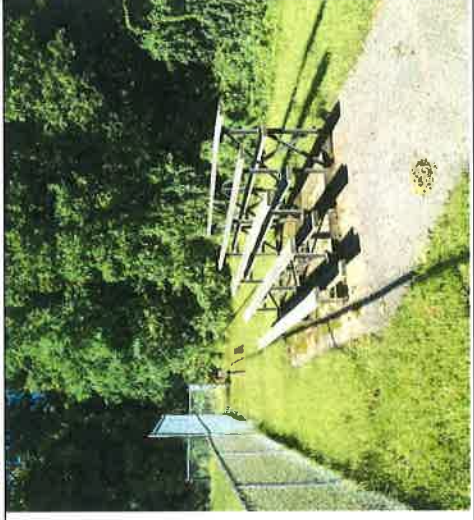
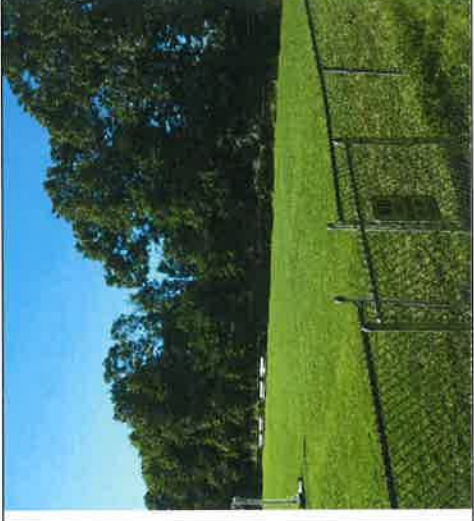
JORDAN PARK (FIELD)

- a. Comments / Observations:** Youth soccer put irrigation system in; believe its off town water.
- b. Recommendations:**

- a. General condition/effectiveness:** No formal drainage; field relies on sheet slow and infiltration.
- b. Recommendations:**

- a. Describe Fencing Condition:** Two (2) sides only: 4' high CLF; needs to be replaced; starting to ruse and has areas that are collapsed.
- b. Recommendations:** Fence all four (4) sides.

- g. spectator seating** – Portable wooden bleachers; does not meet code; needs to be replaced/upgraded.
- h. flag pole** - No flag pole
- i. player benches** – Six (6) portable aluminum benches in good condition
- j. goals/goal posts** – Three (3) sets of soccer goals in good condition
- k. field marking/stripping** – Youth Soccer
- l. parking facilities** – Approximately 48 parking spots with 3 handicap parking spots
- m. site accessibility** – Site is not ADA compliant; walkway grades are 6-10% leading to the field.
- n. site safety** – Secluded behind residential homes; no site lighting
- o. site buildings (list type and general assessment only)** – No site amenities buildings

Turf condition is good with high growth density; some dips and humps and some weed infestation.

Recommend aerating, fertilizing, top dressing and re-seeding.

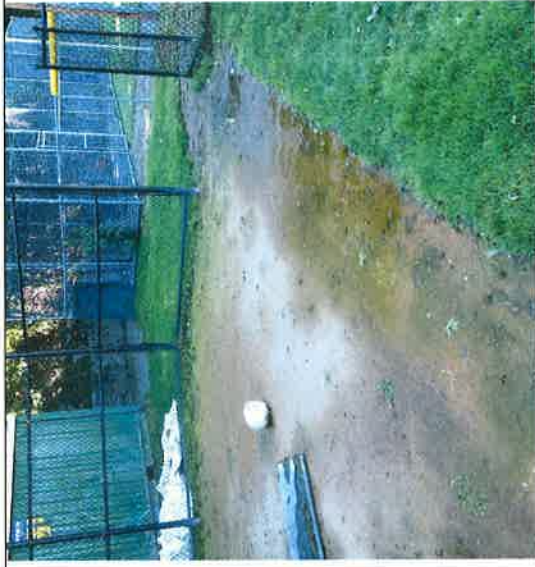
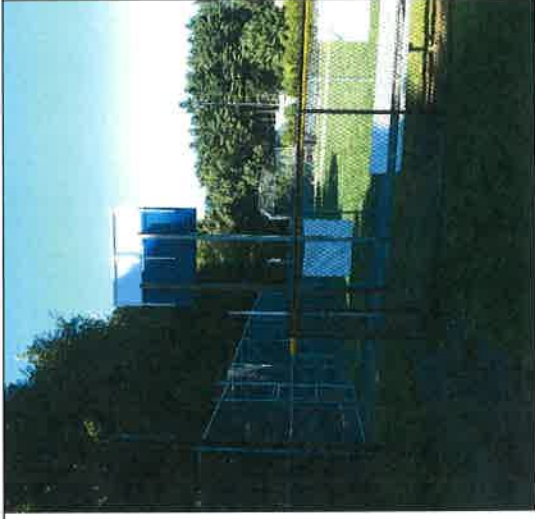
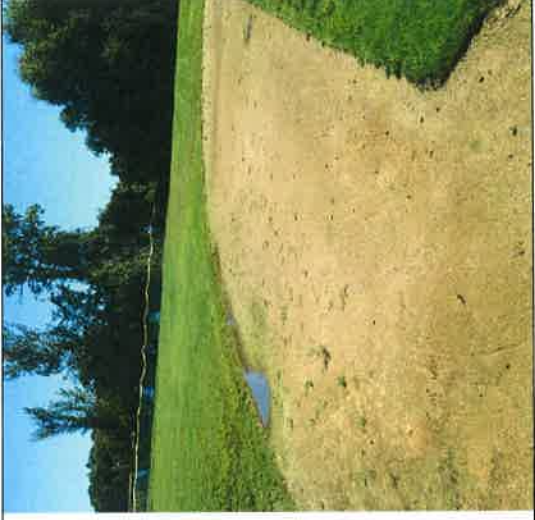
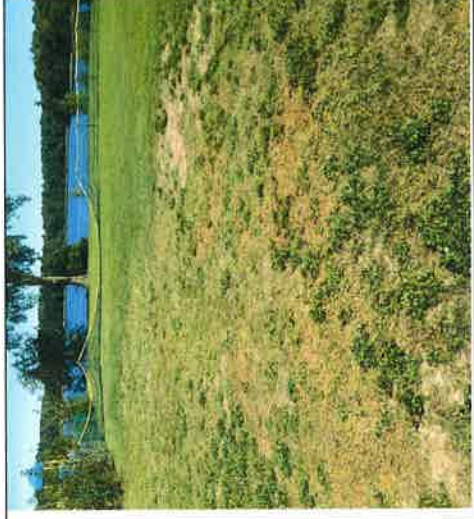
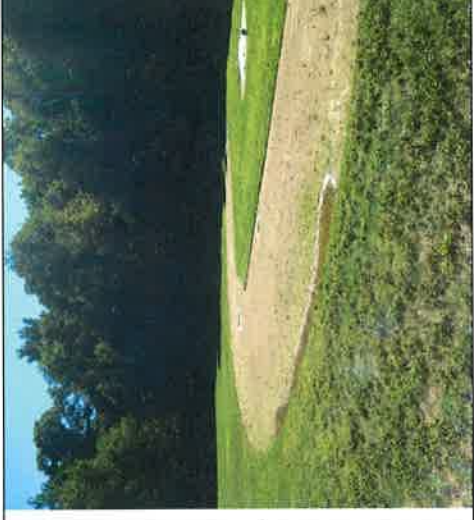
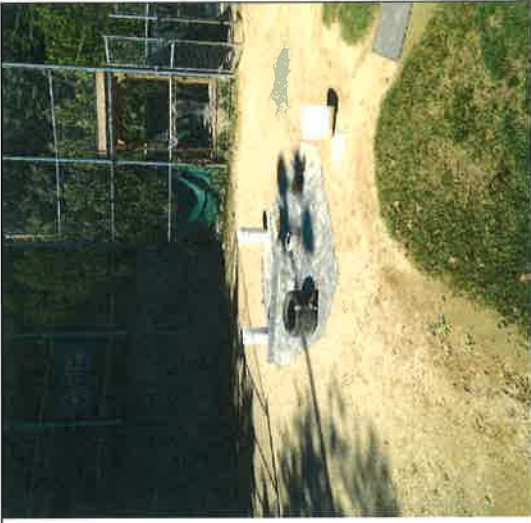
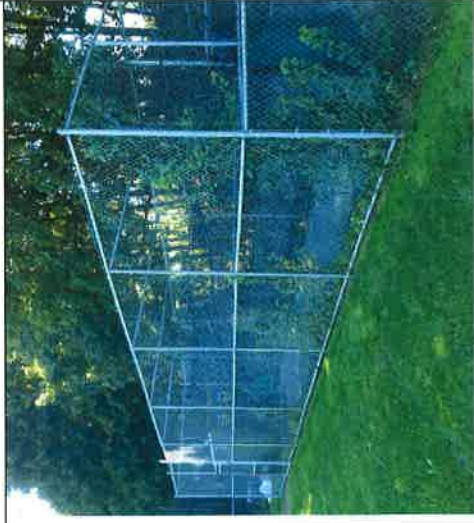
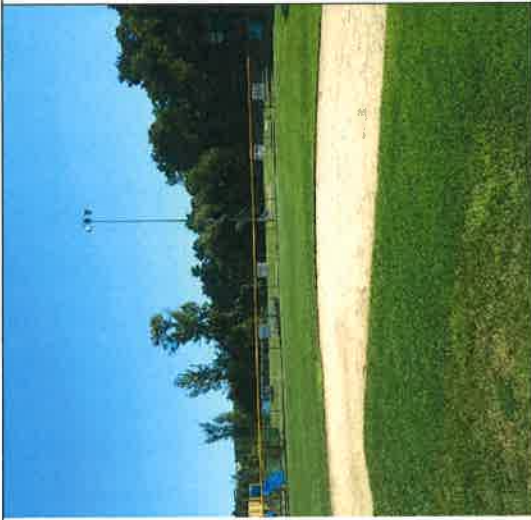
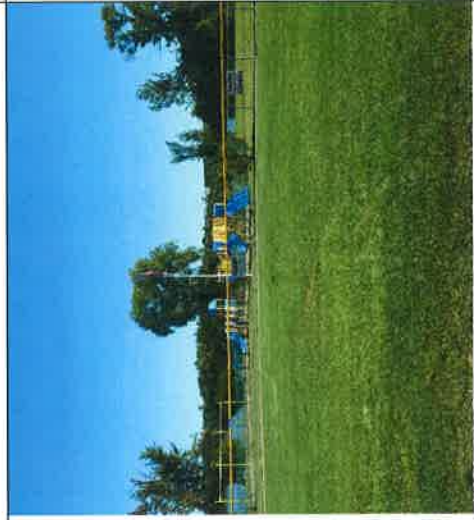
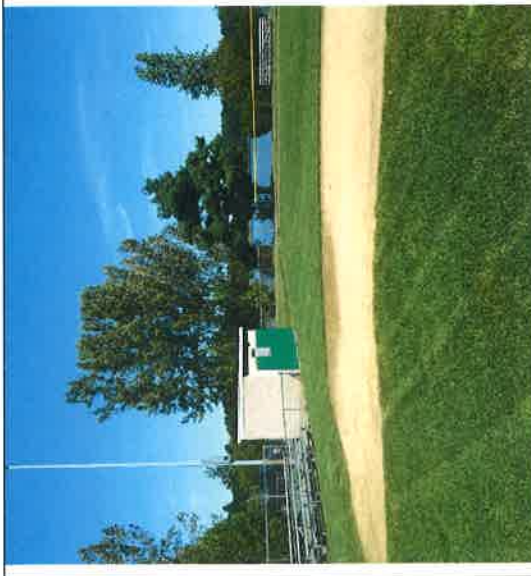
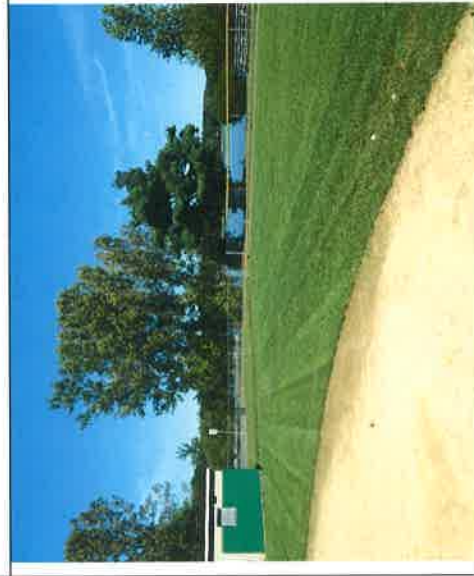
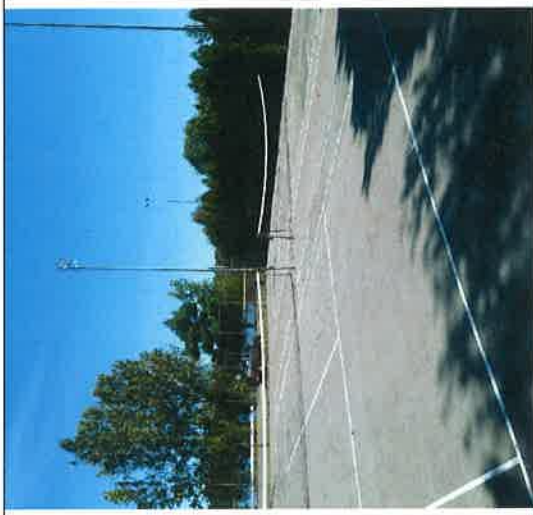
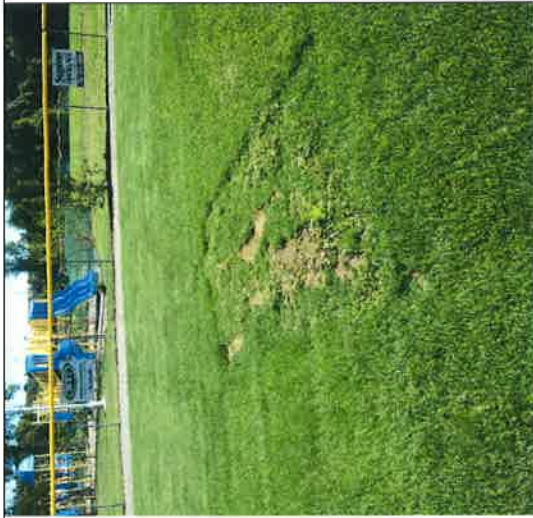
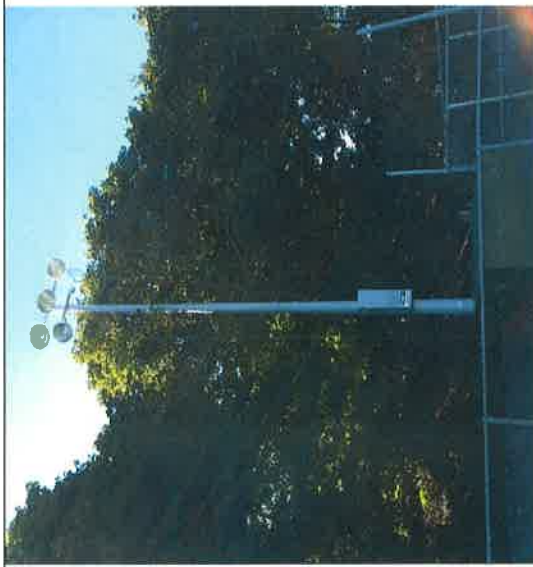
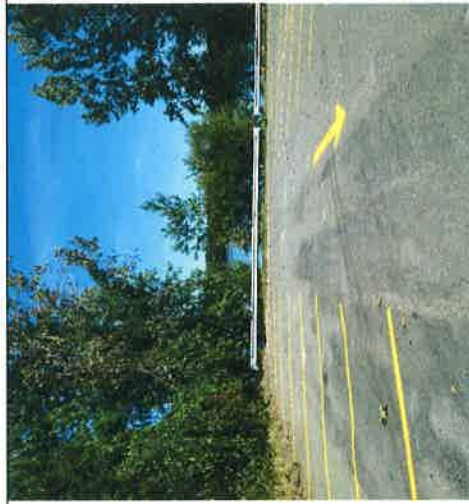
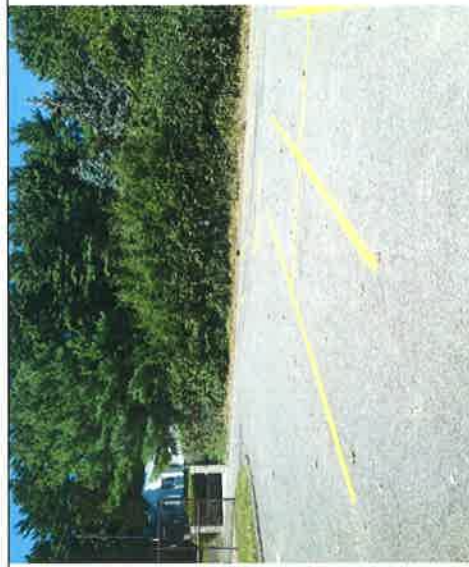
NEWHALL PARK

- a. Comments / Observations:** Irrigation boxes present
- b. Recommendations:**

- a. General condition/effectiveness:** No formal drainage present on both fields. Field 2 appeared to be wet.
- b. Recommendations:**

- a. Describe system (make/model; age; type poles; controls; coverage; condition):** Field 1 – 6 MUSCO poles; 3-6 fixtures per pole; approximately 30' poles.
- b. Recommendations:**

- a. Describe Fencing Condition:** Field 1 – 6' perimeter fencing; in decent shape; some areas need to be repaired. Field 2 – new vinyl backstop baseline fencing in good condition; outfield temporary fencing.
- b. Recommendations:** Update fencing

- a. pitchers mound and rubber** – Good condition on both fields
- b. bases and home plate** – Not present
- c. scoreboards** – Field 1 – Yes, small and in good condition
Field 2 - No
- d. backstop** – Field 1 – update/repairs needed
Field 2 – black vinyl new; good condition

- e. **dug out(s)** - Field 1 – needs updating
Field 2 – benches behind 6' fence
- f. **P.A. system** – None
- g. **spectator seating** – Portable aluminum benches (3 total)
- h. **flag pole** - Yes – center field
- i. **player benches** – Field 1 – needs to be replaced
Field 2 – good
- j. **goals/goal posts** – N/A
- k. **field marking/stripping** – N/A
- l. **parking facilities** – Approximately 30-40 spaces; 1 handicap
- m. **site accessibility** – Yes, needs repairs to pavement
- n. **site safety** – Good
- o. **site buildings (list type and general assessment only)** – One concessions storage building; storage containers also used
