Request for Determination of Applicability

12 Chatham Way
Assessor's Map 25, Parcel 684
Lynnfield, Massachusetts

LEC Environmental Consultants, Inc.
Richard Kirby
Senior Wetland Scientist
380 Lowell Street
Suite 101
Wakefield, MA 01880

Tree Removal, Site Activities, and Mitigation Sketch Plan

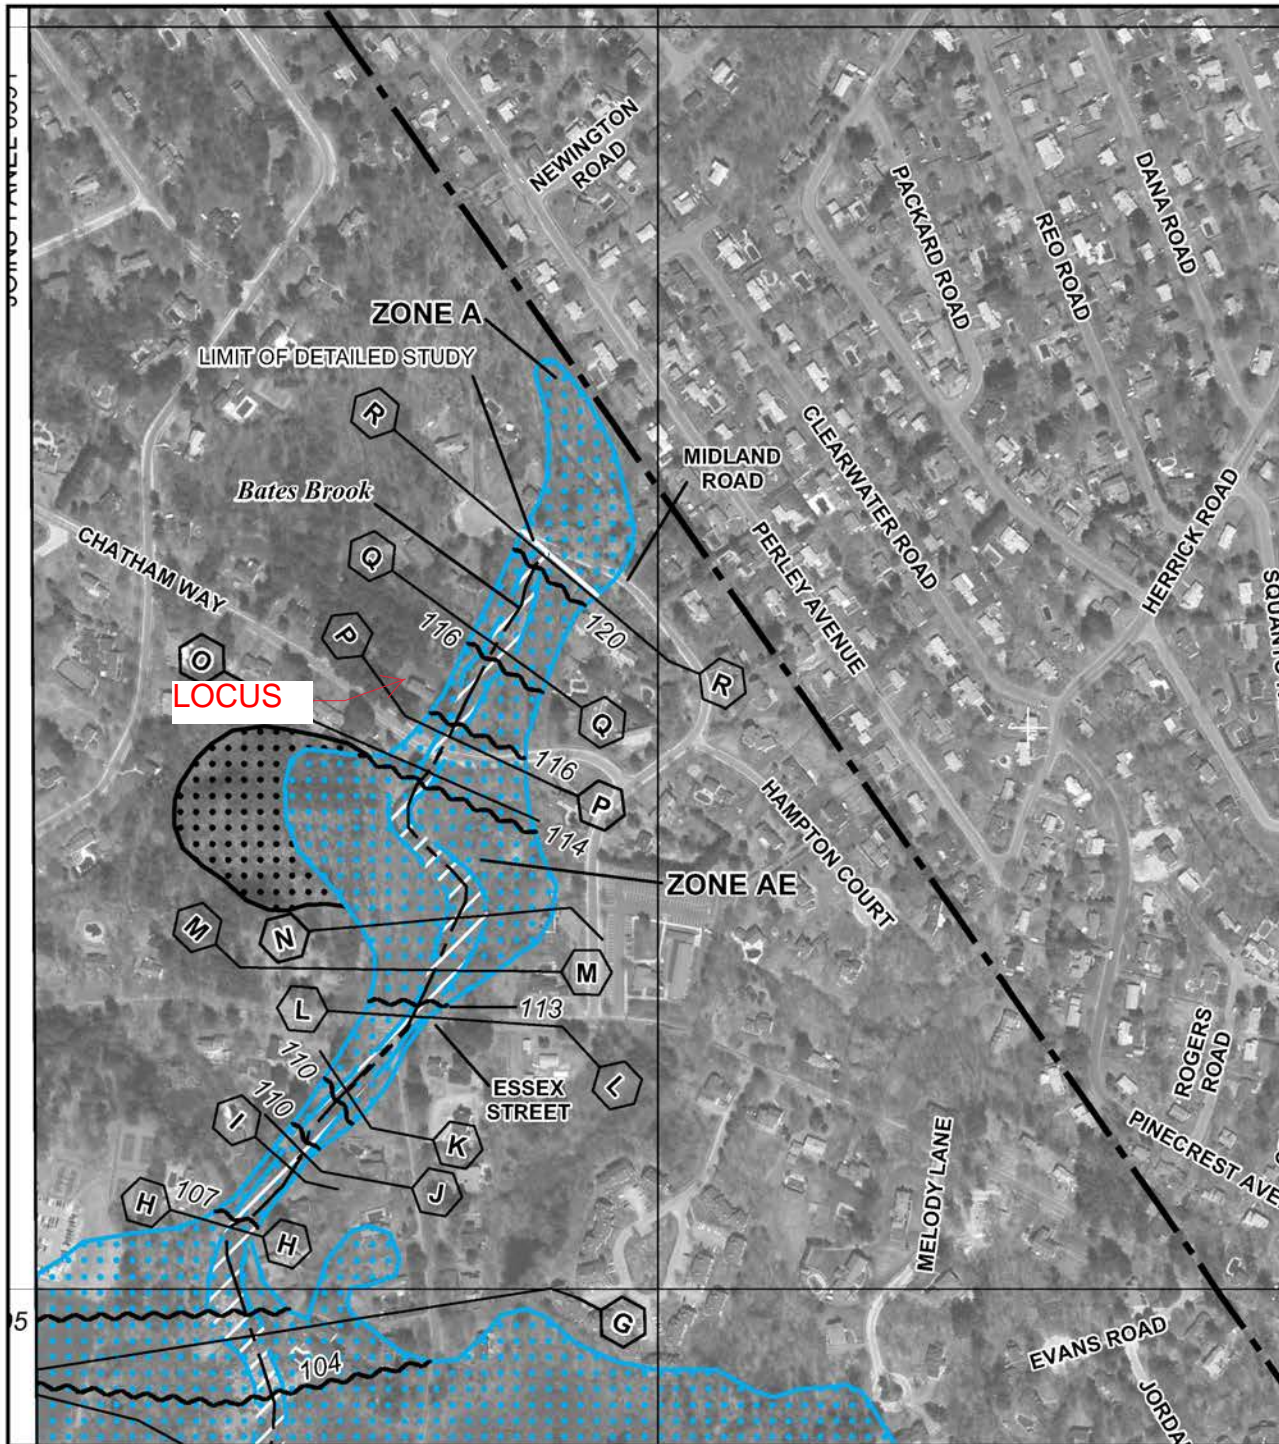
Figure 2: FEMA Flood Insurance Rate Map

PANEL 0392F

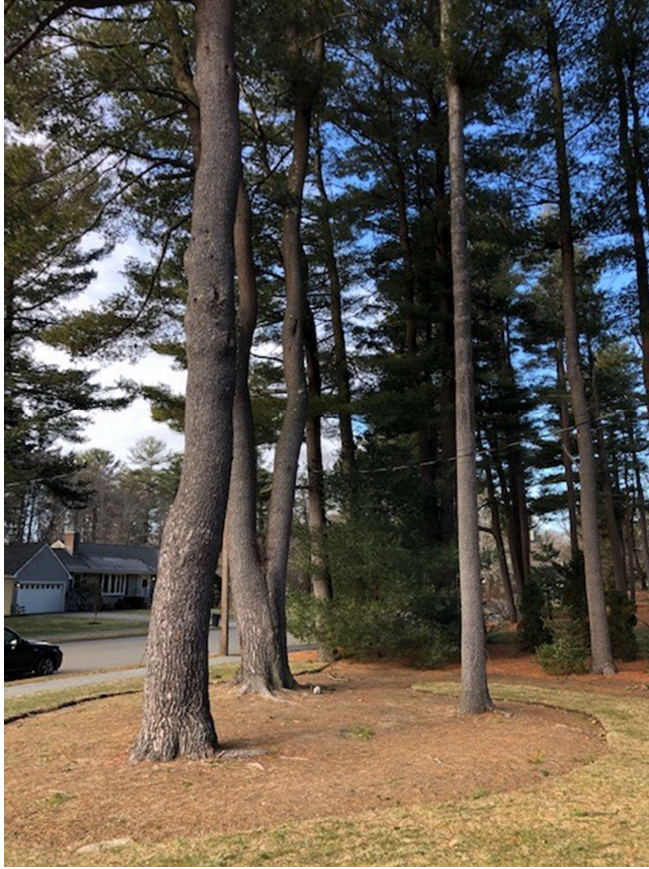
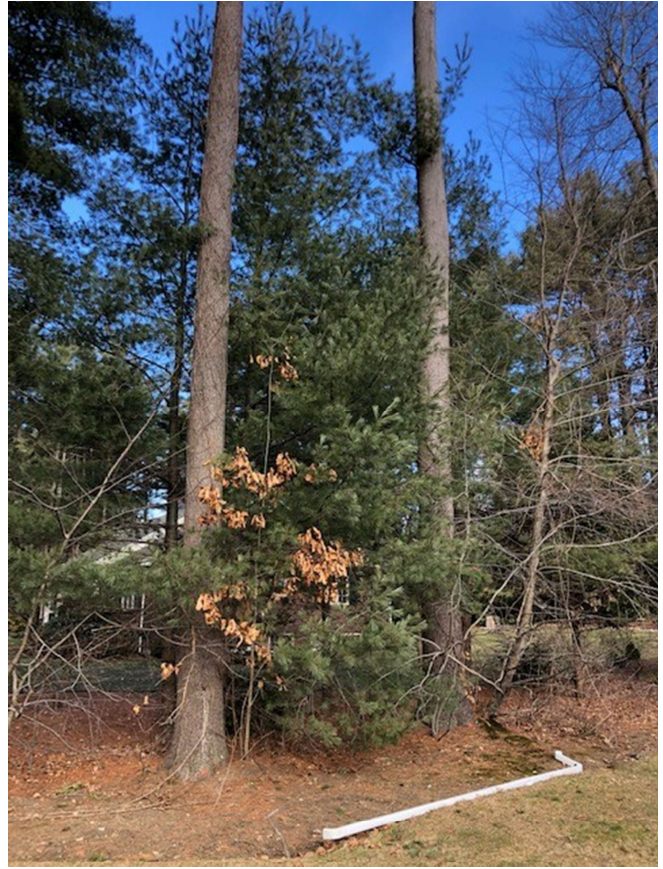
Our certified arborist has inspected these trees and has determined that the Red Maple to the right of driveway has a significant amount of crown damage, the 6 White Pine's along the front left side of property have significant crown damage and propose threat to home and also the White Pine at back left corner of property has a root rot and proposes a threat to home.

Photos 1 and 2: Eastern White Pine trees in front yard to be removed

Seven eastern white pine trees and a red maple tree located on the property (Photos 1 through 4) were evaluated by Keith's Tree Service, as described in a February 18, 2021 Letter by Massachusetts Certified Arborist Ken Green (MCA#: 1182, **Attachment C**). Six of these eastern white pines are located within mulched landscape beds west of the dwelling and contain significant crown damage, while the seventh is located at the lawn edge adjacent to the play set and contains root rot. The red maple tree located within a mulched landscape bed adjacent to the driveway also has significant crown damage. All eight trees pose

a threat to the property, and damage to Ms. McGah's automobile has already occurred due to falling branches from the red maple tree adjacent to the driveway. Accordingly, removal of these hazard trees is proposed. Stumps will be ground and the land will be levelled with topsoil and returned to lawn and/or mulched landscape beds.

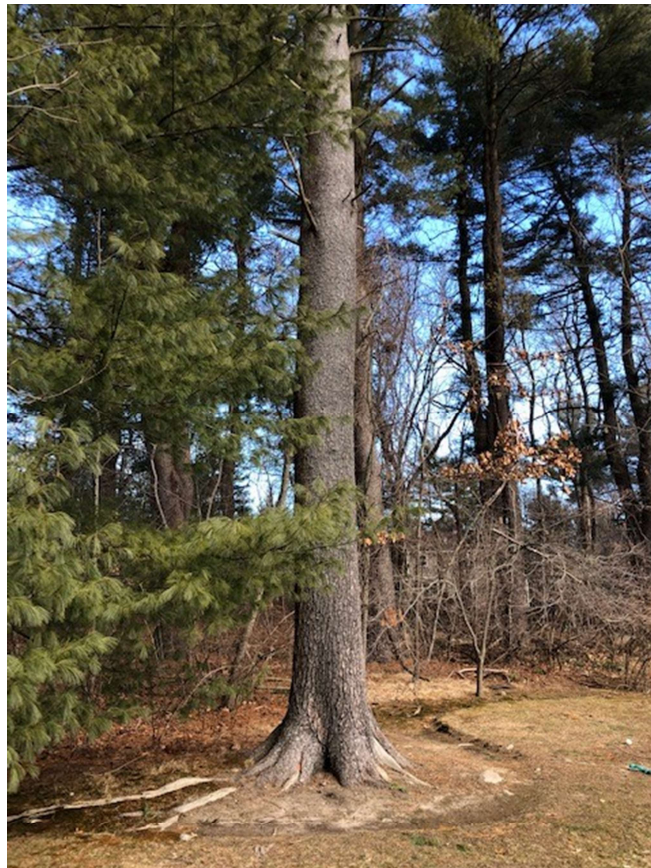
Photo 3: Eastern White Pine tree adjacent to playset to be removed

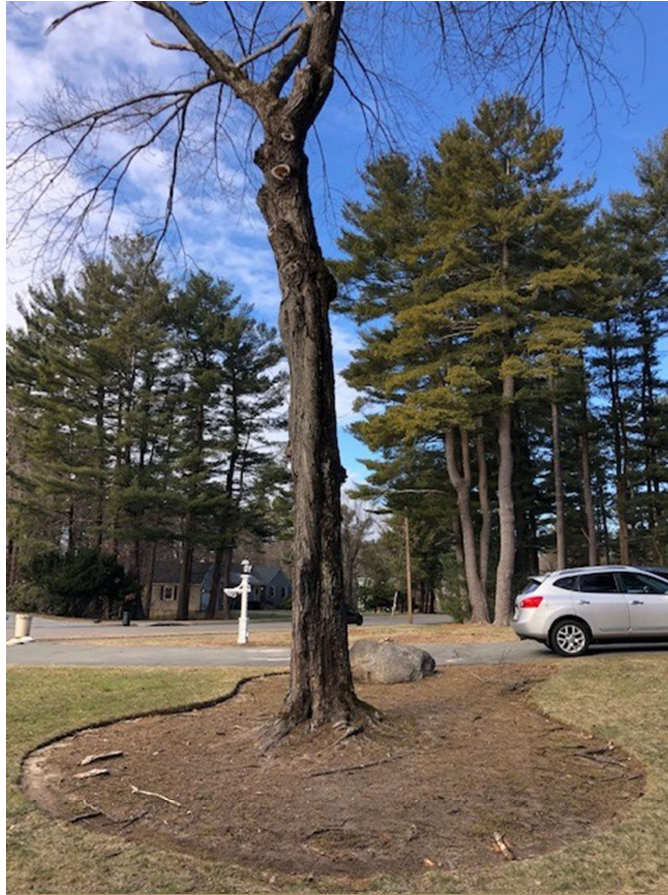
Photo 4: Red Maple tree adjacent to driveway to be removed.
Sports court proposed between existing tree and driveway.

The Applicant proposes to install a 15' x 20' sports court along the southeastern edge of the existing driveway (Photo 4). The footprint of the proposed sports court is currently lawn and landscaped land. The court will be paved, and oriented parallel to the existing driveway to limit/prevent encroachment into the BLSF (see Attachment A, Figure 3). The proposed sports court will be constructed at existing grade, with the top of pavement at the same elevation as the existing land. Accordingly, no displacement of flood water will occur.

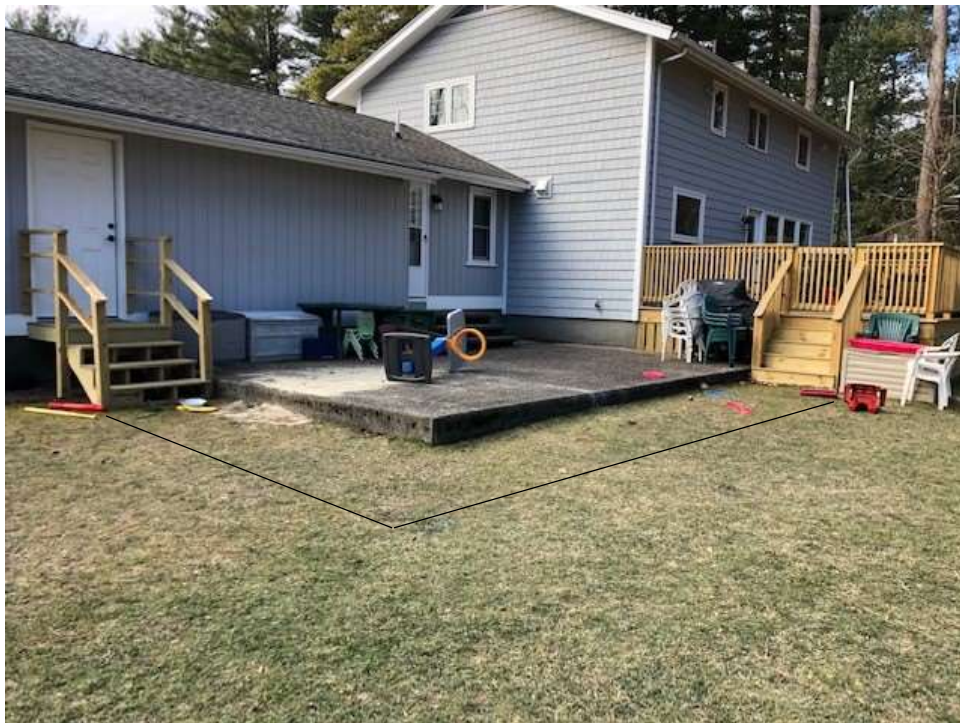
Photo 5: Existing patio off rear of dwelling to be reconstructed and expanded by 4' to existing steps from deck and garage (as approximated by black lines).

The Applicant proposes to reconstruct the existing concrete patio off the rear of the dwelling, expanding it by 4 feet to the northeast and southeast to connect the existing stairs descending from the deck and garage (Photo 5). The footprint of expansion is currently lawn. No change to the surrounding grade is proposed.

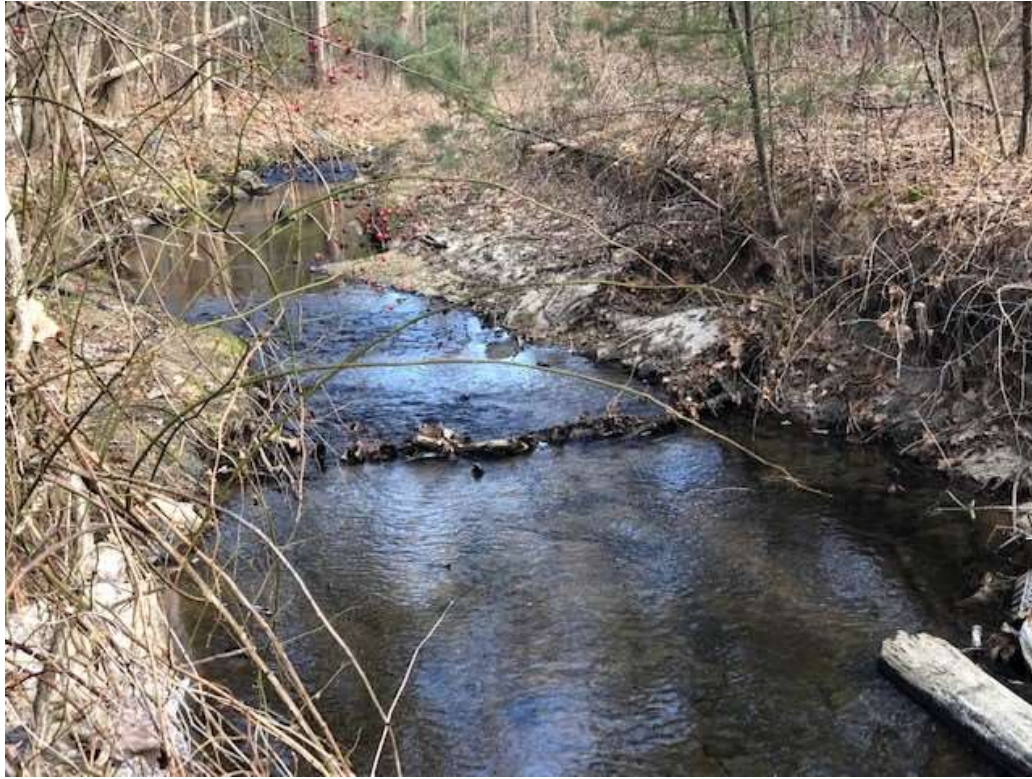
Photo 6: Northeasterly view of Bates Brook.

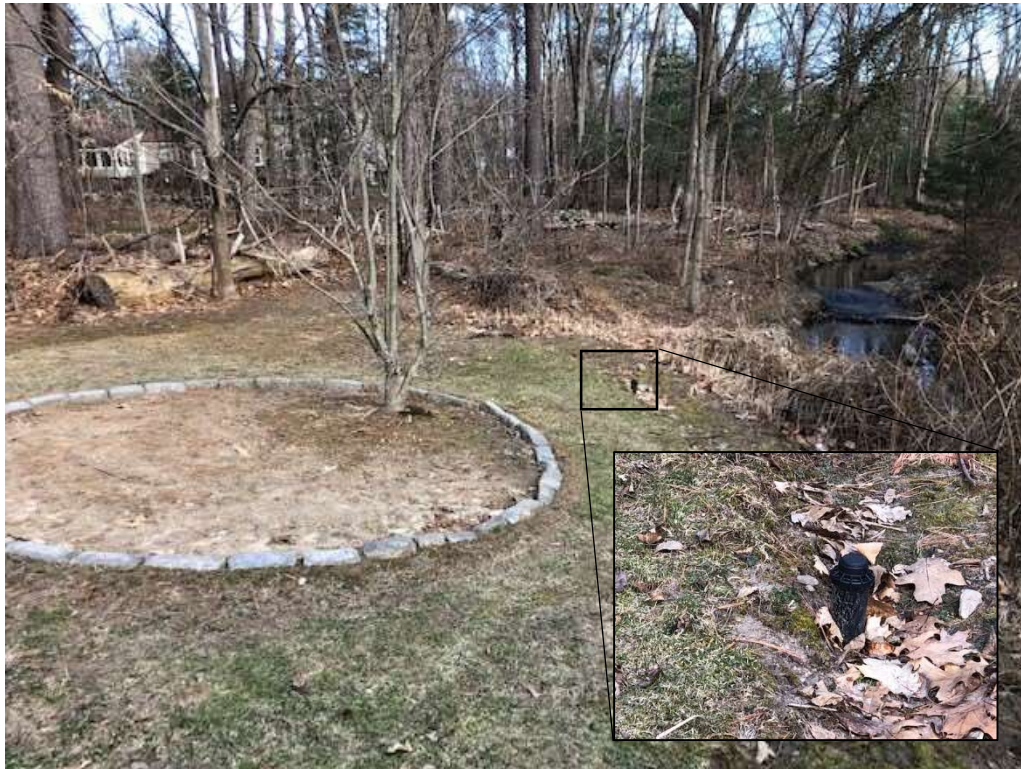
Photo 7: Landscaped land adjacent to Bates Brook in place as early as 2005 according to Google Earth imagery. (Note sprinkler head which was in place when McGah's purchased the property in 2014).

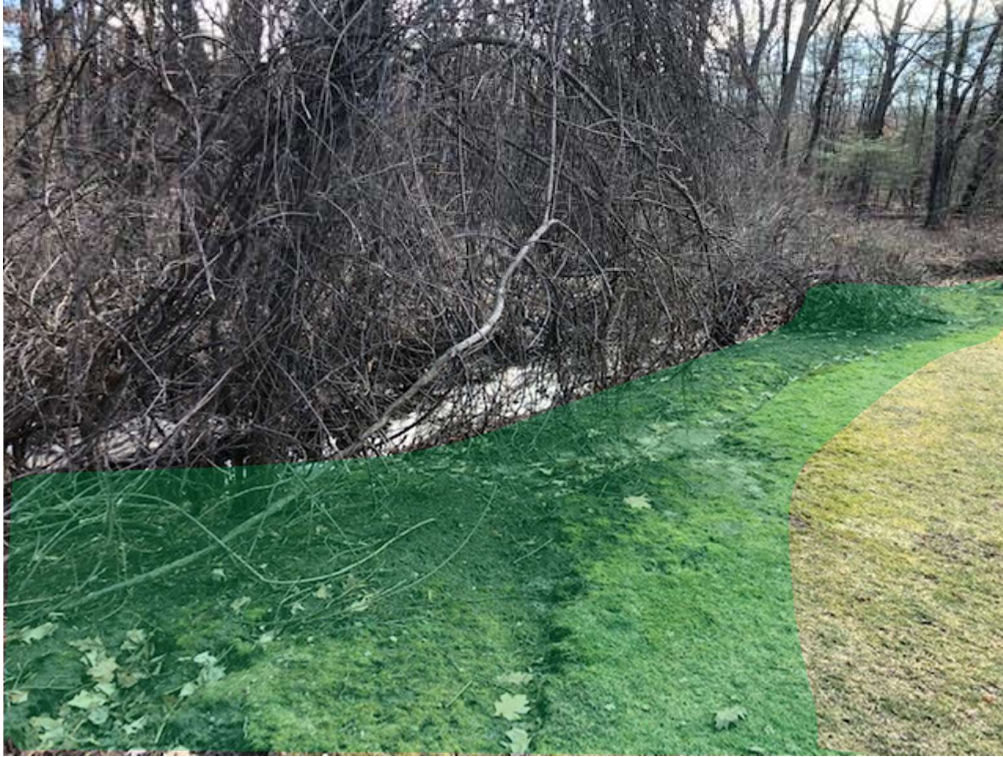
A cluster of Oriental bittersweet (*Celastrus orbiculatus*) and grape (*Vitis* sp.) occurs adjacent to Bates Brook adjacent to the backyard and is choking a sapling fruit tree planted along the Bank (Photo 8). The Applicant proposes to remove these vines by hand by cutting the vines at the base and digging up the roots to the extent practicable. The exposed soil will be smoothed with a rake and straw mulch will be placed on top of the exposed soil to prevent erosion/sedimentation. Native restoration plantings also will be installed as further described below.

Photo 8: Southerly view of invasive vines to be removed and northern planting area shaded in green.

planting areas are identified on the *Sketch Plan*, north (Photos 8 and 9) and south (Photos 10 and 11) of an existing eastern white pine tree. The planting area north of the tree includes the vine removal area described above and a 3' section of existing lawn that will be removed and replanted. The planting area south of the tree includes existing, sparsely vegetated land that will be enhanced with native plantings. All sapling trees will measure between 4' and 6' tall with 1"-1.5" calipers, and all native shrubs will measure 2' to 3' tall at the time of planting.

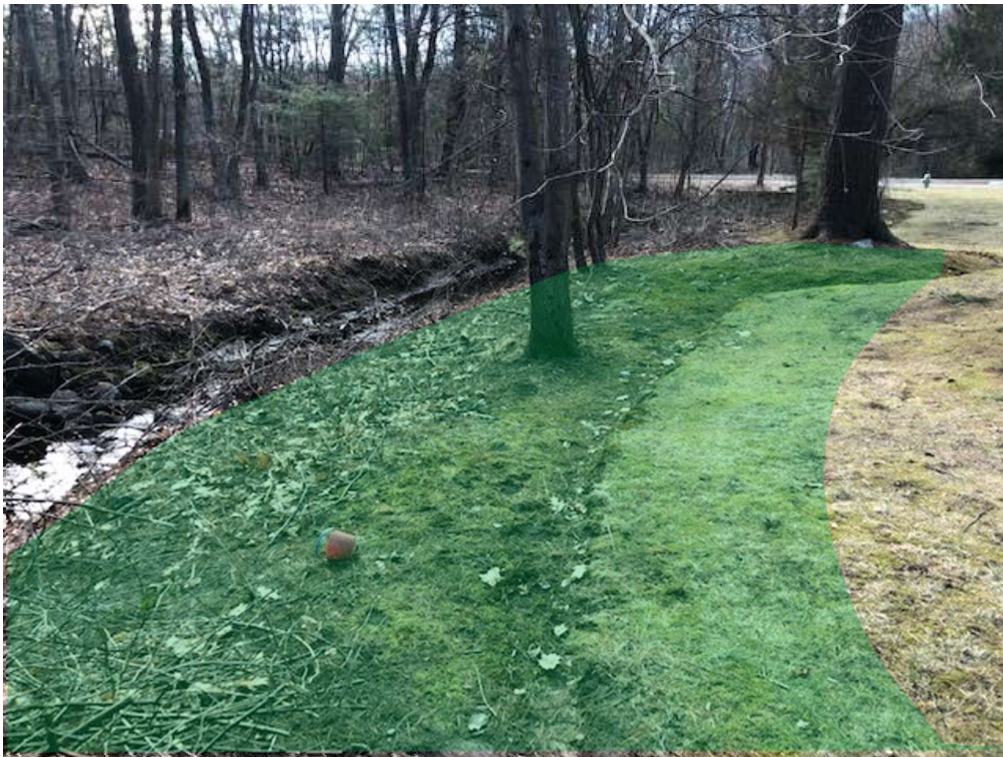
Photo 9: Southerly view of northern replanting area shaded in green.

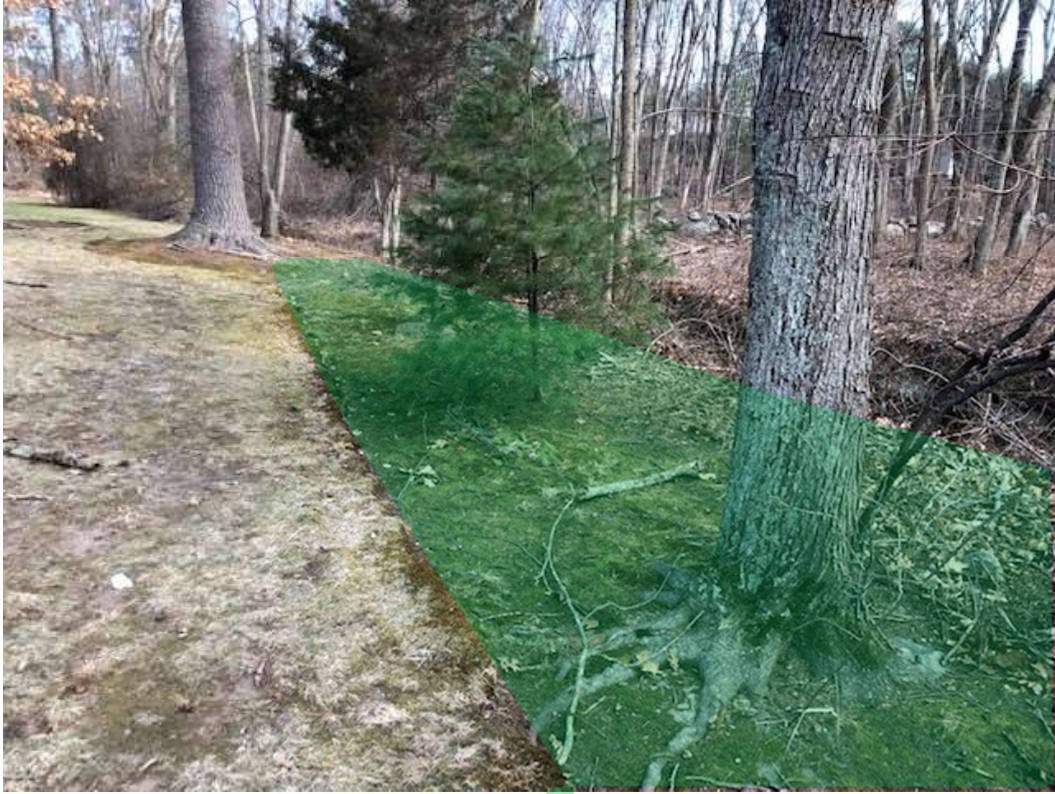
Photo 10: Northerly view of southern planting area shaded in green

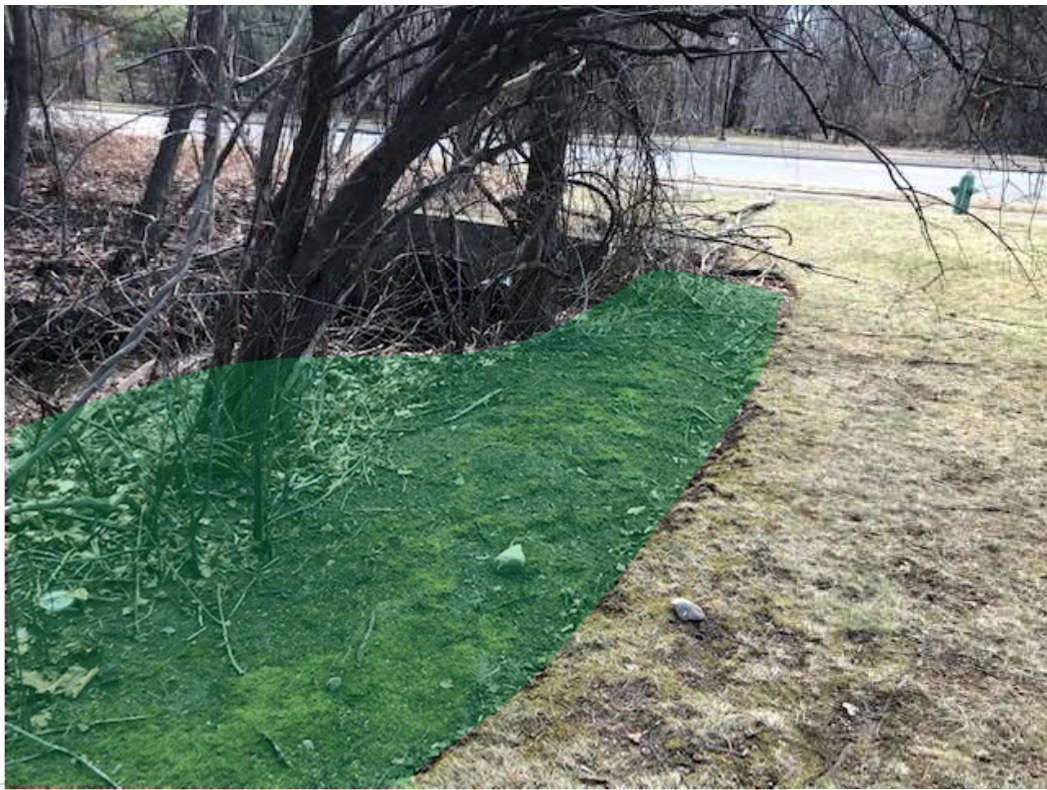
Photo 11: Southerly view of southern planting area shaded in green with Chatham Way in background.
