**Re: Peer Review of Notice of Intent Application**  
**DEP File #: 209-0649**  
**99 Crest Road**  
**Assessor’s Map 35, Lot 255**  
**Lynnfield, Massachusetts**

LEC Environmental Consultants, Inc., (LEC) conducted a site evaluation and peer review of the May, 2021 Notice of Intent (NOI) Application filed by Hayes Engineering, Inc., (Hayes), on behalf of the Applicant, Mary Jo Milano. The purpose of this peer review was to determine compliance with the *Massachusetts Wetlands Protection Act* (M.G.L. c. 131, s. 40, the *Act*) and its implementing Regulations (310 CMR 10.00, the *Act Regulations*), and the *Town of Lynnfield Wetland Protection Bylaw* (Chapter 240, the *Bylaw*) and the *Town of Lynnfield Wetland Protection Regulations* (Chapter 320, the *Bylaw Regulations*). As part of this peer review, LEC conducted a site evaluation on July 21, 2021 and reviewed the following documents:

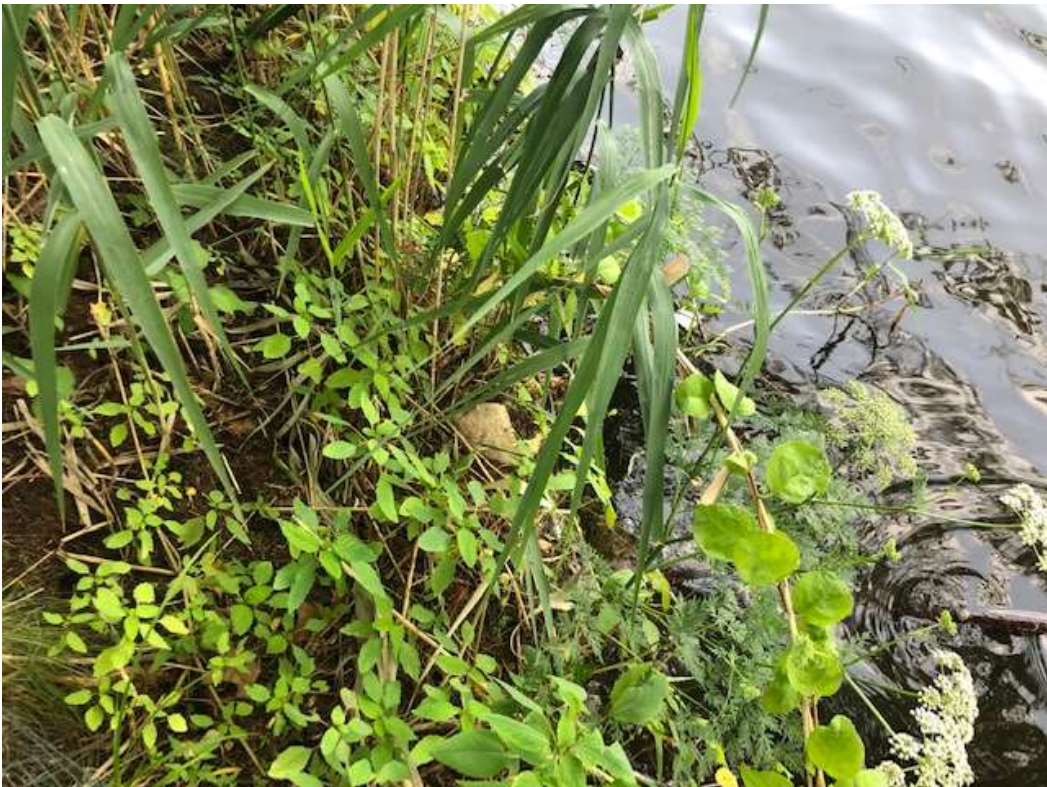
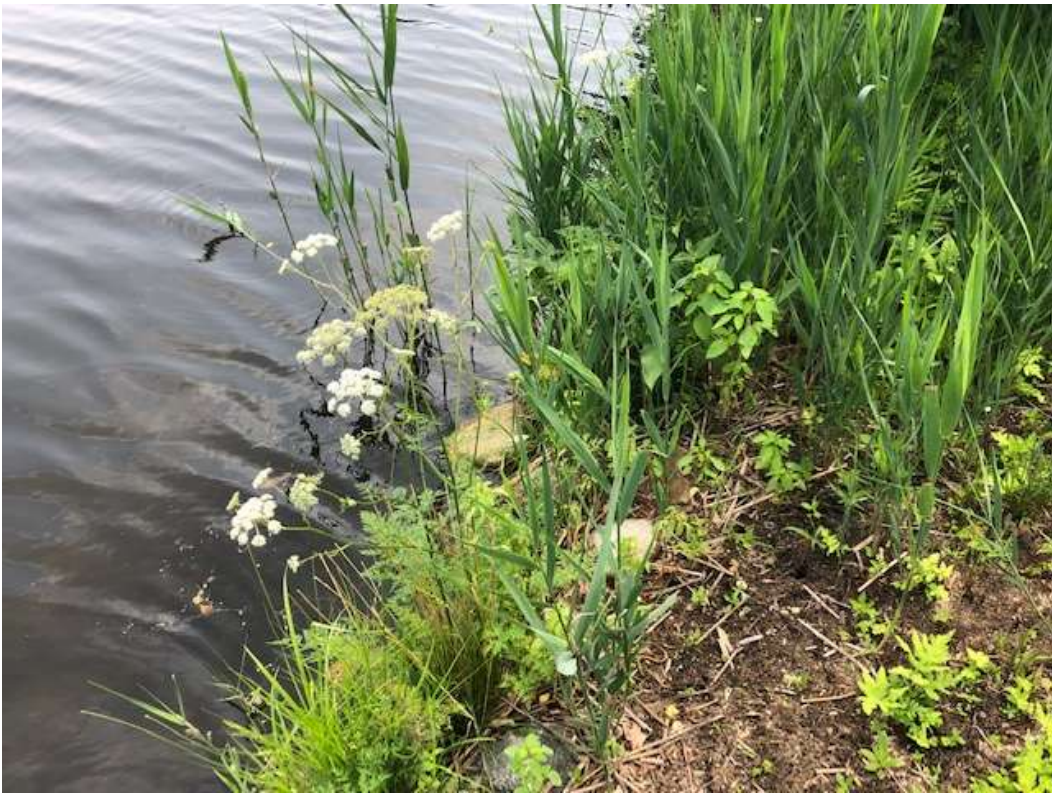
**Site Photographs:** June 21, 2021 Site Evaluation

Based on our observations (site photographs included herein as **Attachment A** and in the NOI Application), the lot appears to have been constructed, at least in part, on historic fill material, as evidenced by a roughly 12-inch thick, loamy sand fill layer (C horizon) observed along the vegetated pond edge, and human transported material (e.g., concrete and brick fragments, stones, etc.) observed intermittently within the water column immediately adjacent to the pond edge. Scattered larger stones and tree roots were observed along the pond edge as well.

Views of abrupt break in topography along pond edge.

The abrupt slope along the edge of Pillings Pond transitions from historic fill soil to comparatively coarse stones, brick and concrete fragments, etc., located roughly 6 inches below the water surface observed during our June 21, 2021 site inspection. Such conditions warrant an evaluation of soft engineering solutions to stabilize the pond edge, such as:

- Coir (coconut) Fiber Logs: Fiber logs are generally available in 10 to 12-foot lengths and 12 and 16-inch diameters, and are available as ‘Standard’ or ‘Premium’ depending on density. A double-log installation may be prudent for this site with the upper log protecting the historic fill soil from wave action above the water line. Coir logs must always be staked in place with hardwood stakes (both layers if two), and a rip-rap toe also may be used to anchor the coir logs in place. The logs can be backfilled with an organic-laden topsoil (8-10% organic content) and planted with live-stakes and/or tubelings (see below), native herbaceous plugs suitable for the site’s hydrology, and/or seeded (those portions above the water level) with an appropriate native seed mixture.

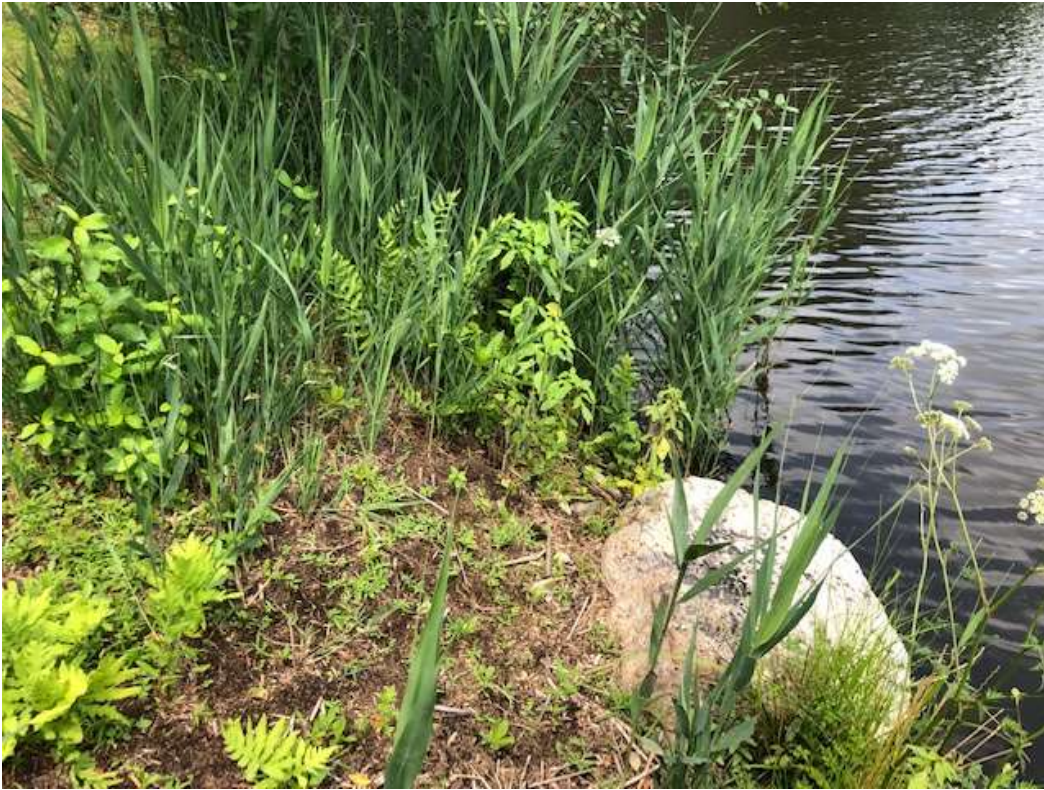
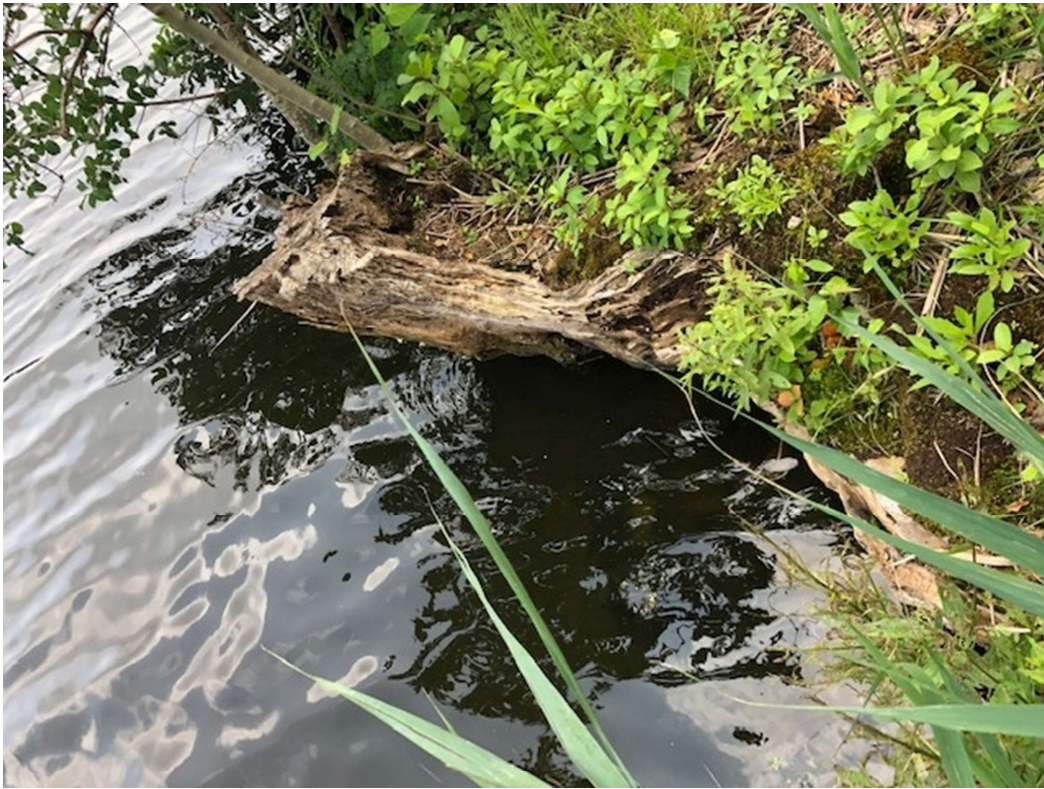
**Site Photographs:** June 21, 2021 Site Evaluation

Stones and tree roots stabilize the pond edge intermittently along its length.

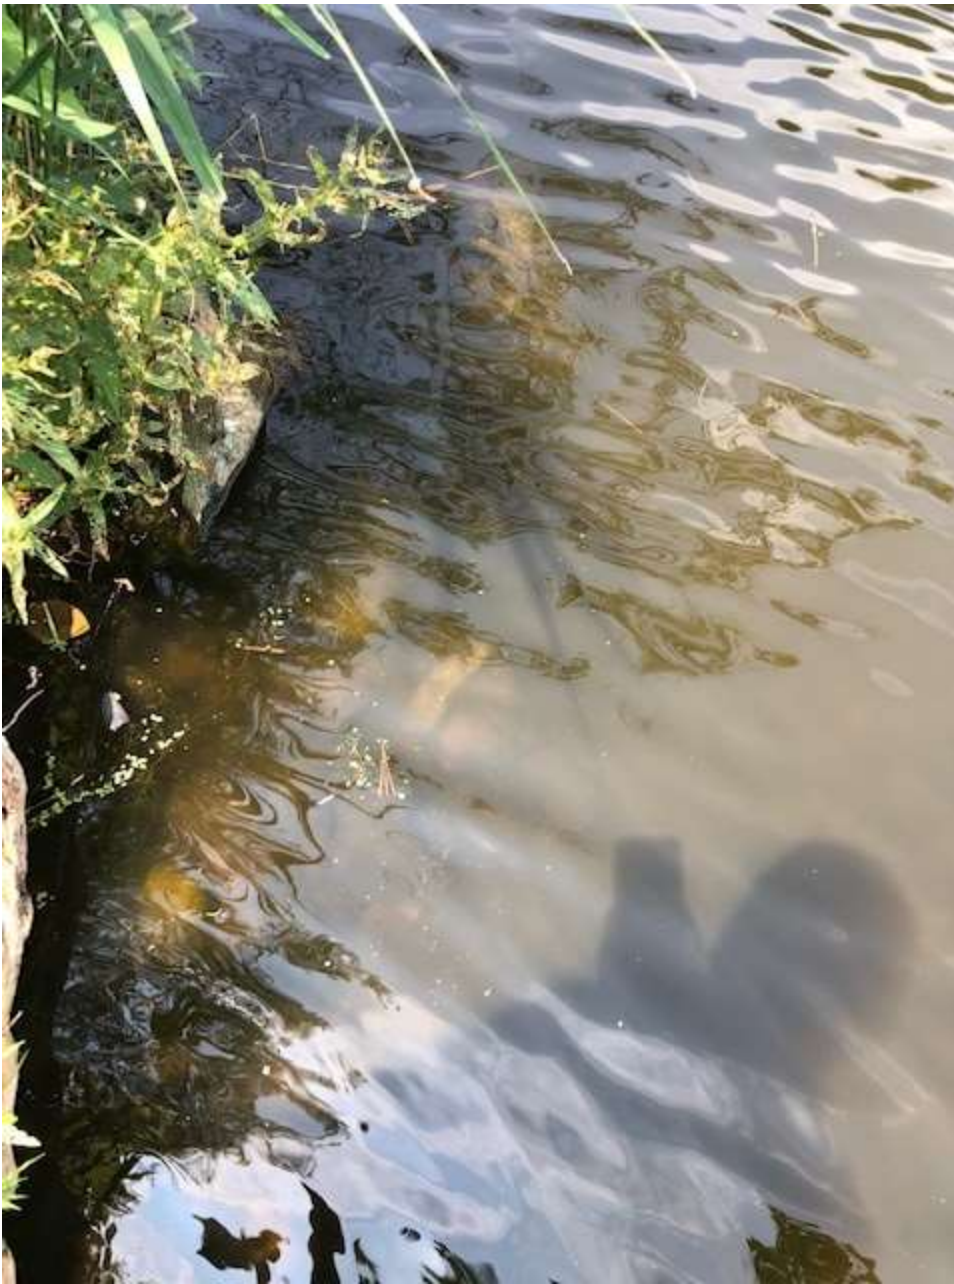
**Site Photographs:** June 21, 2021 Site Evaluation

View of stones, concrete and brick fragments immediately adjacent to historic fill pond edge.

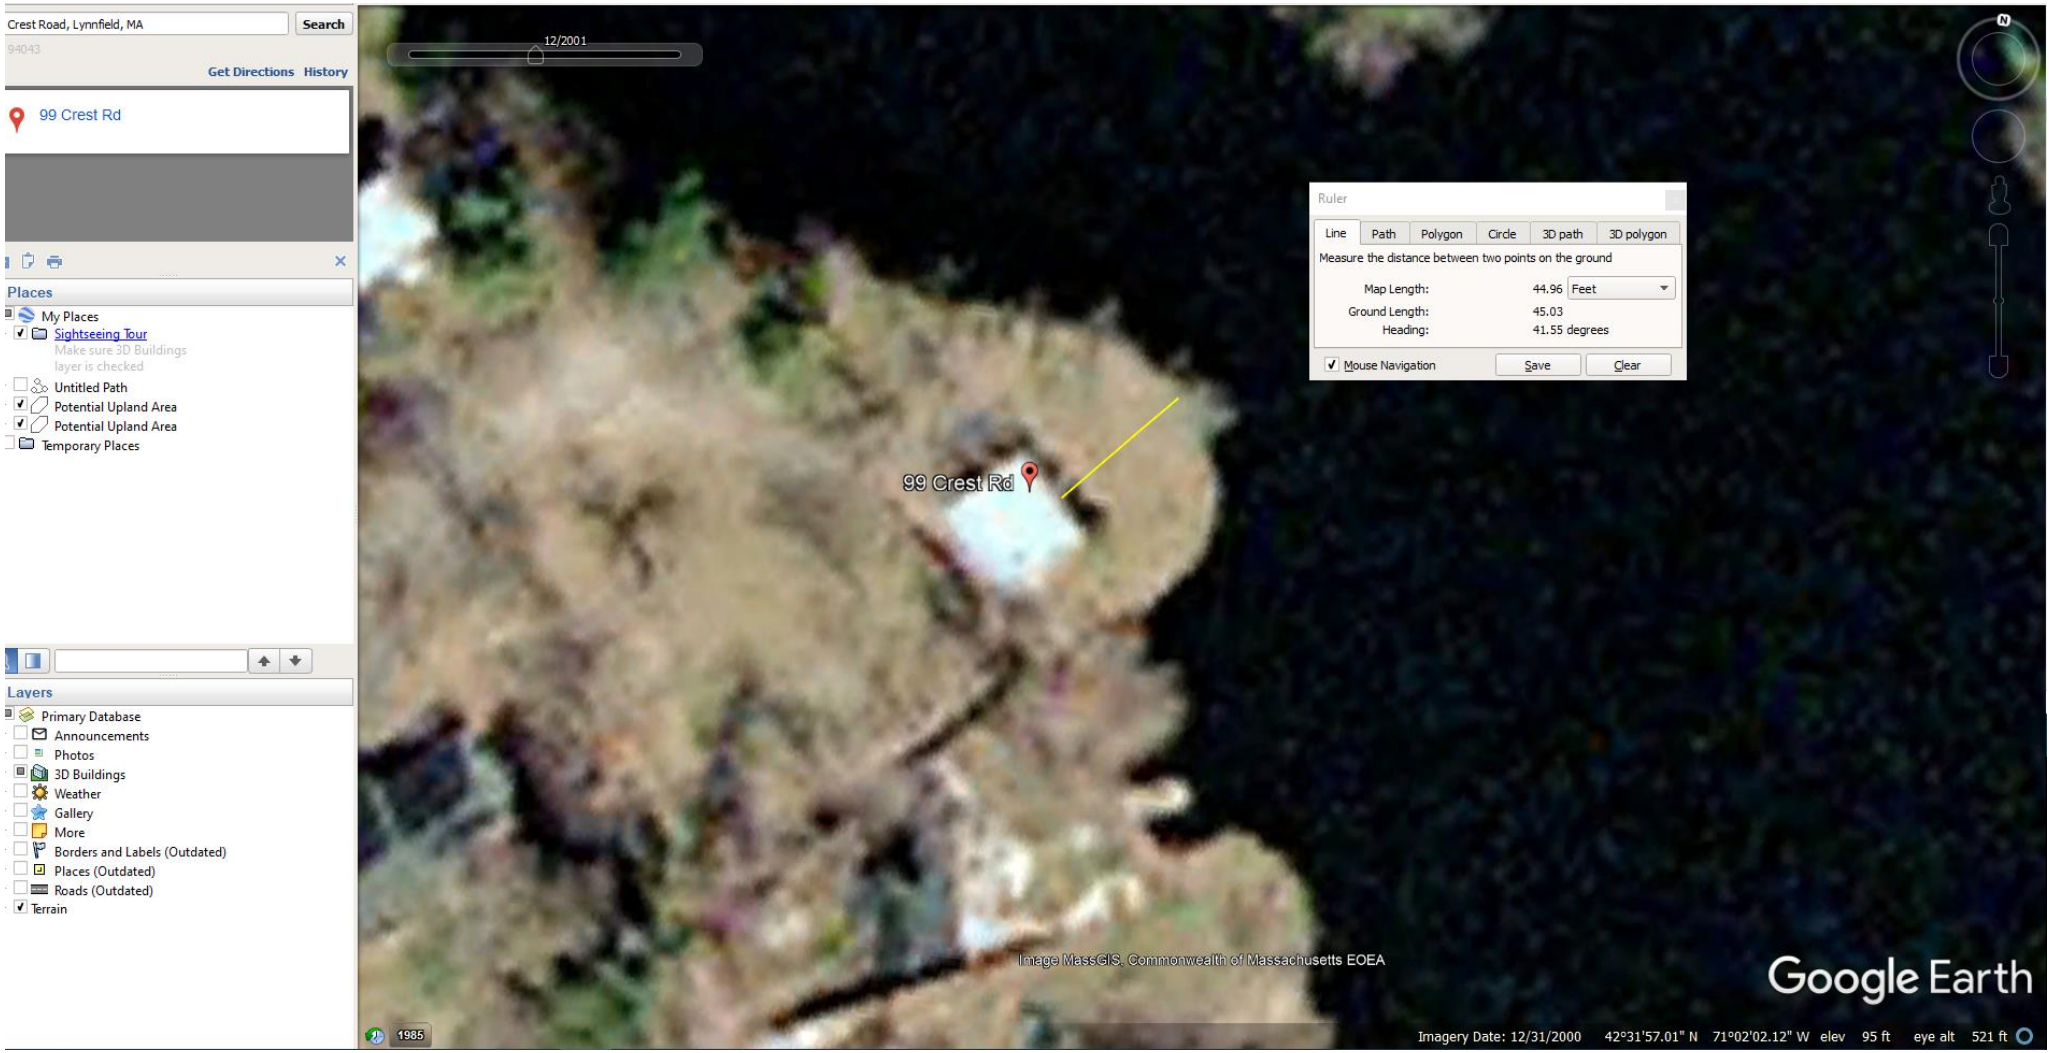
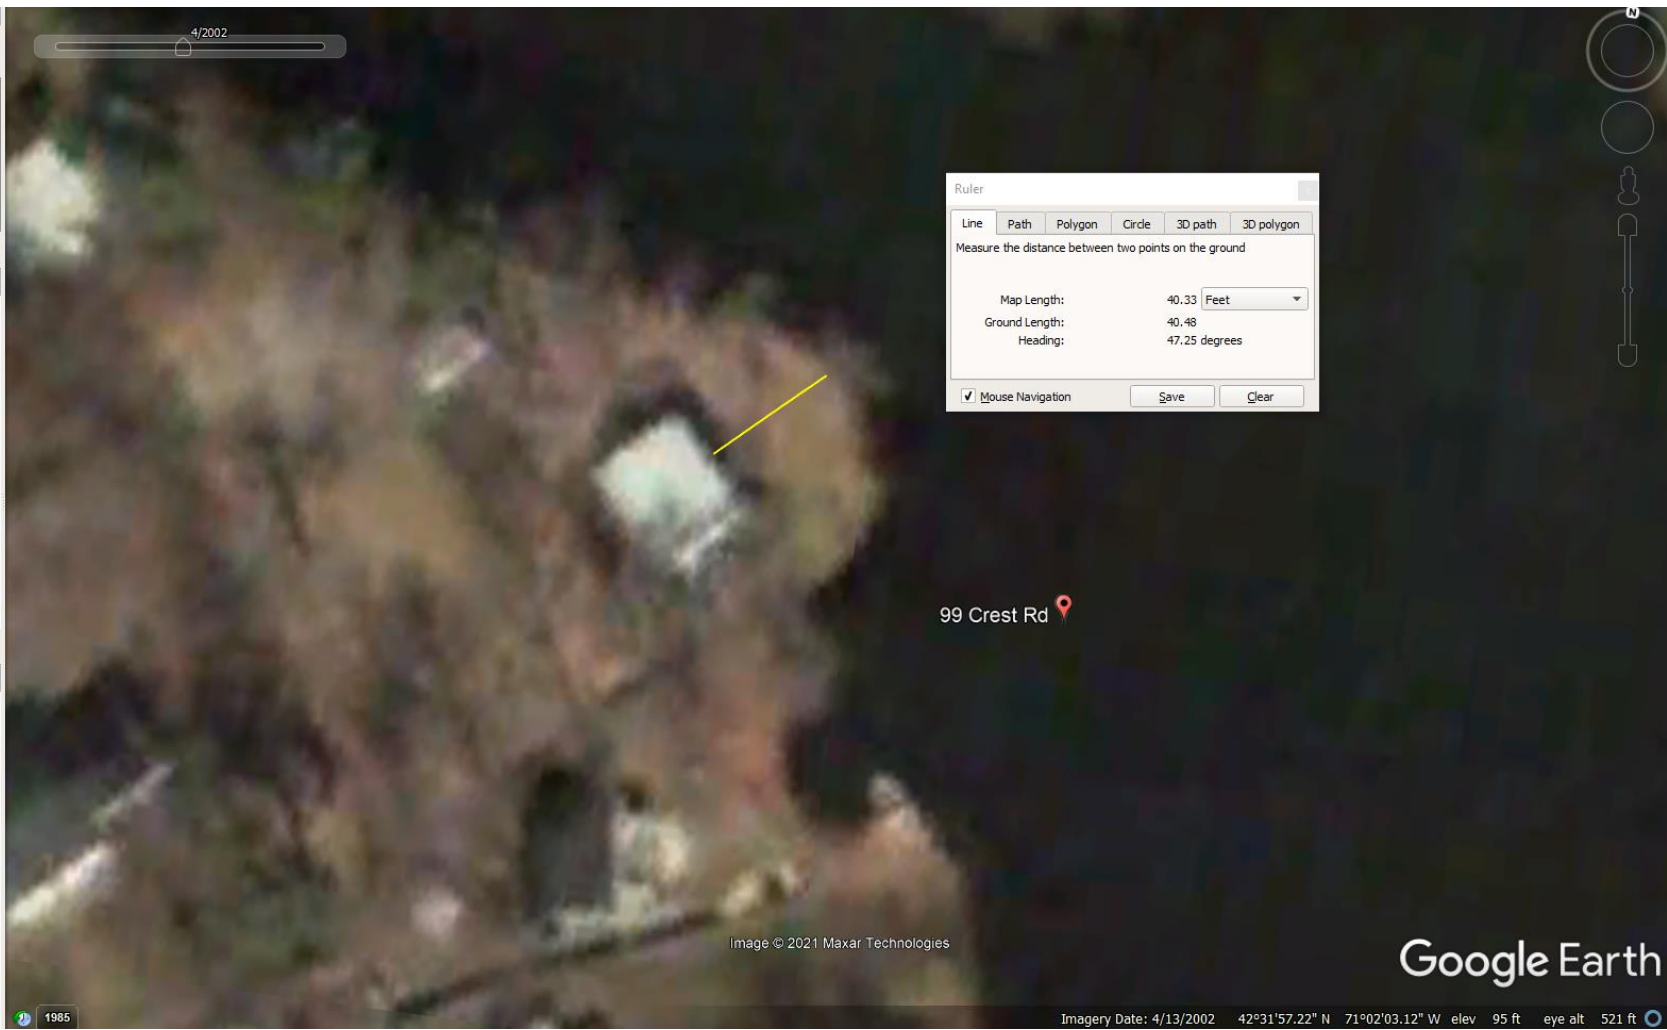
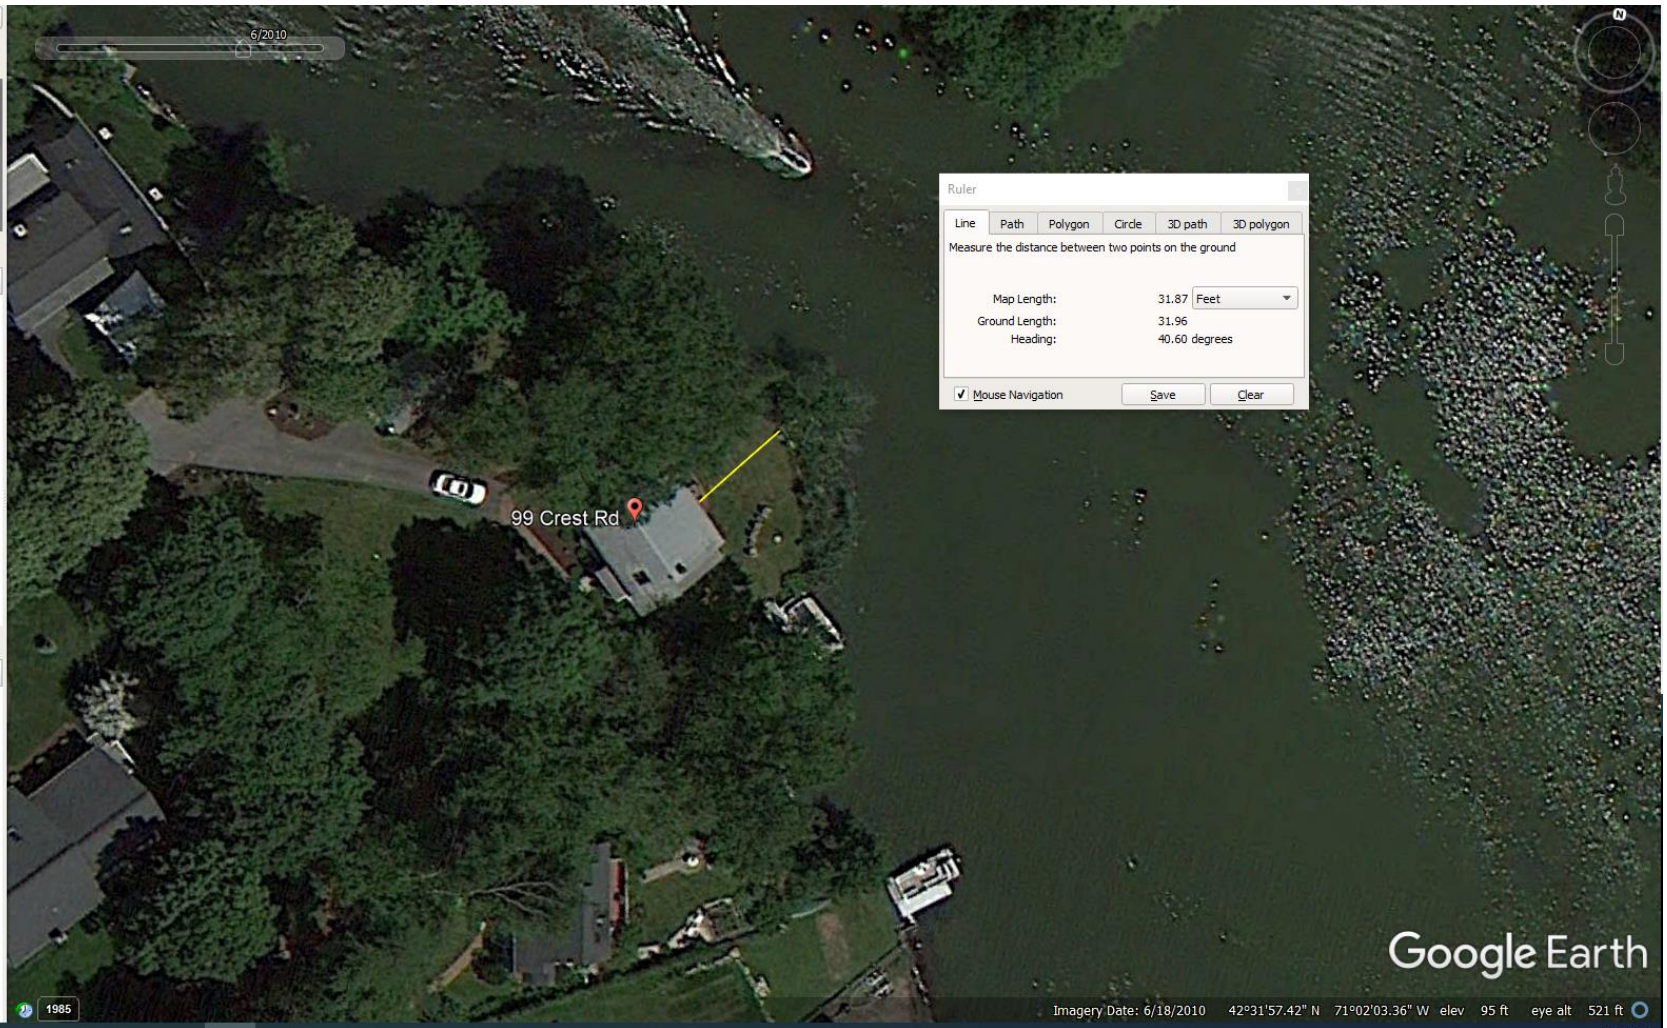
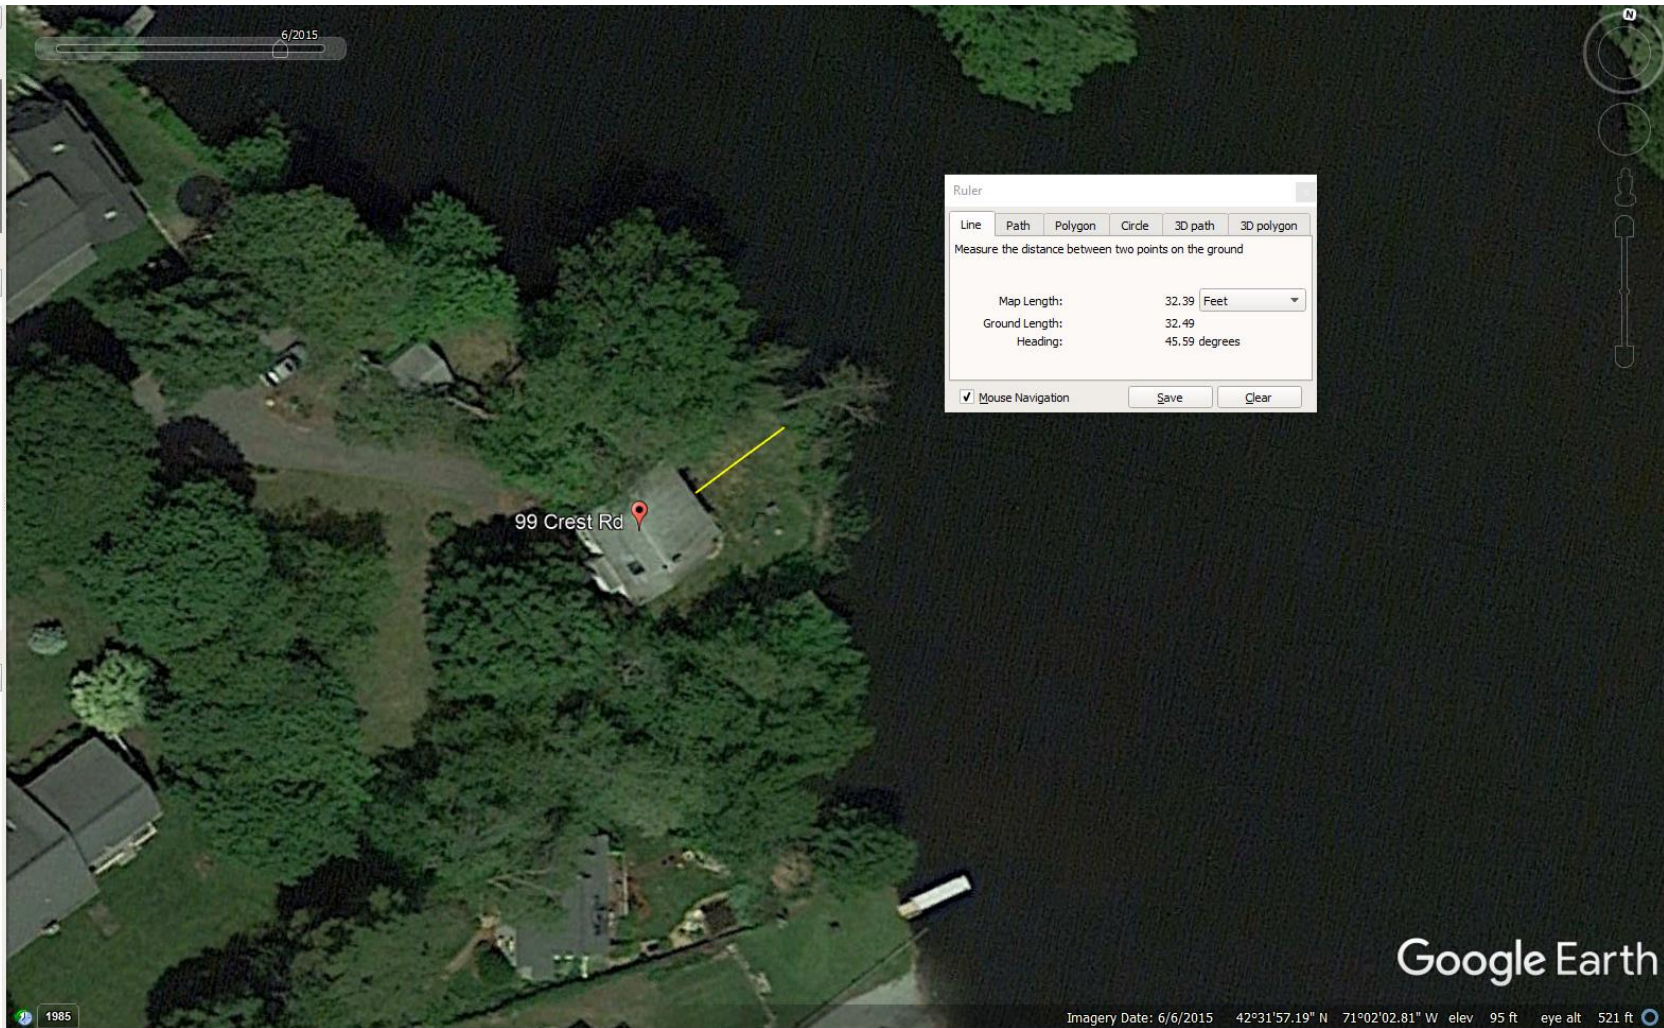
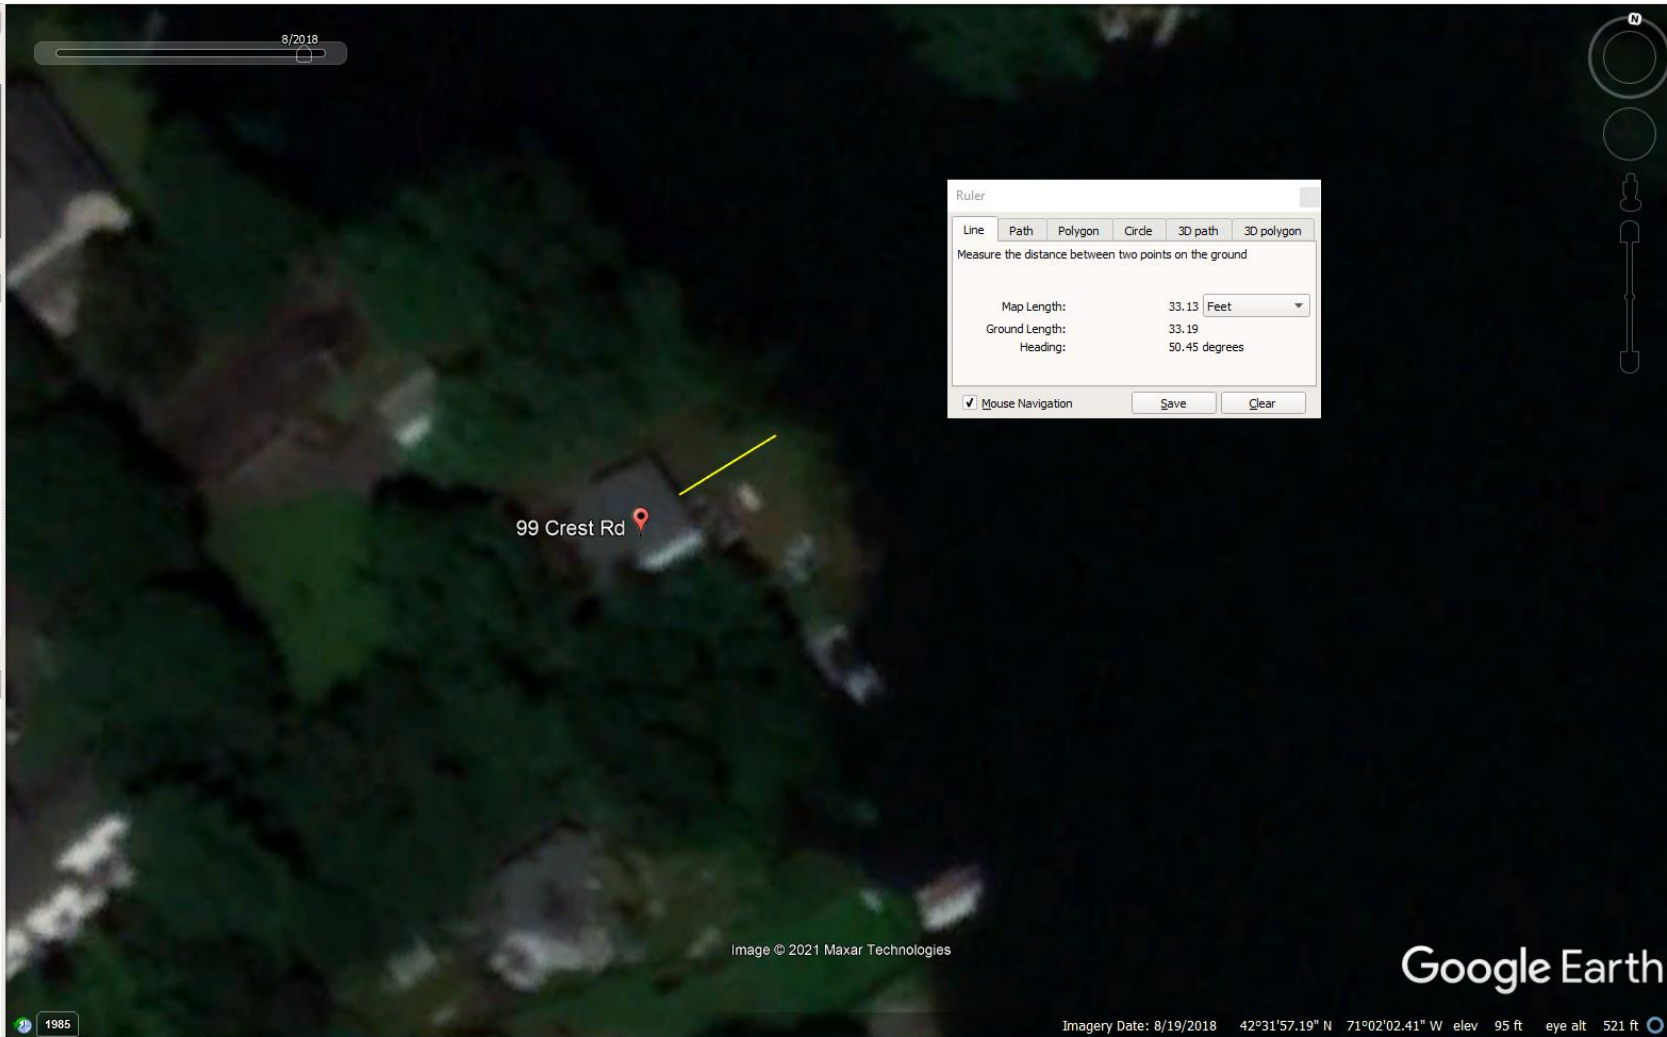
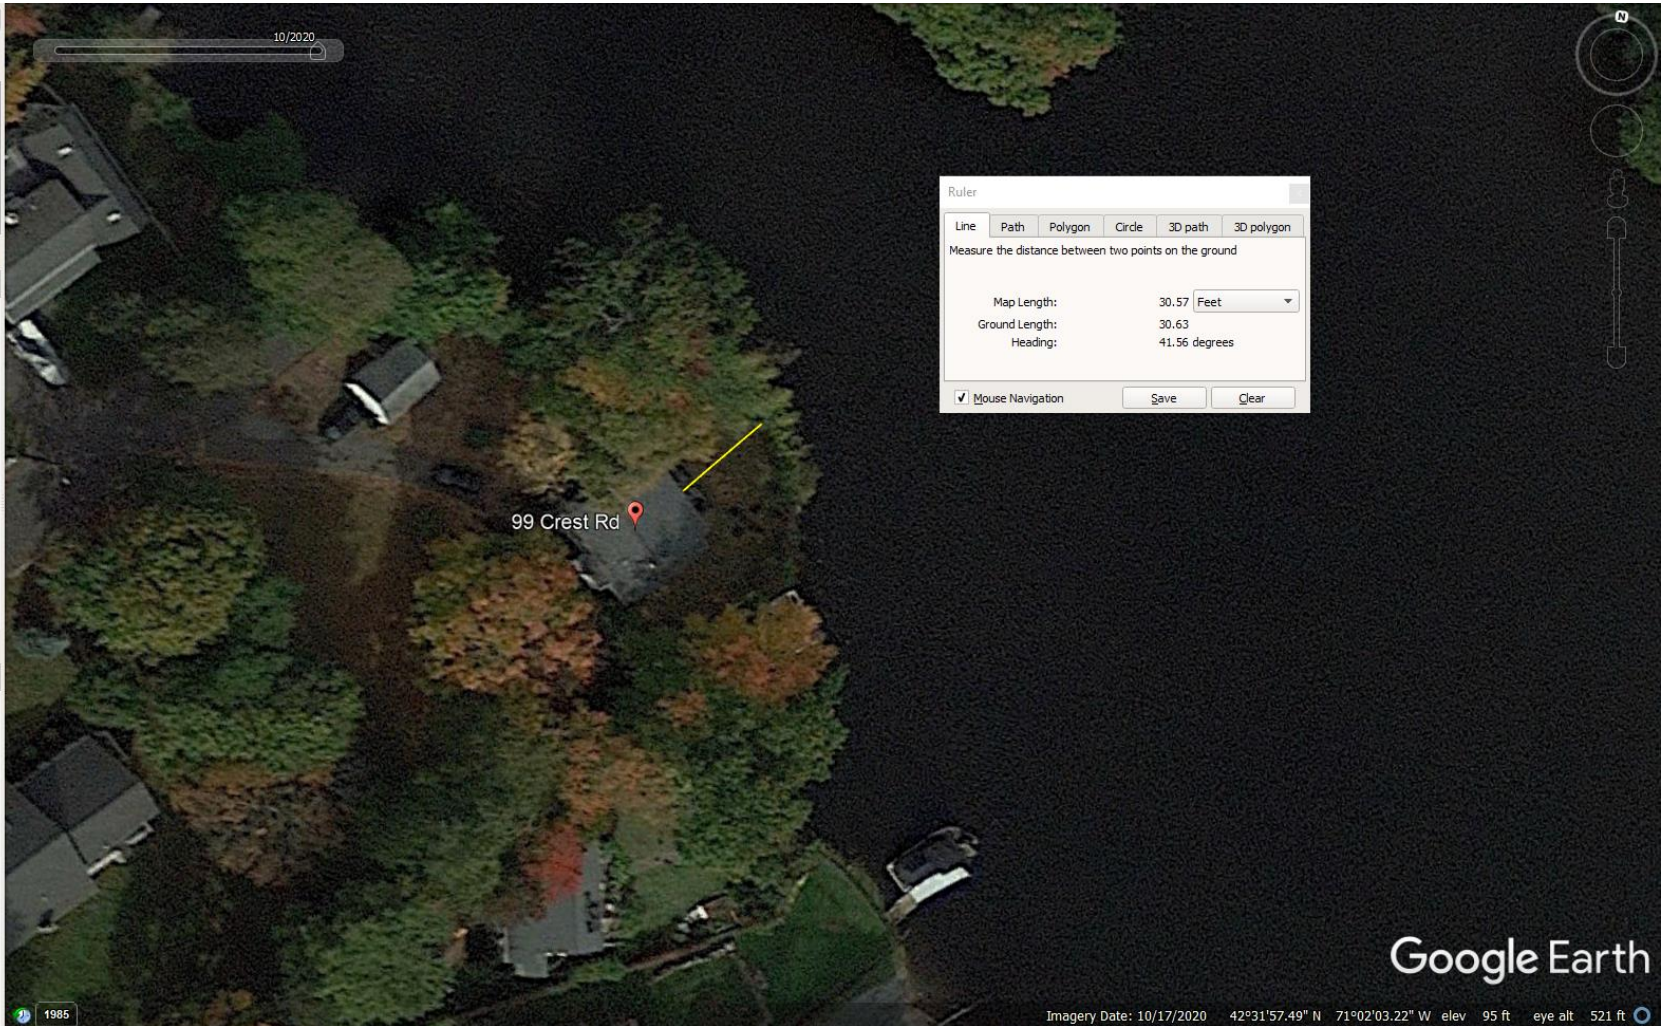
Google Earth imagery from April 1995 through October 2020

According to the Supplemental Letter, wave action caused by boat wakes is eroding the pond edge, increasing the size of the pond, and decreasing the size of the land surface on the property. While it is challenging to determine the extent of erosion that may have taken place over time, **Attachment B** contains Google Earth imagery from April 1995 through October 2020. The measurements depicted on these images using the ruler tool are variable, likely due (in part) to the angle from which the images were taken. However, a reduction in the amount of land between the dwelling and the pond edge appears to be evident when comparing the size of the dwelling to the area of land between the dwelling and the pond edge. This is particularly evident when comparing the April 1995 image to the December 2001 and April 2018 images, and likely caused by the boat wave action as suggested by the Applicant.
