**RE: Riverfront Restoration & Management Plan
70 Walnut Street | Lynnfield, Massachusetts**

Recommended Planting Plan

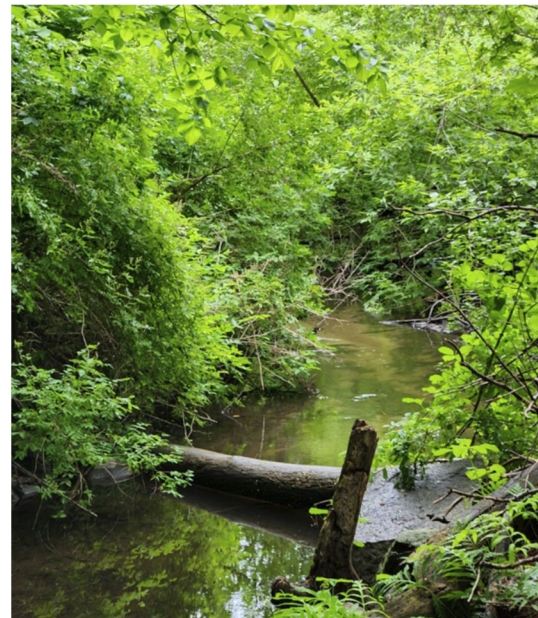
Representative photo of the 70 Walnut street with dense invasive plant growth

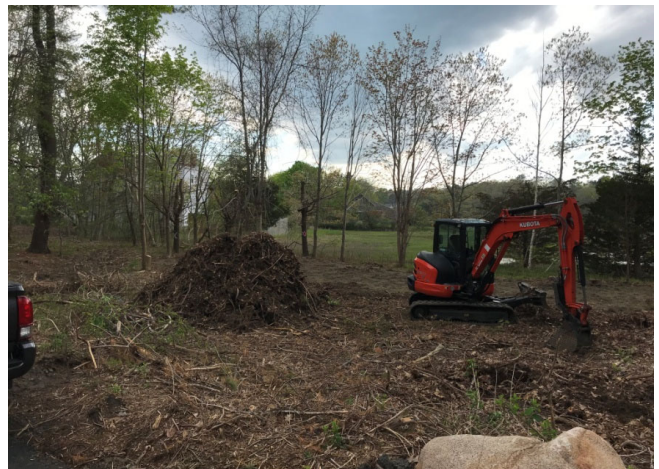
Whole Plant Removal techniques employed using a mini excavator

Standing vegetation should be cut, removed, and stockpiled for burning or chipping for compost. A mini-excavator and/or flail mower should be used to remove the targeted species from the restoration area. This will leave the exposed roots and stumps of the invasive species accessible for removal. The area can be cut with a machine as well during this phase of work. If heavy machinery is used for removal of root material, mats should be placed to minimize the disturbance of the soils by dispersing the weight of the equipment over a larger surface area, decreasing the compression of the soils. The entire restoration area will be cleared of the invasive woody species and maintained from the re-invasion of the targeted invasive plant species.

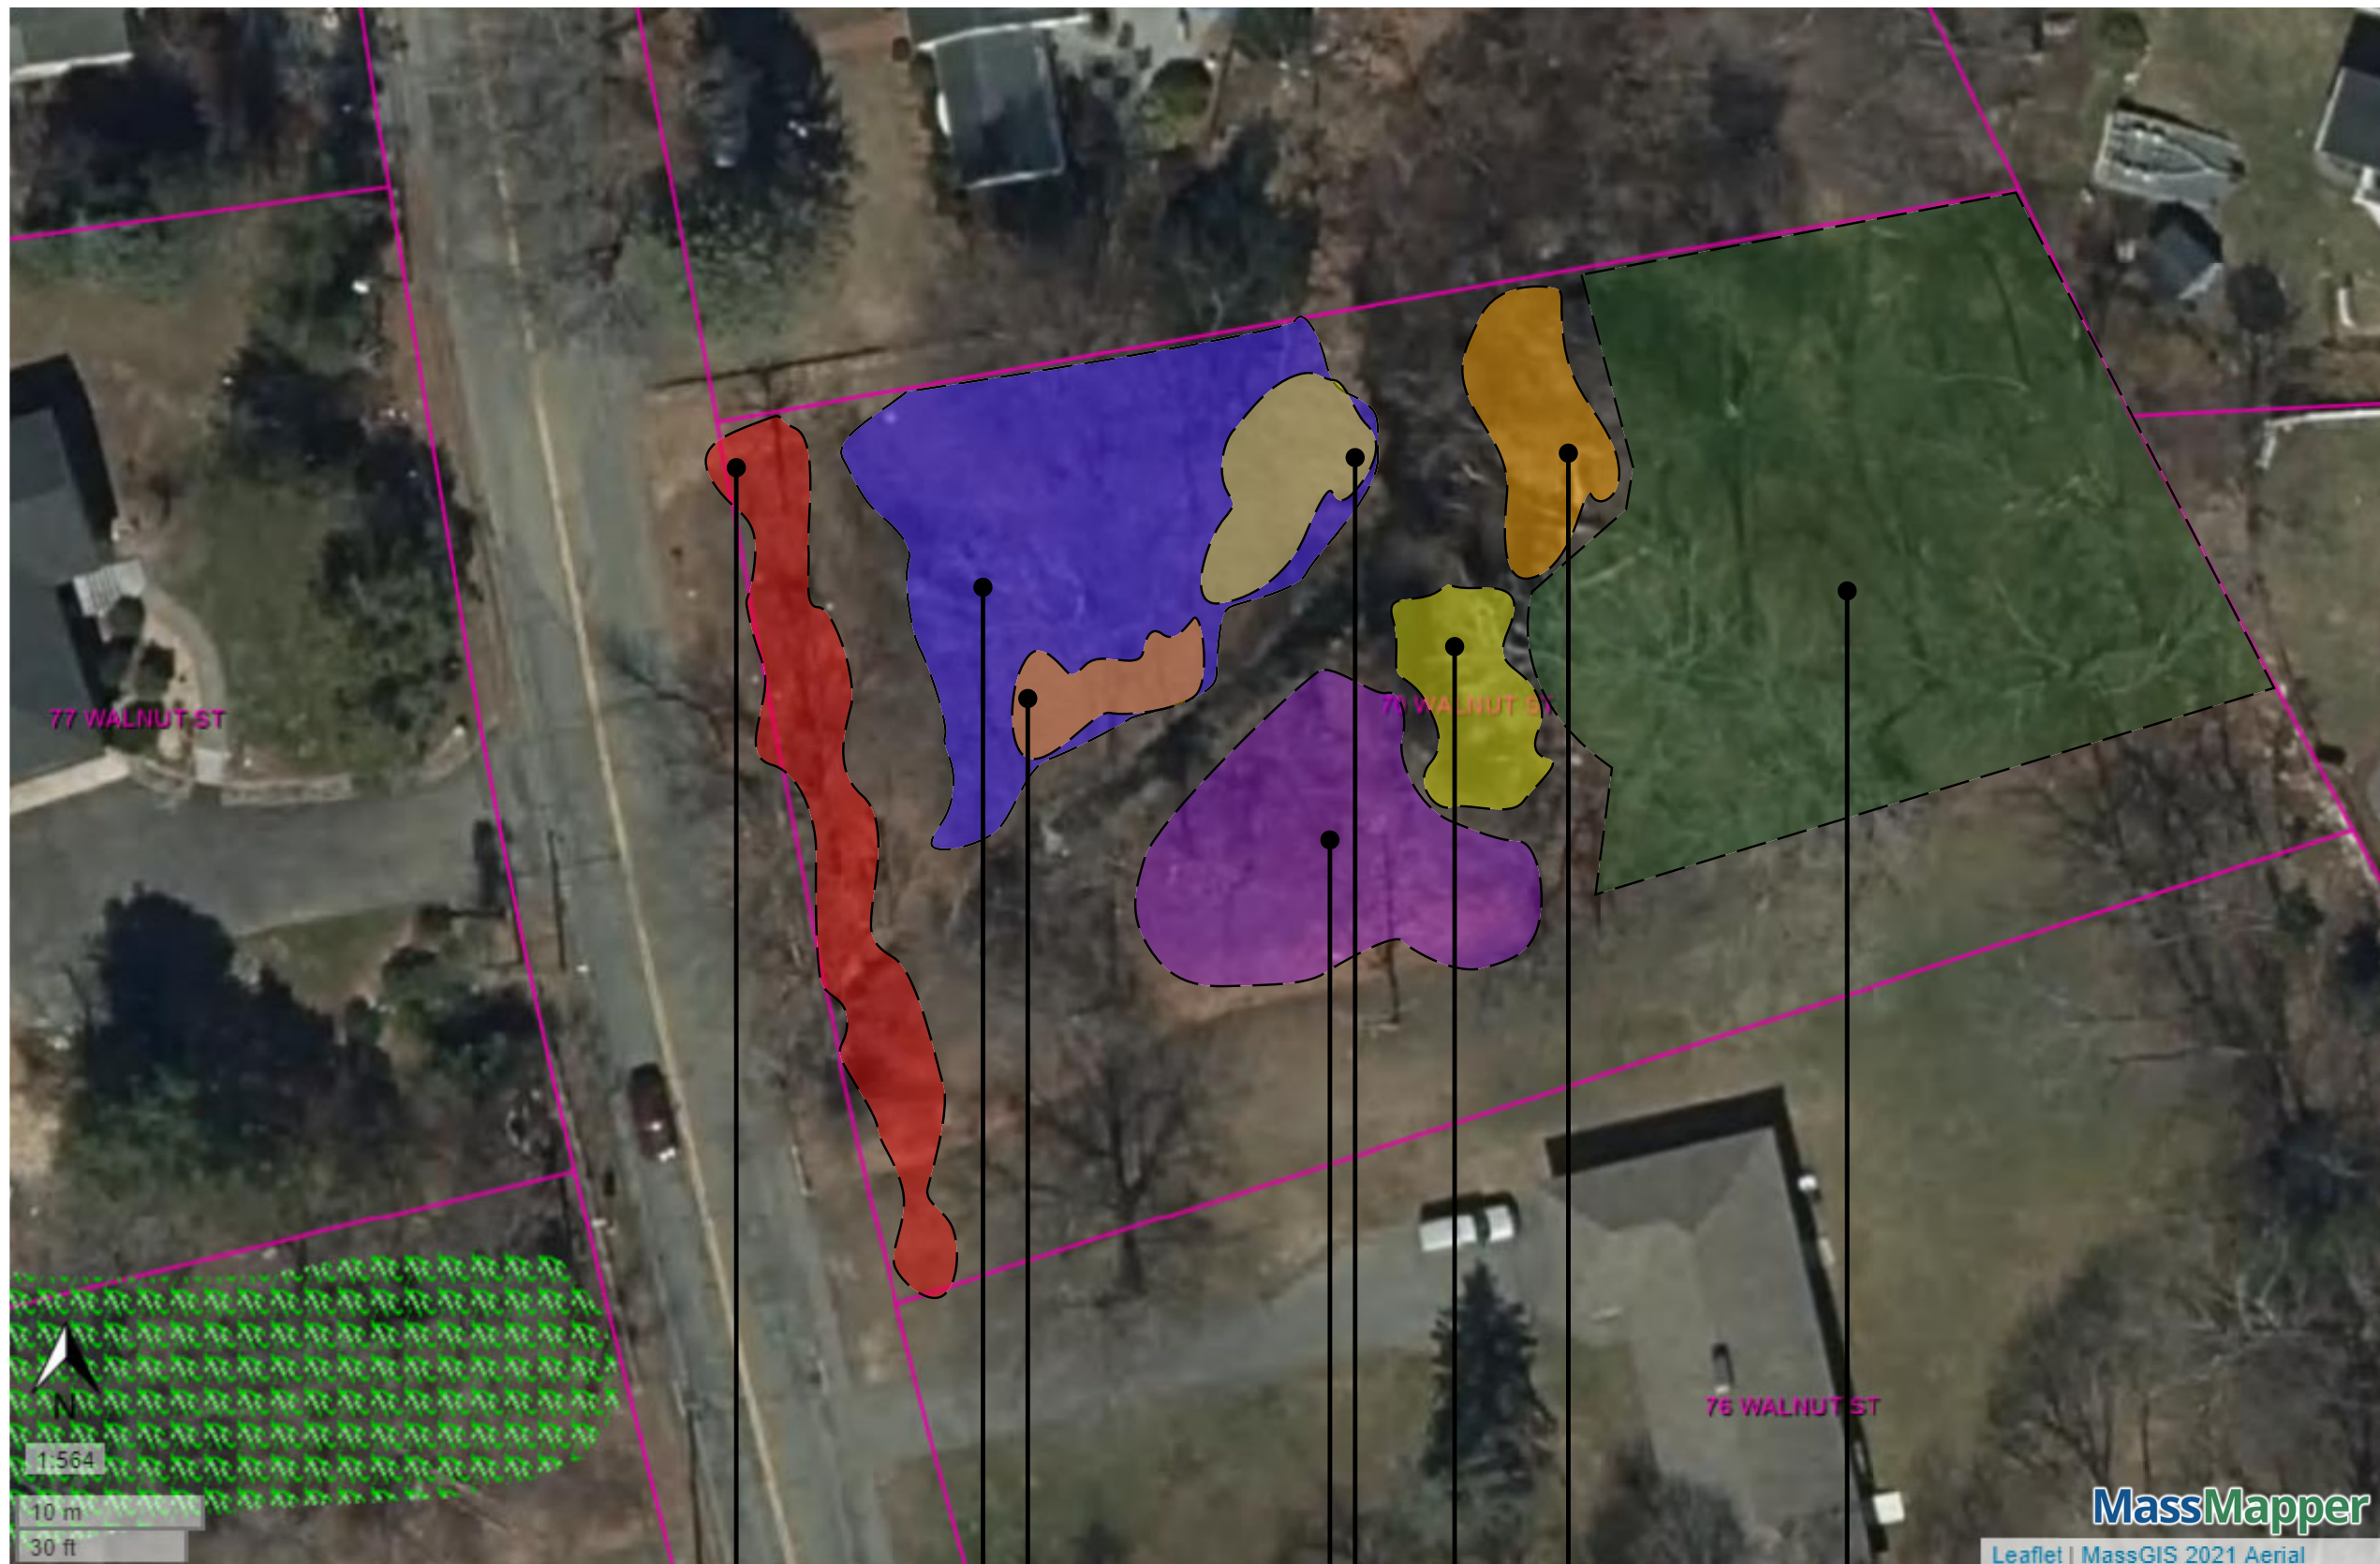
Multiflora rose
Virginia creeper
Bittersweet
Eastern Black Walnut

Garlic mustard
Swallow wort
Bittersweet
Multiflora rose
Honeysuckle
Norway maple

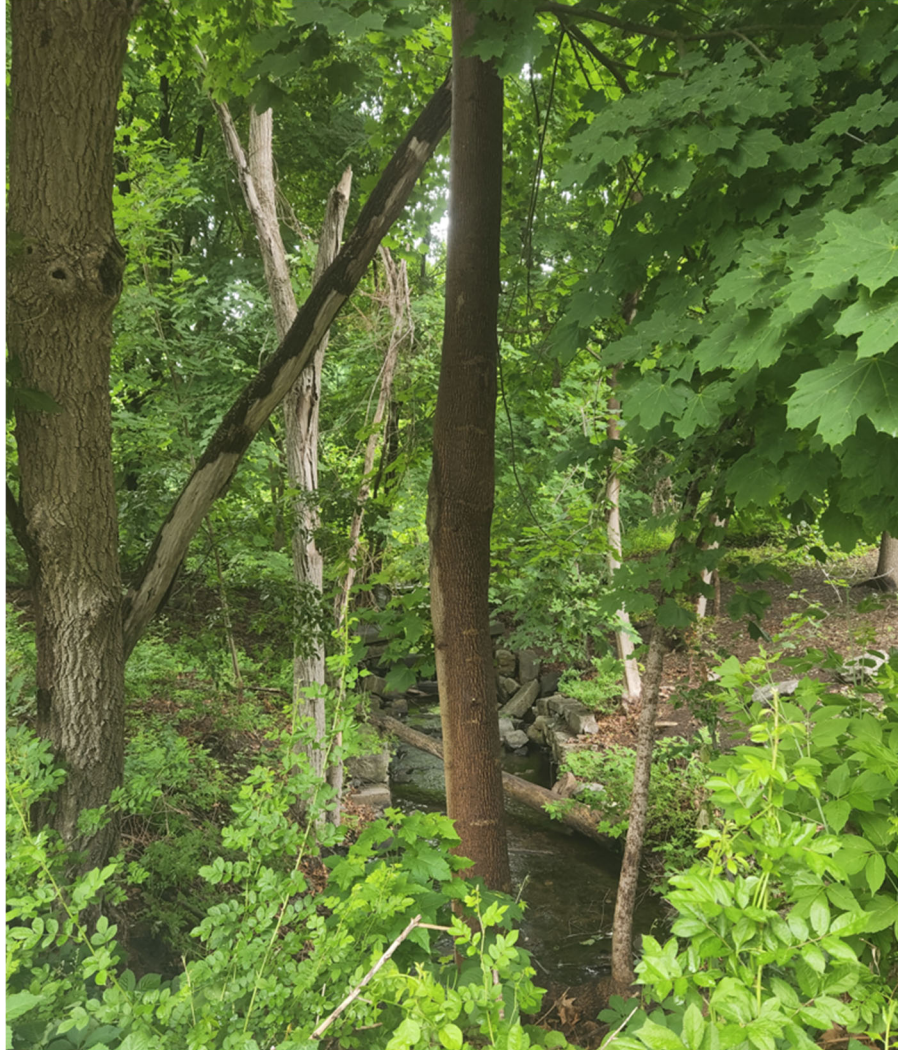
Canopy at the site is predominantly Norway Maple, an invasive species. Multiflora rose is seen in the understory

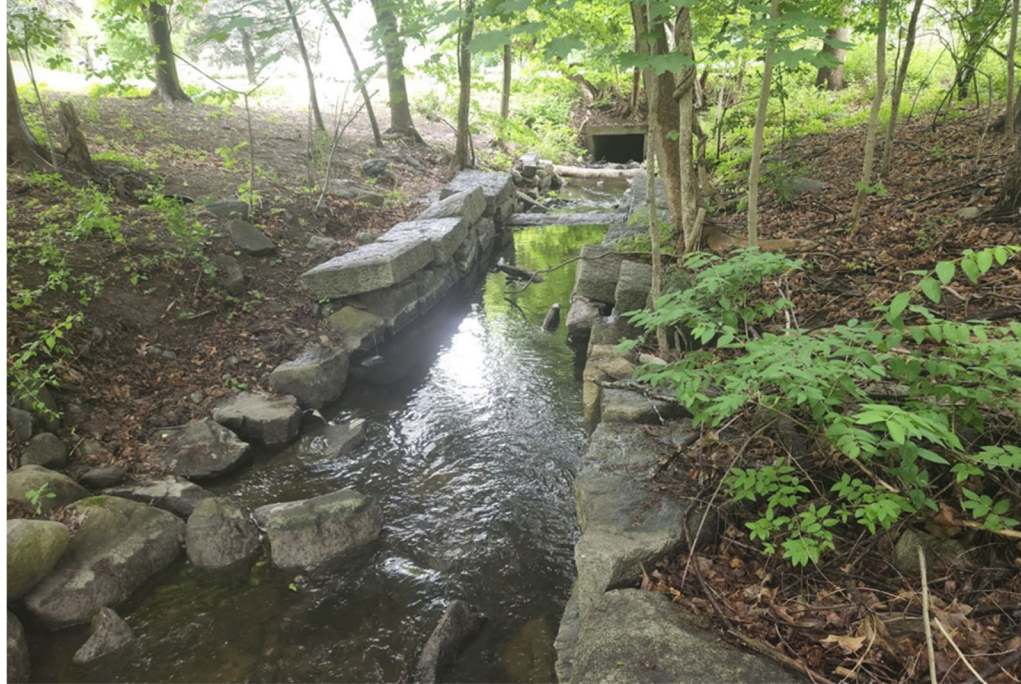
In this photo you see an example of the “Norway Maple Desert”. Norway maple canopies create densely shaded areas reducing the ability for understory growth.

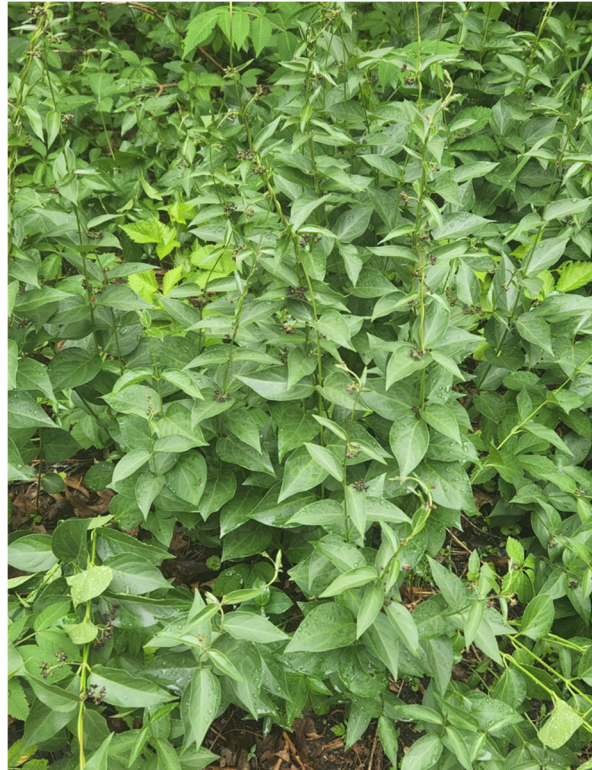
Black swallow wort has aggressively been taking over the herbaceous layer on site and is recommended to be removed.

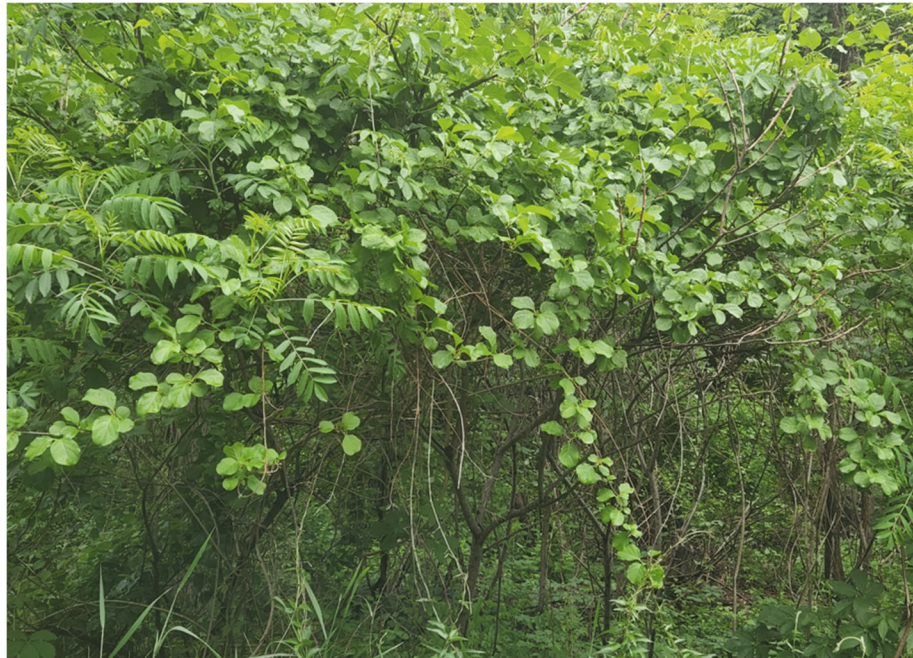
Asiatic bittersweet is seen here climbing walnut tree saplings. It is recommended that the bittersweet be removed from the site so that it does not continue to suffocate the native species on site.

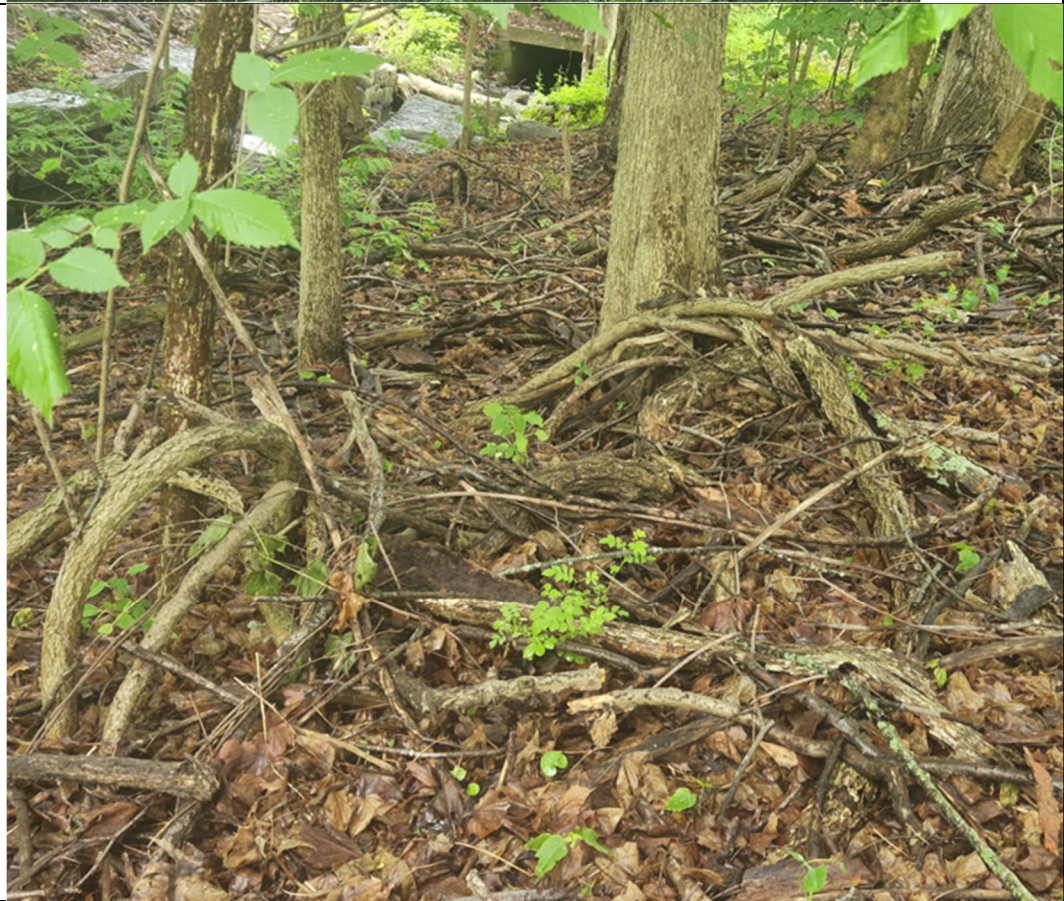
This photo shows extremely large bittersweet roots that will not be able to be removed by hand. Whole plant removal techniques can be employed by a mini-excavator to assist with removals of this size.

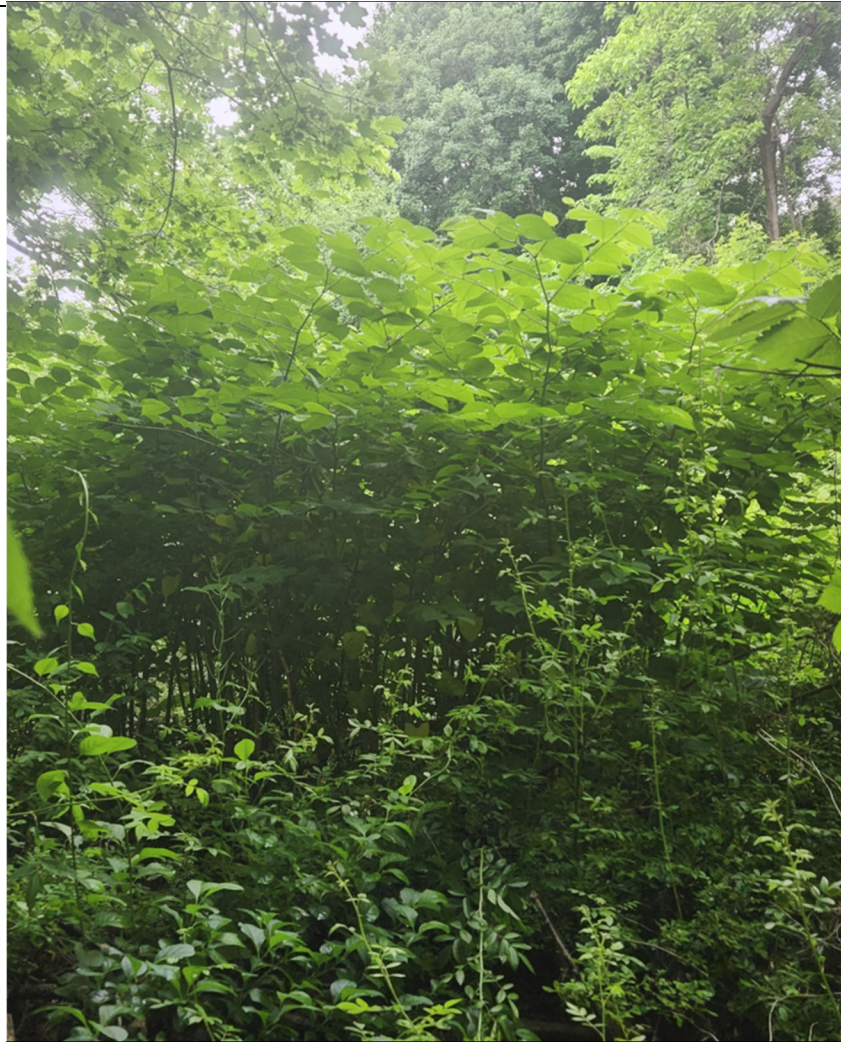
A large stand of Japanese knotweed has occupied the riverbank that will compromise the stability of the bank if not removed.

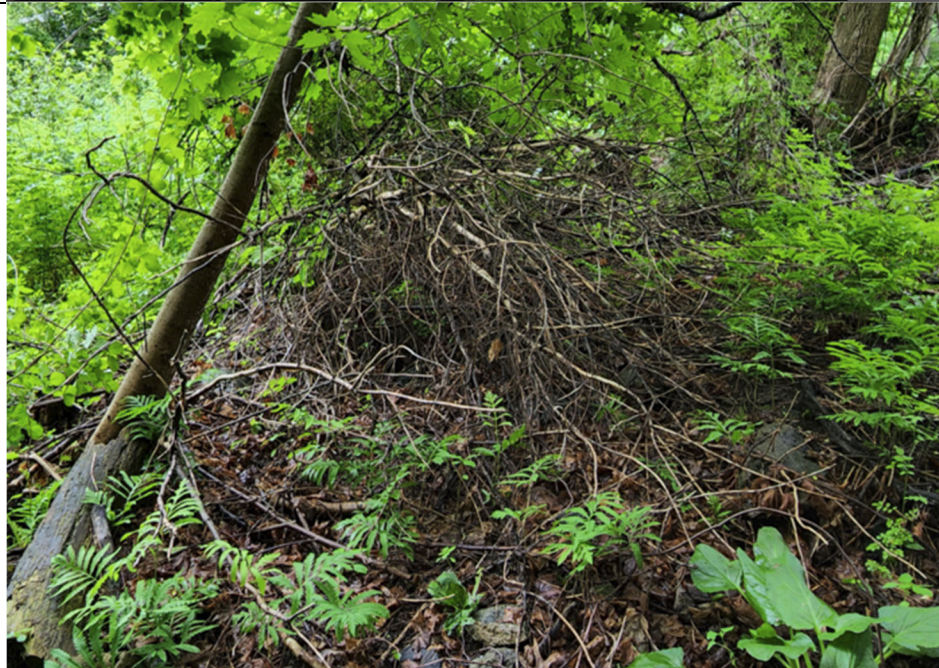
Photo showing a debris pile that was dumped. We recommend removing the debris piles as part of this restoration plan.

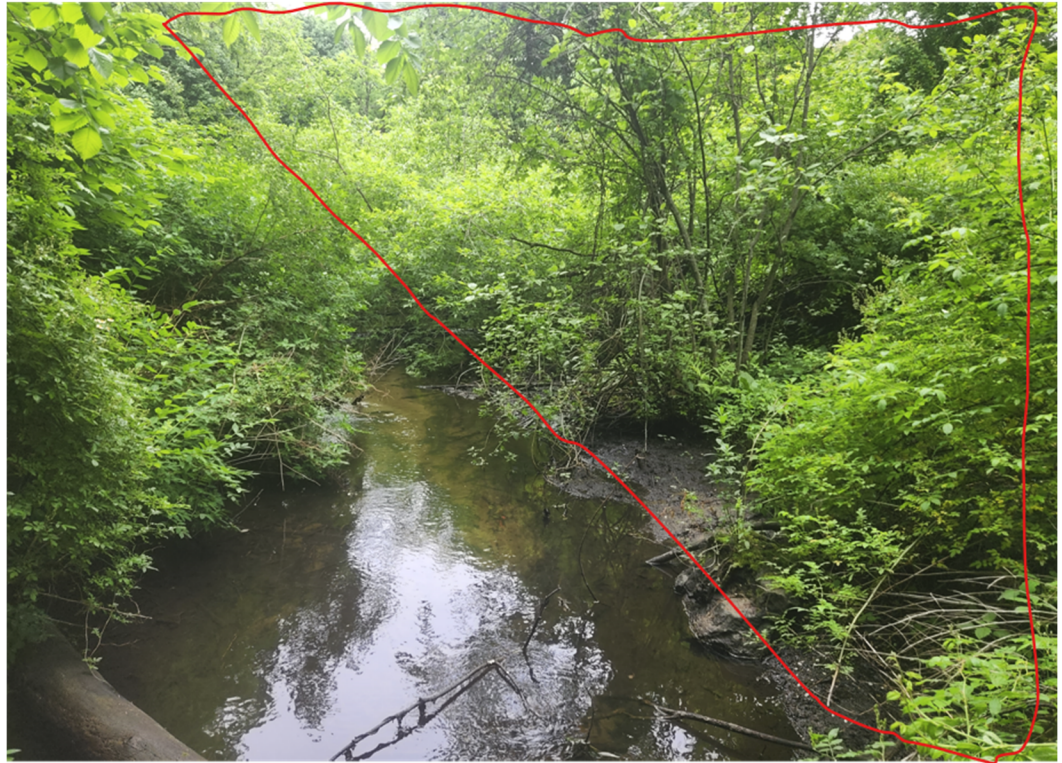
We were unable to access the rear of the property due to the thick vegetation, climbing bittersweet vines, and debris piles as shown in the previous photo. It seems that the vegetation consists primarily of invasive species similar to the accessible areas.

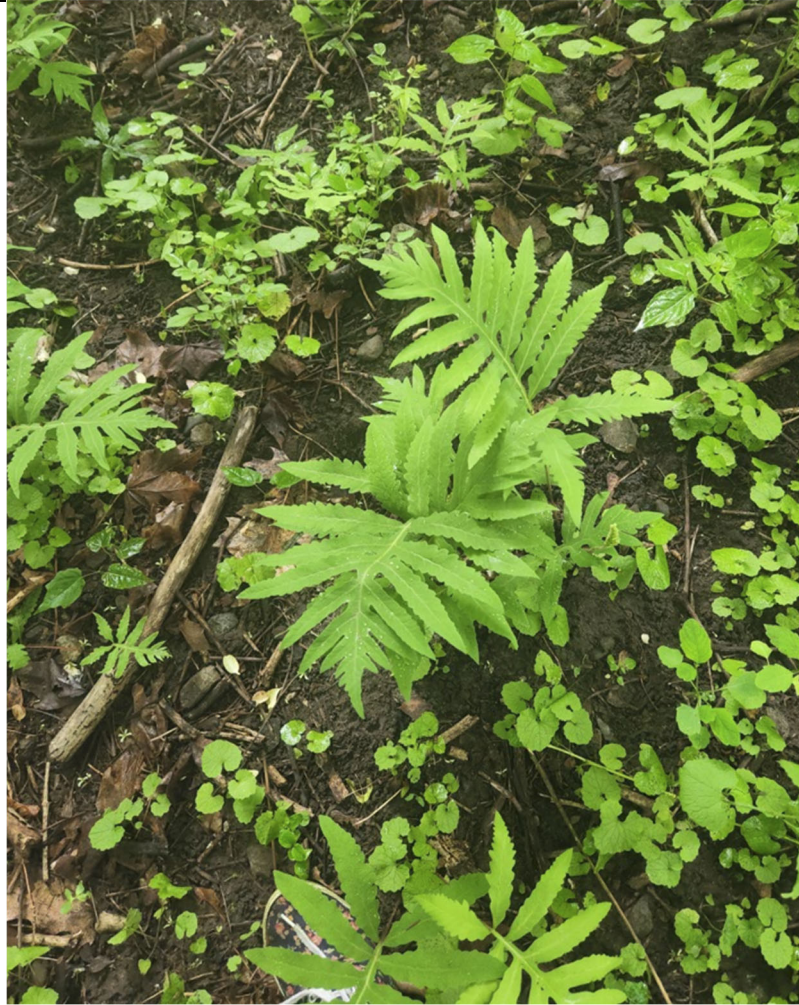
Sensitive fern was seen throughout the site. This is a native species that should remain. Once invasive species are removed, this species will be able to spread and benefit from the recommended planting plan.
