**Re: Initial Dredging Assessment of Pillings Pond  
Lynnfield, Massachusetts  
ESS Project No. 016193.0000.0000**

**Assessment of Pillings Pond**  
Lynnfield, MA

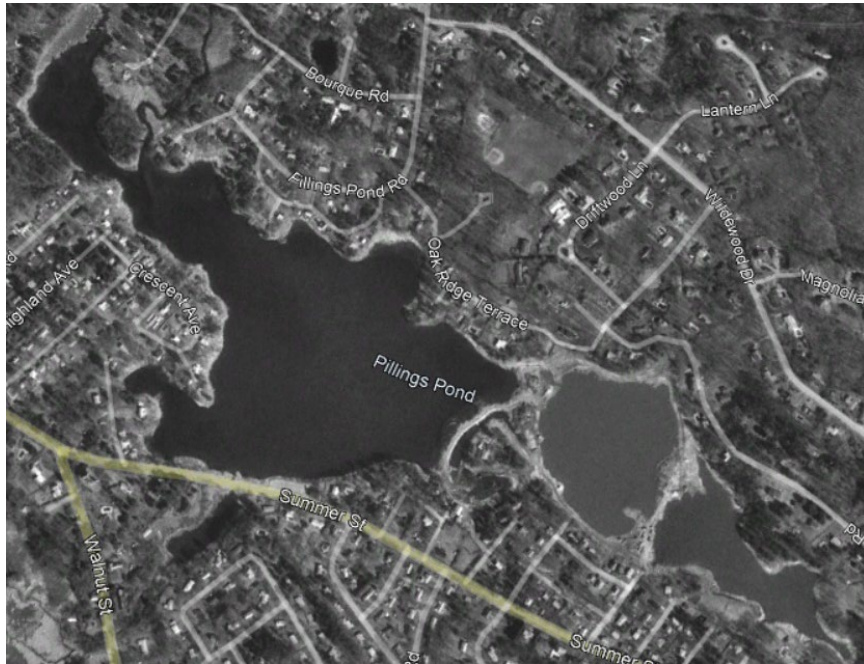
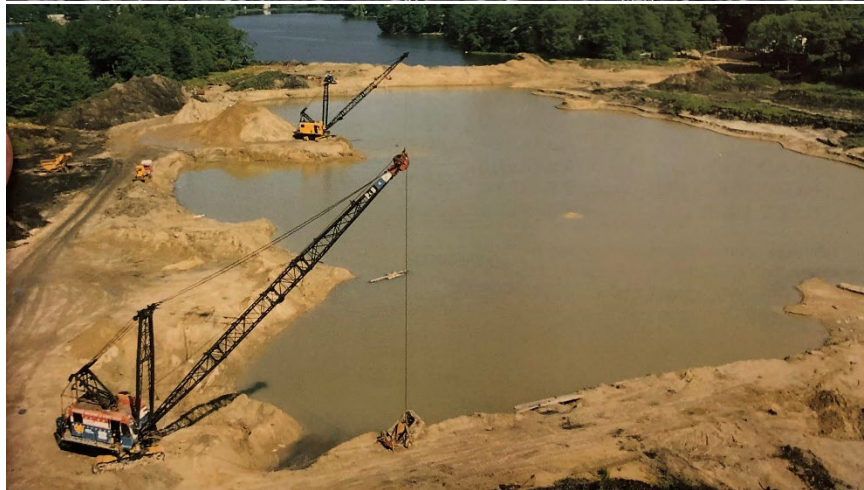
The southeastern half of Pillings Pond was found to have greater water depths, reaching more than 15 feet (Figure 1). The greater water depths in this area are not surprising, given that this is where the

pond was dredged in the 1990s. Water depths elsewhere were shallow, typically less than five feet. However, water depths in the northwestern extreme of the pond, as well as the areas adjacent to the large island were very shallow, generally one foot or less.

*Historical imagery of Pillings Pond. **Top.** The active dredging operation is clearly visible in the southeastern half of the pond from this 1995 orthophotograph. Source: Google Earth. **Bottom:** Aerial view of dredging at Pillings Pond from an undated oblique aerial photograph. View is from southeast looking toward the northwest. Source: Anonymous.*

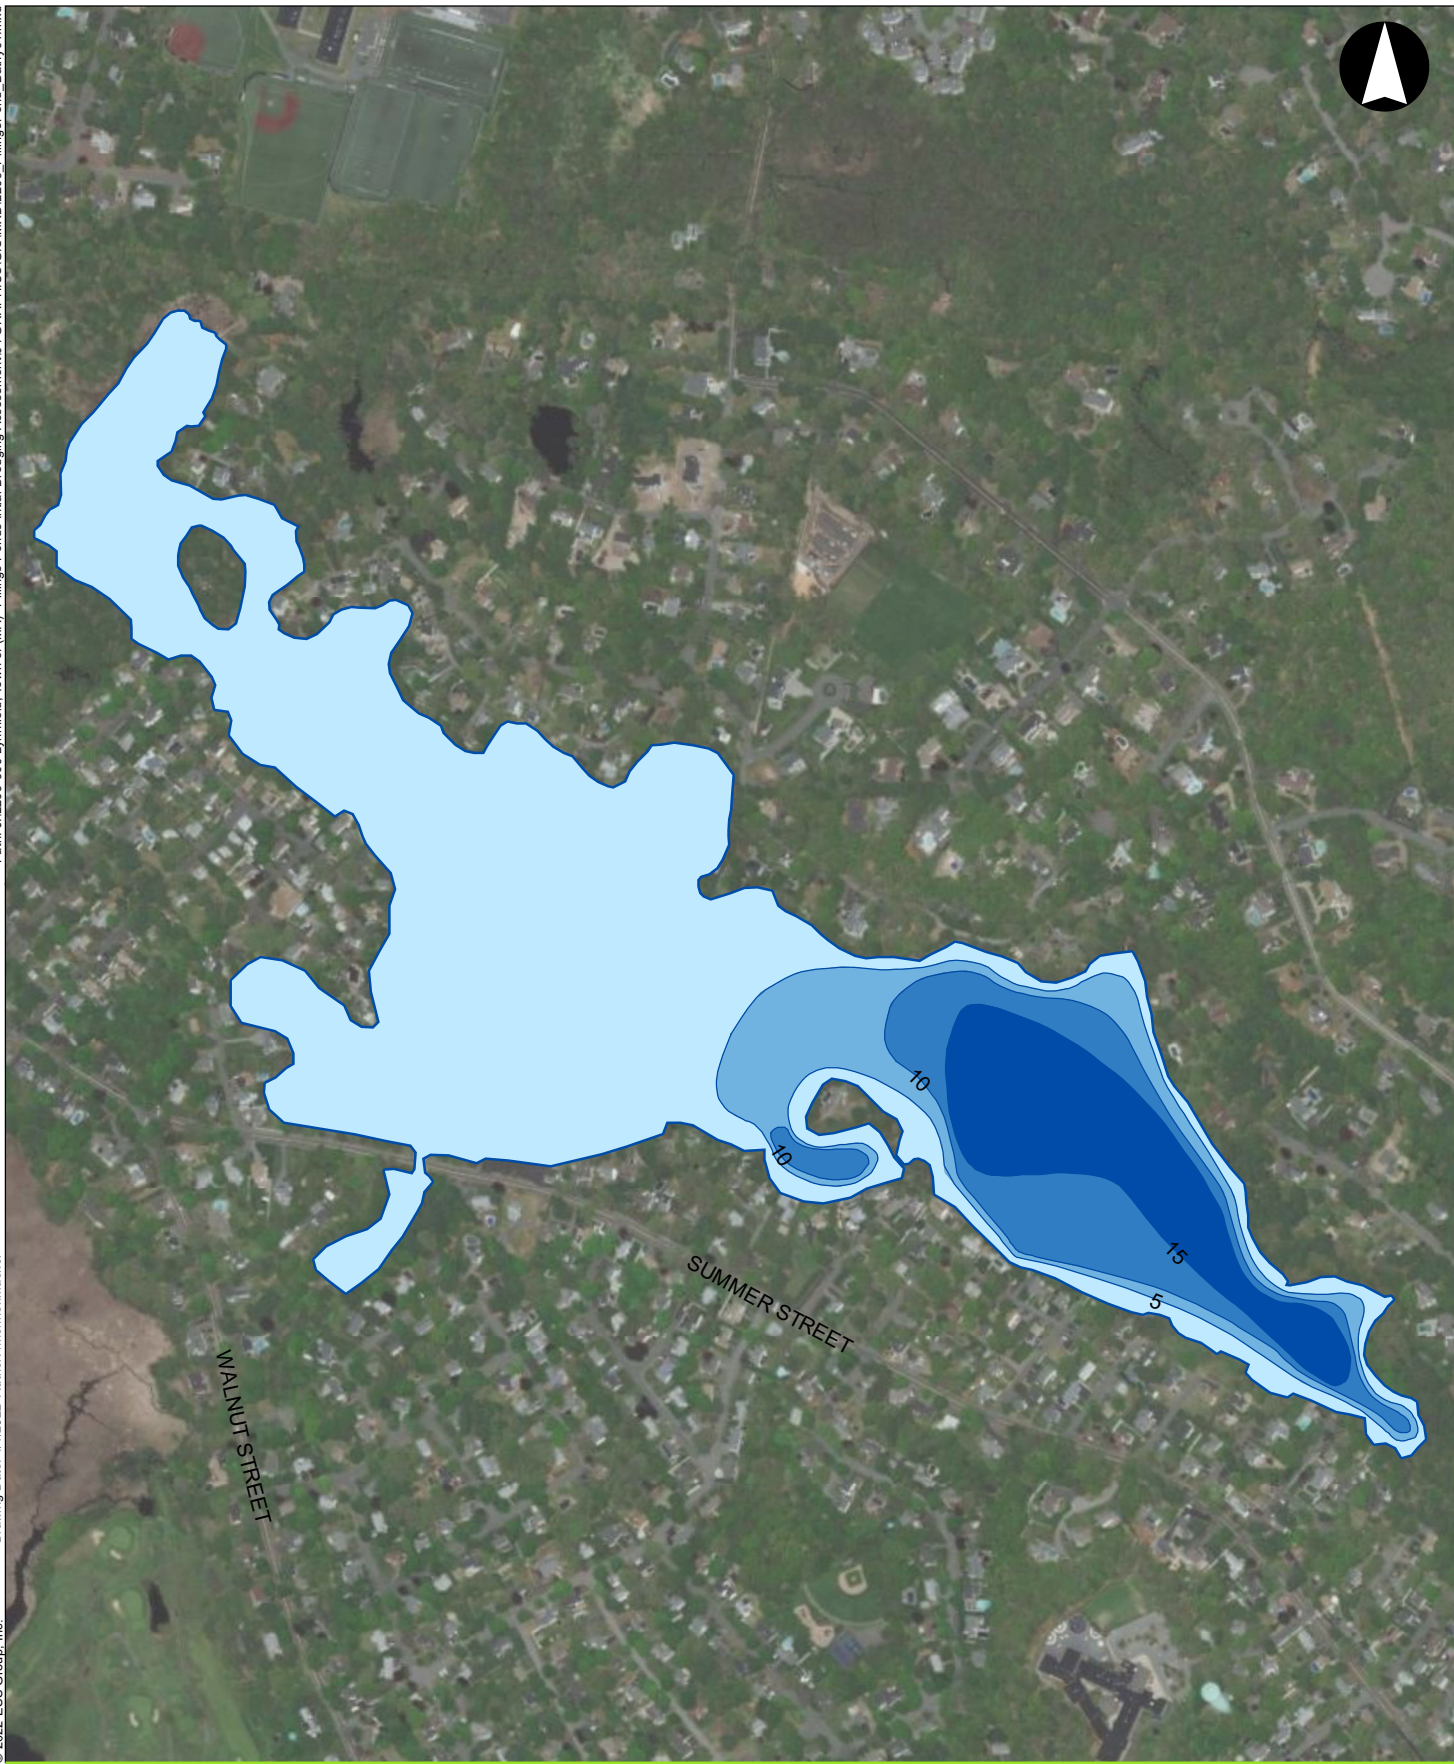
**Figure 1**

**Bathymetry**

— Bathymetry Contours (5 Ft. Intervals)

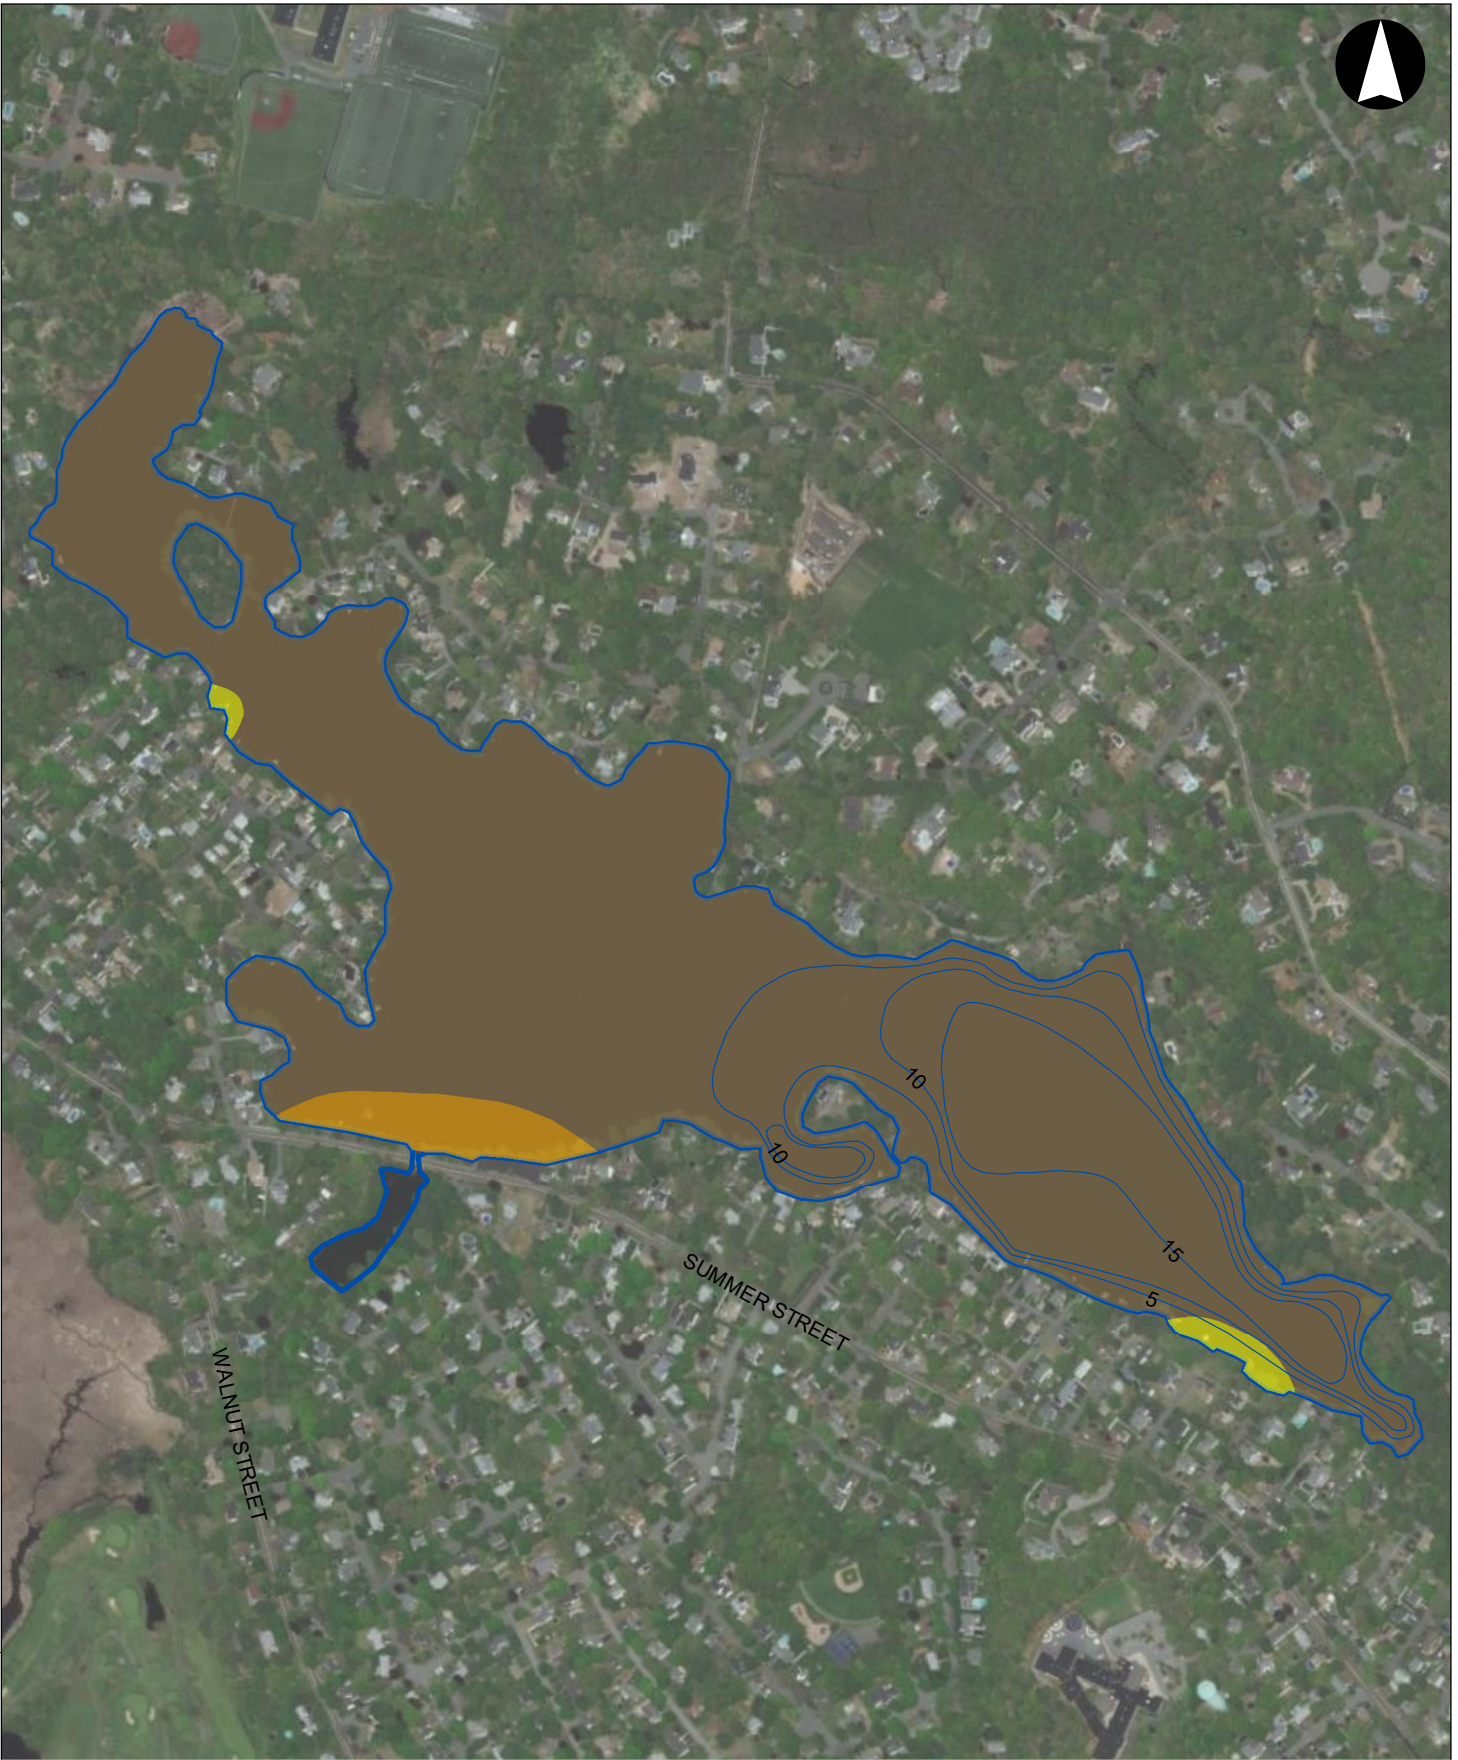
**Substrate Type**

- Coarse (3.5 Acres)
- Muck (94.3 Acres)
- Sand (1.2 Acres)
- Bathymetry Contours (5 Ft. Intervals)

The vast majority of substrate in Pillings Pond appeared to consist of fine organic muck or silt (Figure 2). Areas of exposed sand and coarse substrates (gravel, cobble, and boulder) were primarily confined to the northwestern shoreline and the area near Rotary Park. However, it is likely that these coarse sediments are more extensive below the surface substrate.

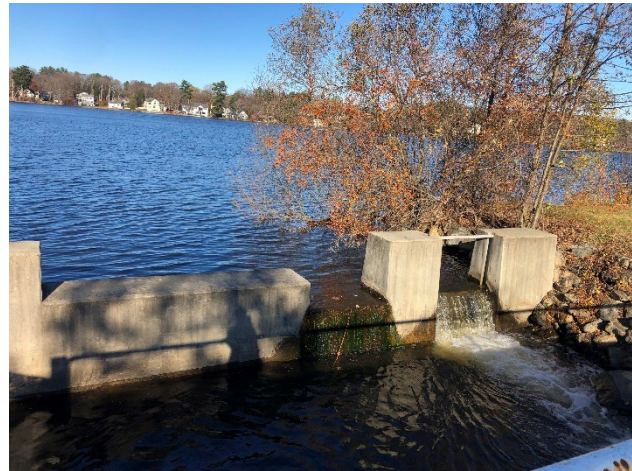
*The spillway at Pillings Pond. A stoplog system appears to allow for some level of drawdown. However, deeper drawdown may require coordinated dewatering of the basin just downstream. This would need to be evaluated further to pursue a conventional “dry” dredging project.*

Dry dredging requires drawdown of the pond to allow sediment dewatering and the use of conventional excavation equipment. The outlet of Pillings Pond located on Summer Street appears to allow some level of water level control by means of a stop-log control system. This type of control system may allow for the pond to be drawn down, which would be helpful if conventional “dry” dredging was the desired dredging method. Typically, conventional dry dredging is best completed during the winter months when cold temperatures enhance access for dredging equipment and make for improved handling of excavated sediments. This is particularly true in cases where fine sediments account for a large portion of total material. Additionally, the reduced metabolic activity of wetland and aquatic organisms at this time of the year reduces stress from dredging disturbance.
