FIELD NOTES SUMMARY

Customer: Town of Lynnfield (Pillings Pond)

Site Location: Lynnfield, MA **Date:** 5/8/23, 1:15 PM

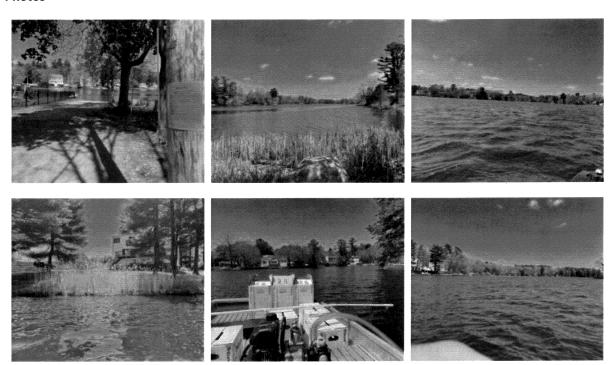
As planned, and based on the surveys, a treatment was conducted for the control of curly leaf pondweed (invasive). The liquid herbicide, diquat, was applied using a treatment boat equipped with a calibrated sub-surface injection system (Photo 5). This application methodology allows for even coverage within the treatment areas. A map of the curly-leaf pondweed is attached. The treatment was completed without issue. Prior to the treatment, the shoreline was posted with neon pink posters noting the treatment, affiliated water-use restrictions, and Water & Wetland contact information (Photo 1).
