Re: **Walnut Street Traffic Assessment**

As requested, BETA Group, Inc. (BETA) has completed our review of the Walnut Street Traffic Assessment in the Town of Lynnfield, Massachusetts. Five main sources provided necessary input for this study, including:

The study area consists of a segment of Walnut Street bounded by the intersections of Gianna Drive to the south and Market Street to the north, including three signalized and three unsignalized intersections. The study includes a qualitative study of the Walnut Street intersections with: the I-95 (Exit 43) southbound ramps and Market Street; the northbound ramps; and Salem Street. In addition, an origin-destination study was conducted in the study area. **Figure 1** shows the location of the study intersections along with an Origin-Destination key.

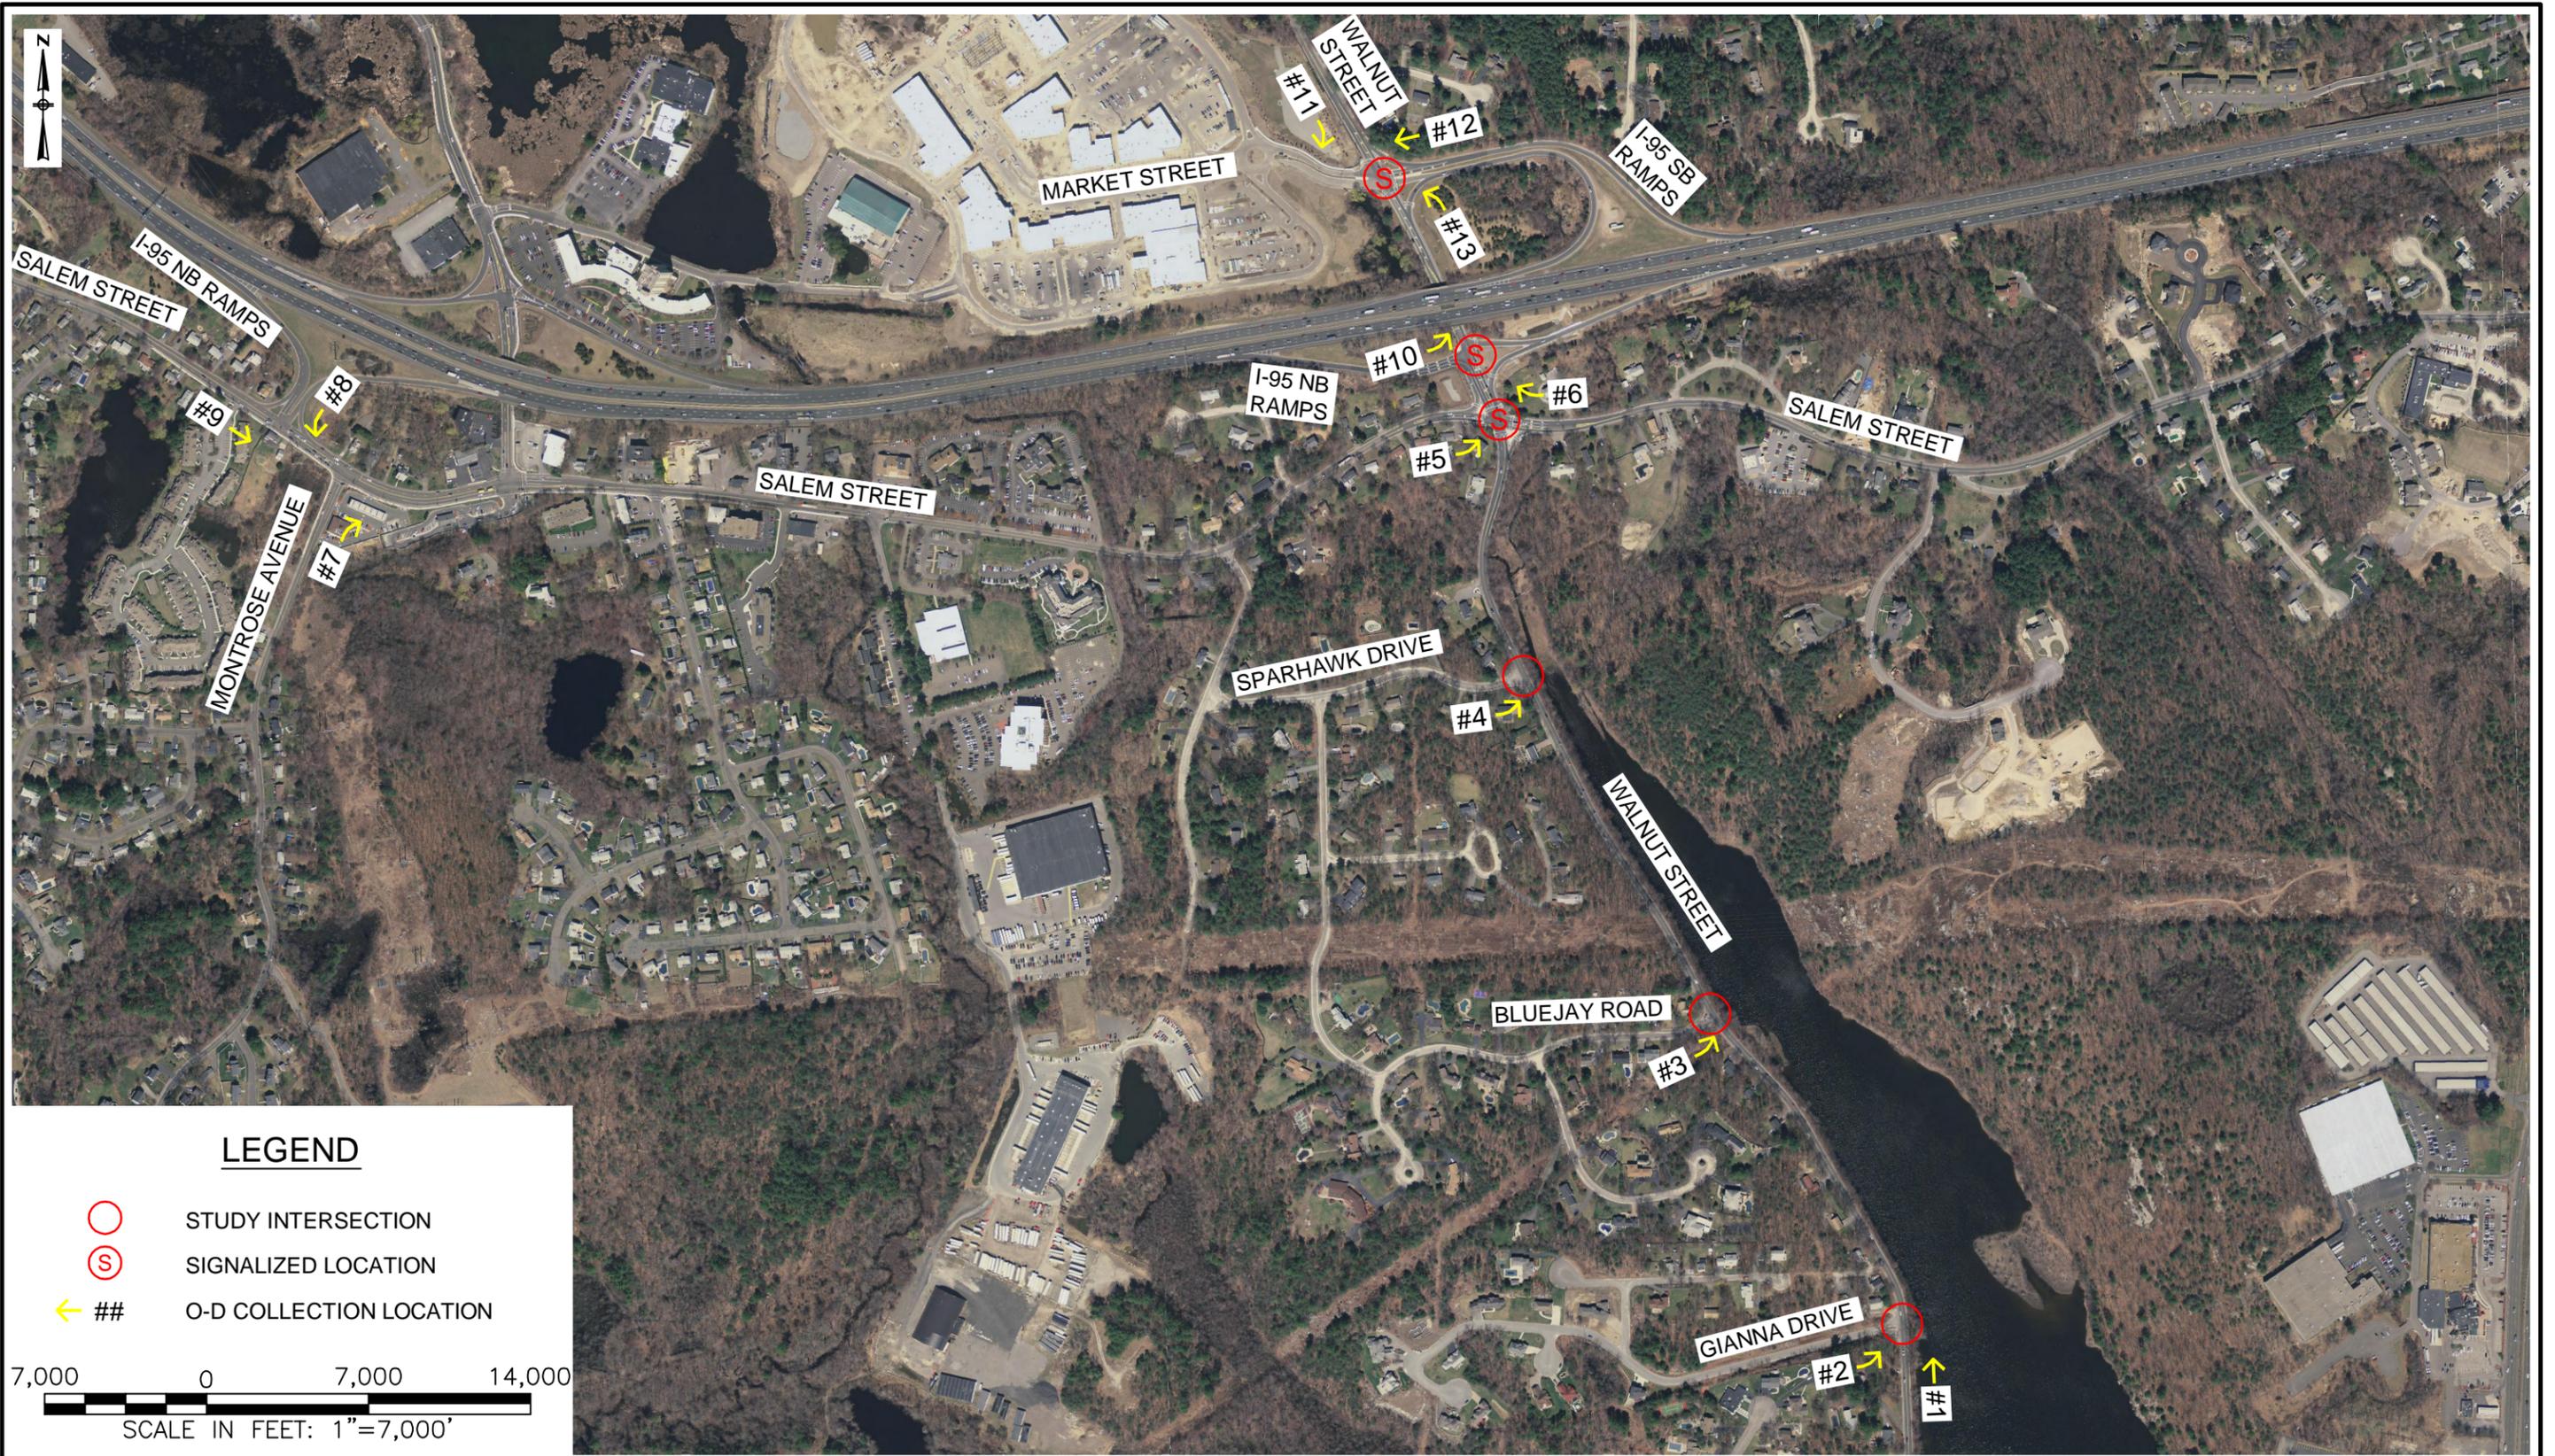
Figure 1

- STUDY INTERSECTION
- S SIGNALIZED LOCATION
- ← ## O-D COLLECTION LOCATION

Project Key

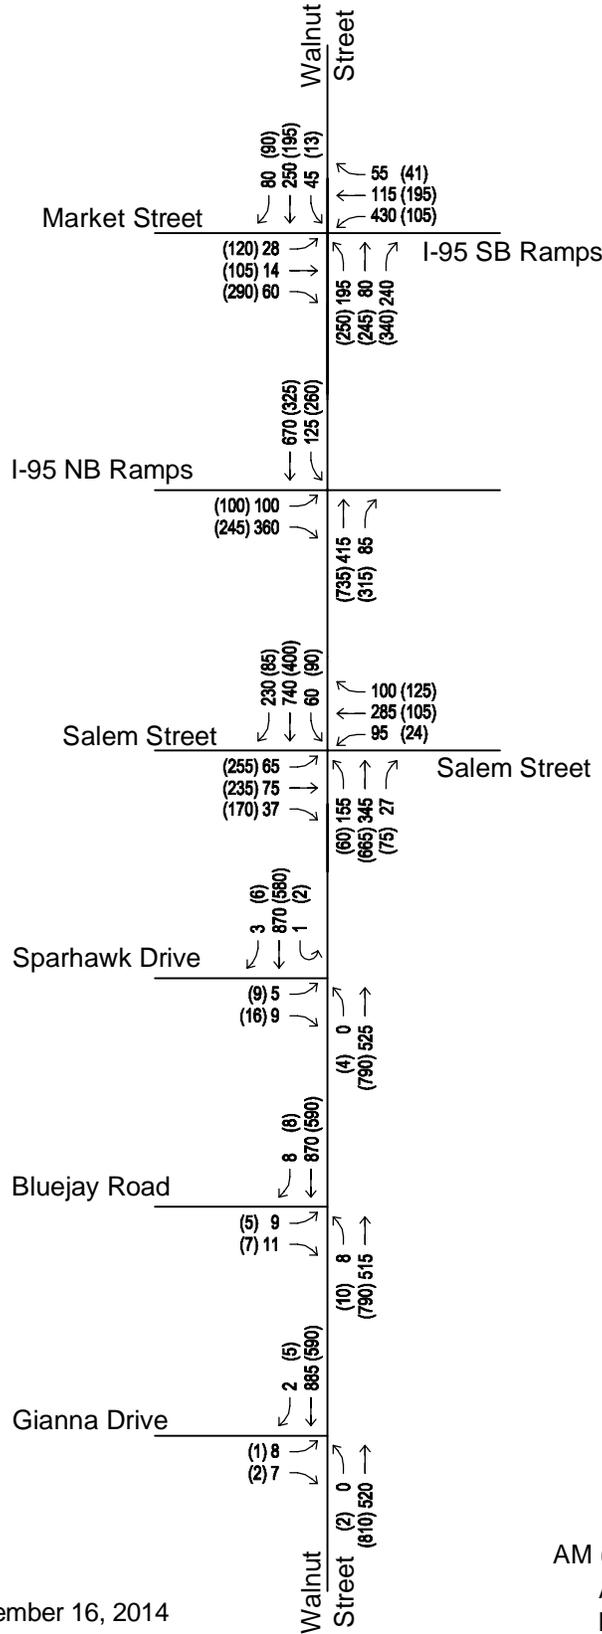
Figure 2

Count Date: Tuesday December 16, 2014

Existing (2014) Peak Hour
Turning Movement Volumes

Based on the peak hours of the project locations, the overall peak hours for the corridor were 7:30-8:30 AM and 4:30-5:30 PM. The peak hour turning movements are shown in **Figure 2**.

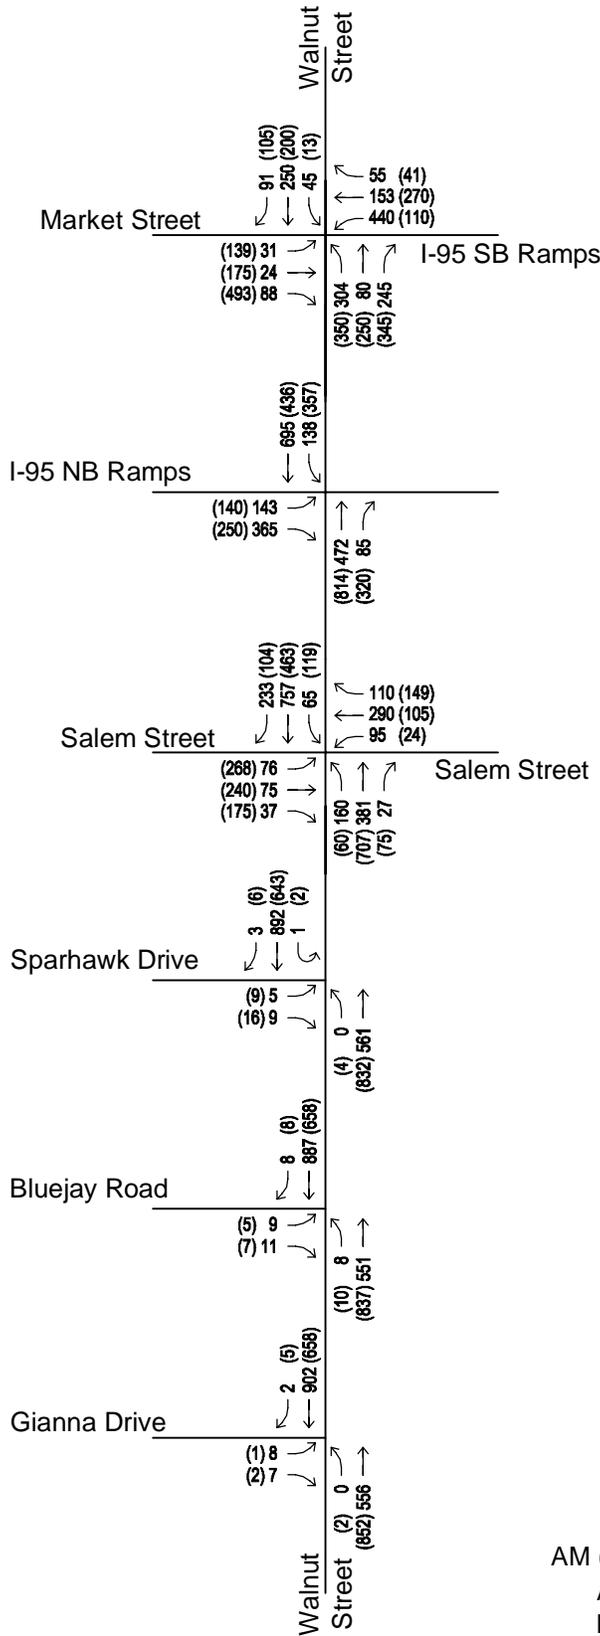
Figure 3
 Build (2017) Peak Hour
 Turning Movement Volumes

AM (PM) Peak Hour Traffic Volumes
 AM Peak Hour = 7:30 - 8:30
 PM Peak Hour = 4:30 - 5:30

Site generated trips were added to the traffic growth, to create a Build (2017) network shown in **Figure 3**. These volumes were then analyzed without any changes to the existing signal timing or phasing and compared with the Forecasted results in the MeadowWalk report. After comparison with the Forecasted analysis and the October 2014 Counts, it was determined that a significant portion of the counts from the MeadowWalk report were forecasted higher than expected. The October 2014 Counts were compared with the December 2014 Counts, and were determined to be an accurate representation of the traffic throughout the corridor. It was decided to use the December 2014 data for further analysis and disregard the MeadowWalk results. A complete summary of the results of the signalized capacity analysis are shown in **Table 3**, and a comparison of Build (2017) results are provided in **Table A-1** in the appendix.

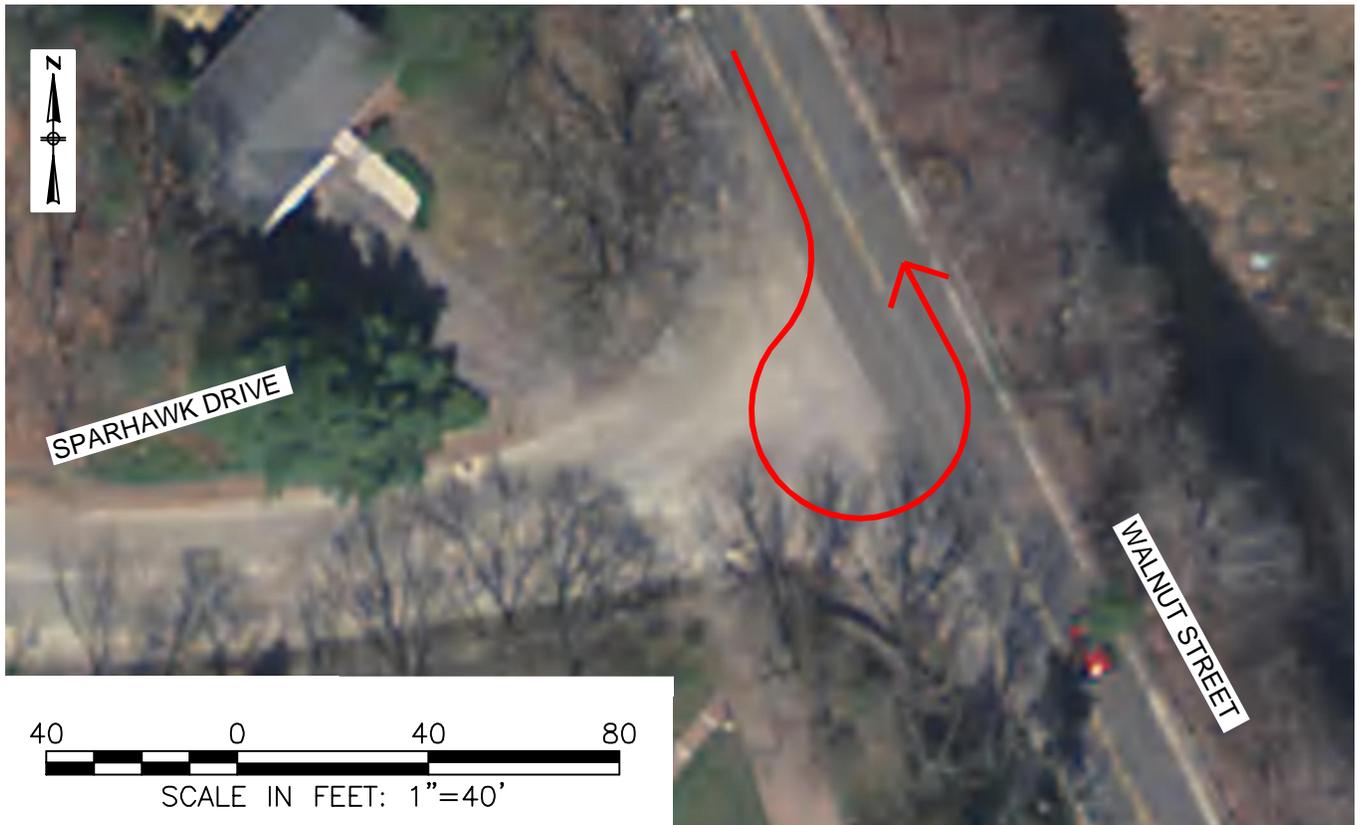
Figure 5

TIME	SB U-TURNS
4:00 - 4:15 PM	0
4:15 - 4:30 PM	2
4:30 - 4:45 PM	0
4:45 - 5:00 PM	0
5:00 - 5:15 PM	1
5:15 - 5:30 PM	1
5:30 - 5:45 PM	0
5:45 - 6:00 PM	1
TOTAL	5

U-Turns at Sparhawk Drive

Sparhawk Drive was the only one of the three residential side streets observed to have U-Turns. These U-turns all headed southbound, with two U-Turns occurring in the morning peak hour and five occurring in the afternoon peak hour. **Figure 5** shows the breakdown of U-Turns by 15-minute interval as well as the movement of these U-Turns. No U-Turns occurred at either Bluejay Road or Gianna Drive.

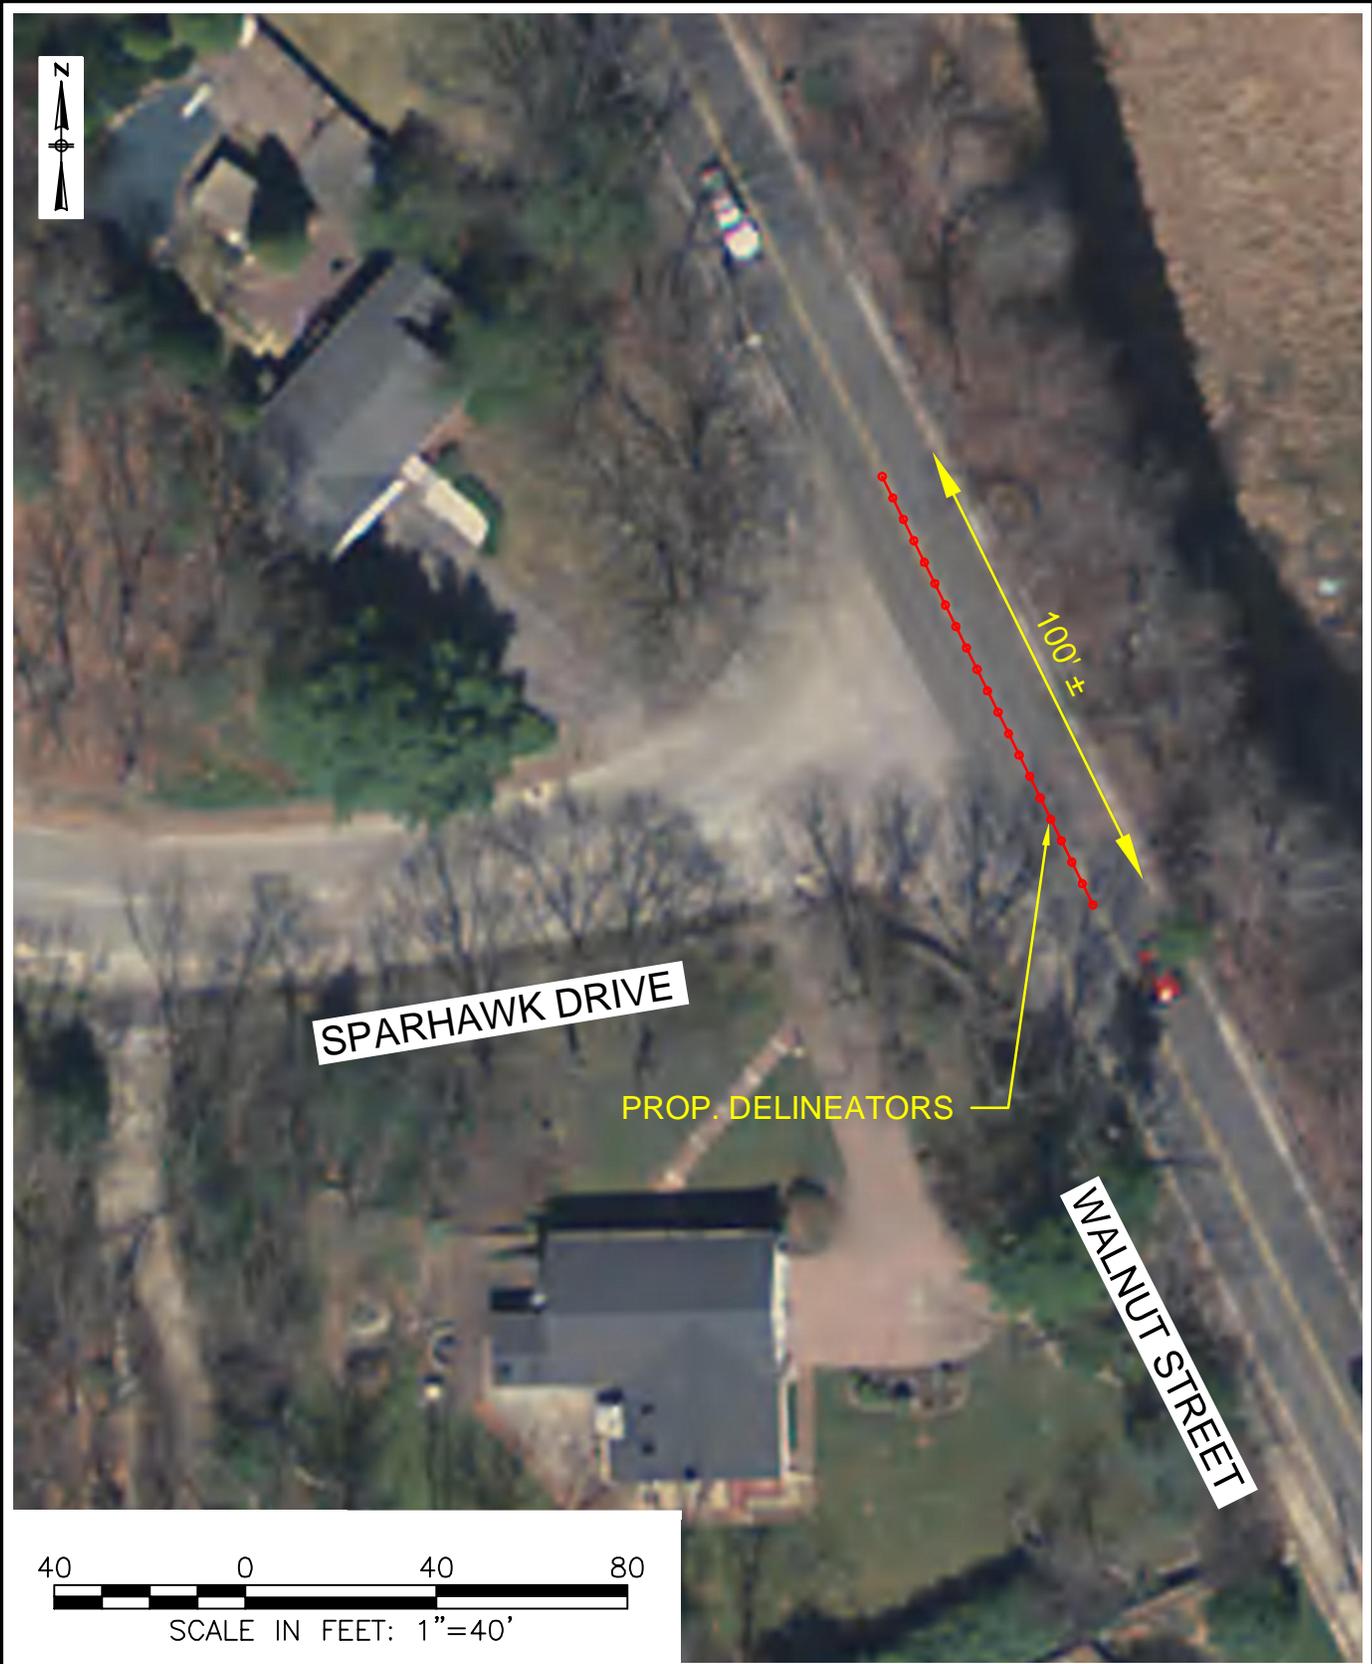
Figure 6

Proposed Improvements
at Sparhawk Drive -
Walnut Street Delineators

- Install delineators along the centerline of Walnut Street in the vicinity of Sparhawk Drive. This would prevent U-Turns for either northbound or southbound vehicles. It would also, however, prevent left turns out or into Sparhawk Drive, and would divert these moves to Bluejay Road or Gianna Drive. Delineators are suggested because the Walnut Street is not wide enough to have a raised island. See **Figure 6**.

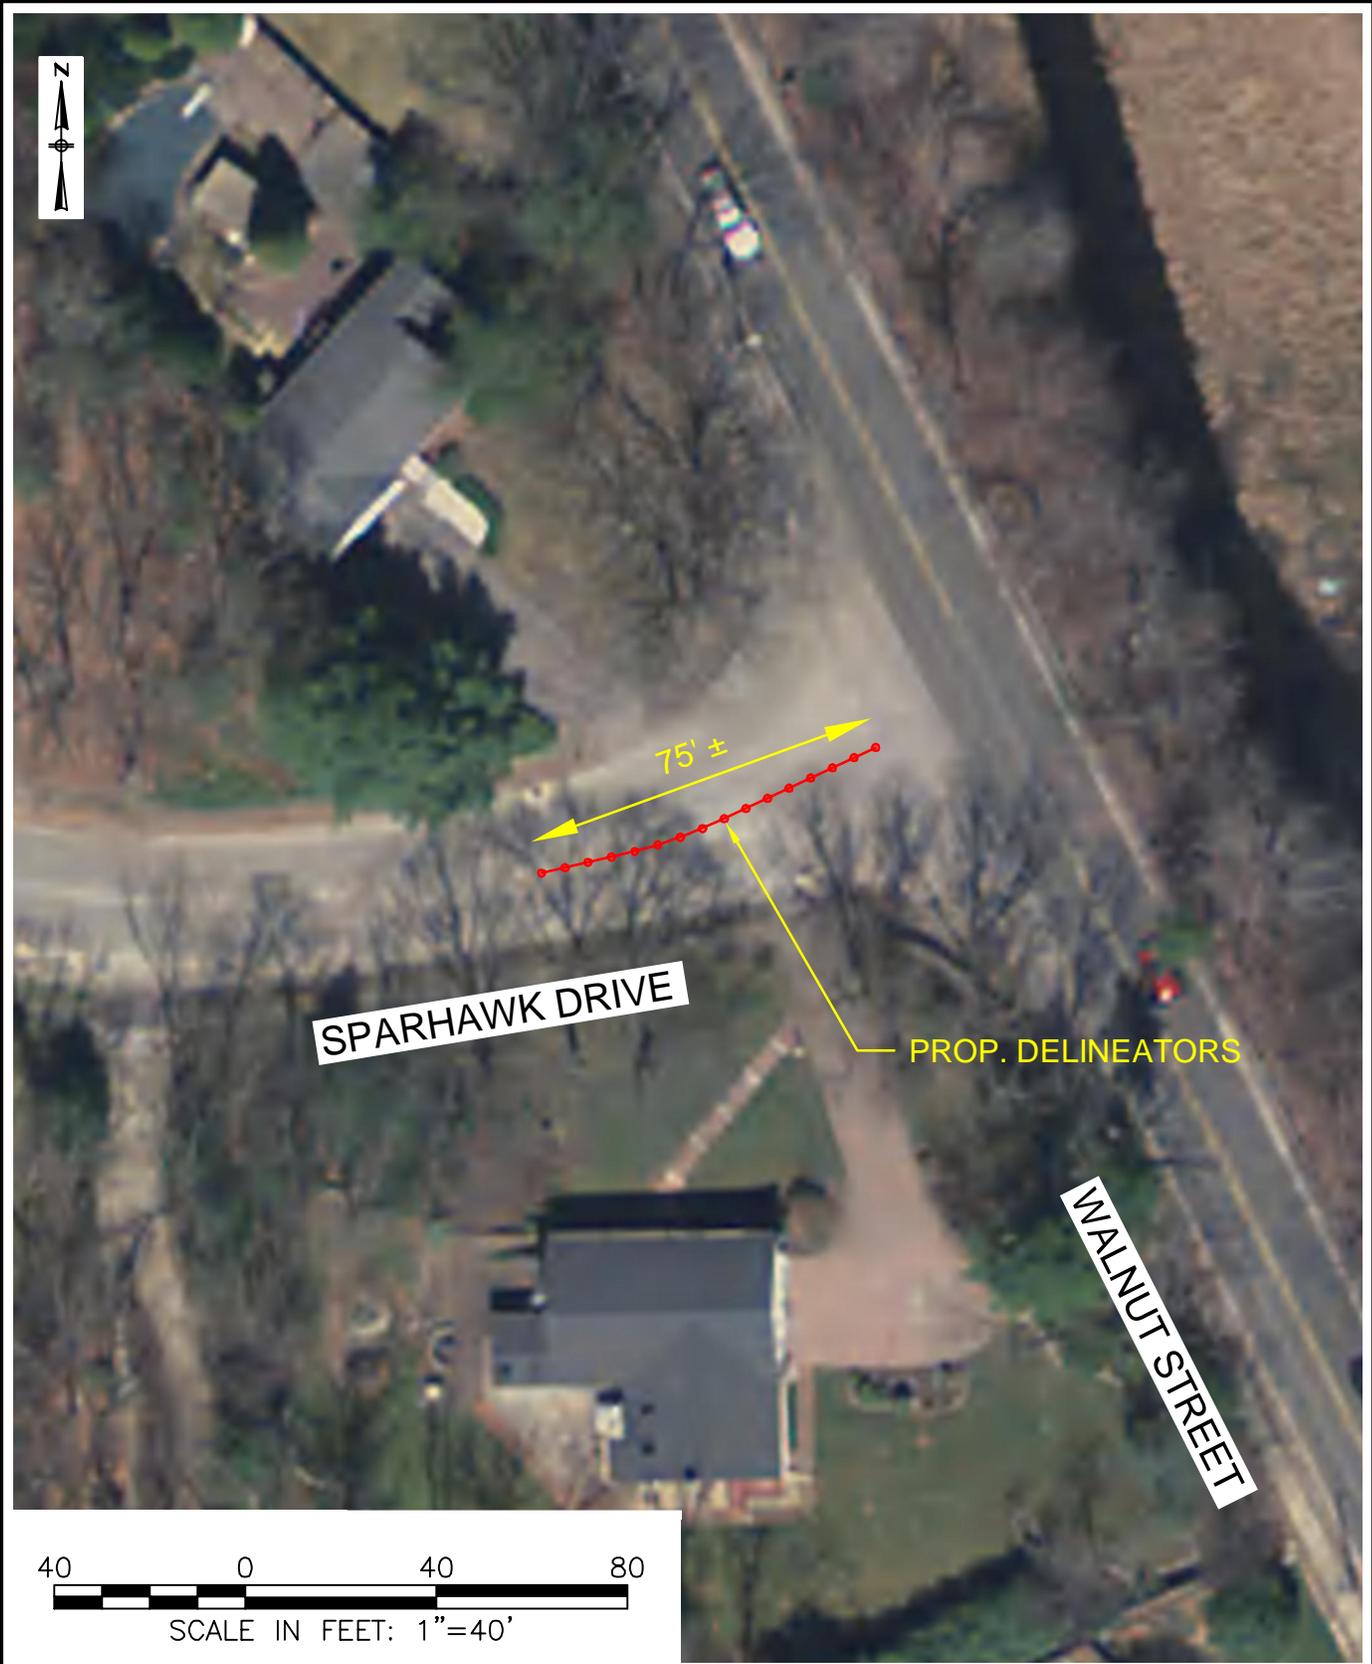
Proposed Improvements
at Sparhawk Drive -
Sparhawk Drive Delineators

- Install delineators along the centerline of Sparhawk Drive at the approach to Walnut Street. This would prevent U-Turns. Delineators could be damaged during plowing activity and could therefore provide a less permanent solution. An advantage of this measure is that access/egress for residents would not be disrupted. See **Figure 7**.
- Install a raised median island. This would also prevent U-Turns, and would not disrupt access/egress for residents. The estimated construction cost would approximately \$10,000, including signage and striping. See **Figure 8**.
- Narrow Sparhawk Drive to physically prevent U-Turns. This would only prevent U-Turns within the roadway limits. Private drives to residences exist on each side of Sparhawk Drive, and it is likely that motorists would use these drives to make a three-point turn to change directions. See **Figure 9**.

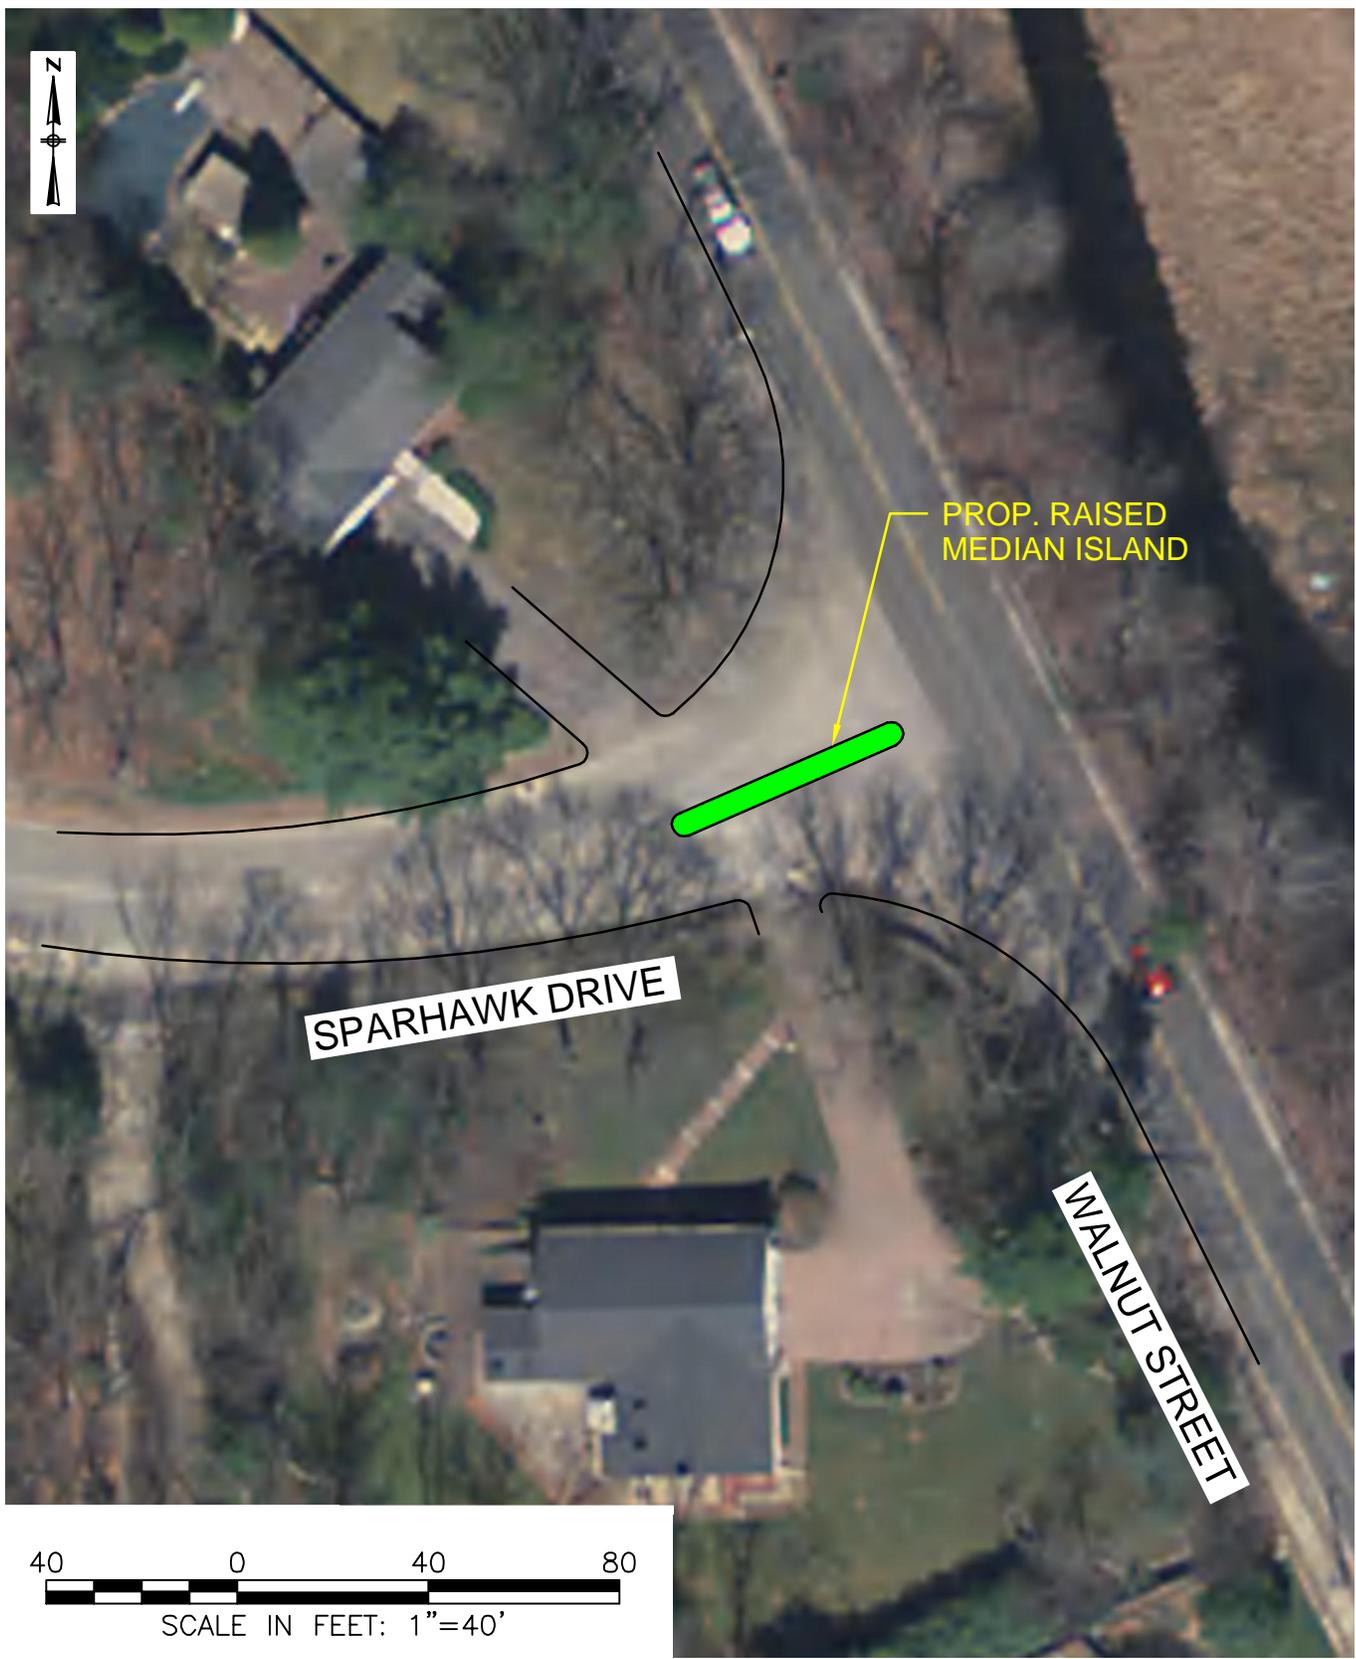
Figure 8

Proposed Improvements
at Sparhawk Drive -
Sparhawk Drive Raised Median
